Bass Lake Subwatershed 2018 Conditions Report

Bass Lake is a shallow, warm-water lake located in Oro-Medonte Township, west of Orillia. The underlying geology in the watershed is limestone-based, resulting in well buffered waters with high pH. The lake is fed by a combination of ground and surface water, with several inflowing streams, both permanent and intermittent. The lake discharges via the North River at the northwest end of the lake.

This report describes the current status, trends, and baseline conditions for Bass Lake. It is supported by the Township of Oro-Medonte and contains data from SSEA, the Nottawasaga Valley Conservation Authority (NVCA), Ministry of Environment Conservation and Parks (MECP), and the MECP's Lake Partner Program (LPP).

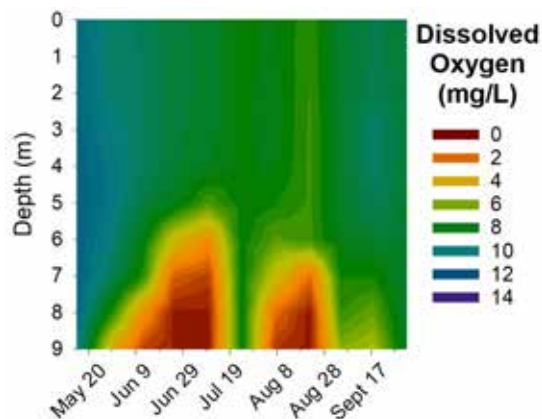
2018 dissolved oxygen contour plot for Bass Lake based on oxygen profiles collected through the water column.

Reds indicate low oxygen conditions (<2 mg/L).

Along with a temperature gradient, Bass Lake also experiences an oxygen gradient. Below 7 m, oxygen levels become depleted from mid June to late August, reaching anoxic levels (<2 mg/L). Winter sampling by NVCA in 2009 indicated that an under-ice drop in oxygen also occurs. This is likely a recurrent phenomenon. Low oxygen can restrict fish movement and even lead to fish kills, and causes the release of iron from lake sediment, which can fuel algae growth.

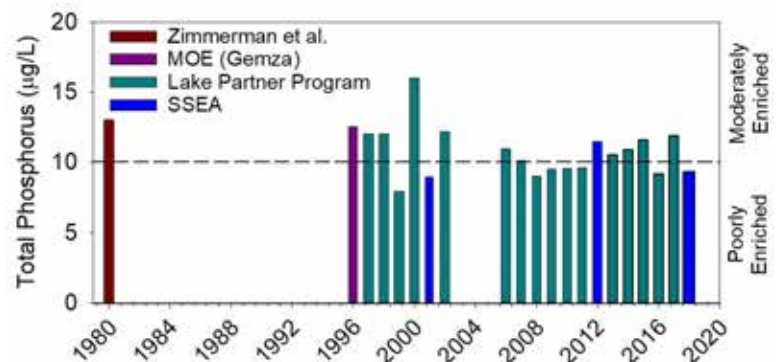
Mean annual total phosphorus from 1980-2018. Multiple data sources were used, including volunteer LPP data. The MECP interim guideline for providing a high level of protection against aesthetic deterioration due to nuisance blooms is also shown (10 µg/L; dashed line).

Phosphorus concentrations in the sunlit portion of Bass Lake are low. Levels at 1 m off bottom are also low despite low bottom water oxygen conditions which often lead to higher phosphorus levels due to release from sediments. Nitrate values are low, likely due to rapid uptake by aquatic plants. Total nitrogen values are moderate.

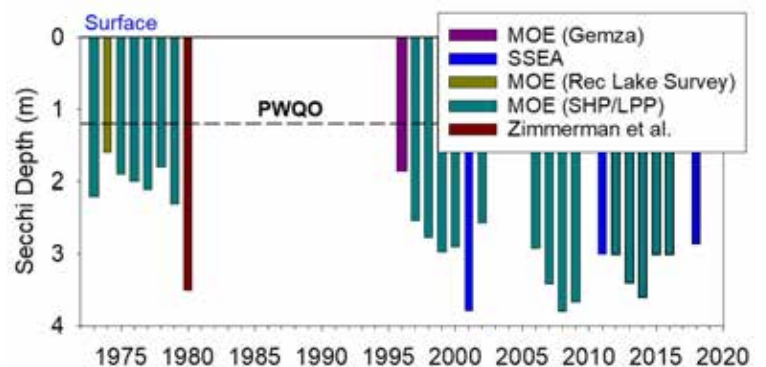
Mean annual Secchi depth from 1973-2018. Multiple data sources were used, including volunteer LPP data. The Provincial Water Quality Objective (PWQO) for swimming safety is also shown (1.2 m; dashed line).

Water clarity in Bass Lake is considered fair to good. Clarity in lakes is described based on the visibility of a Secchi disk. Clarity in Bass Lake increased following the introduction of invasive zebra mussels.

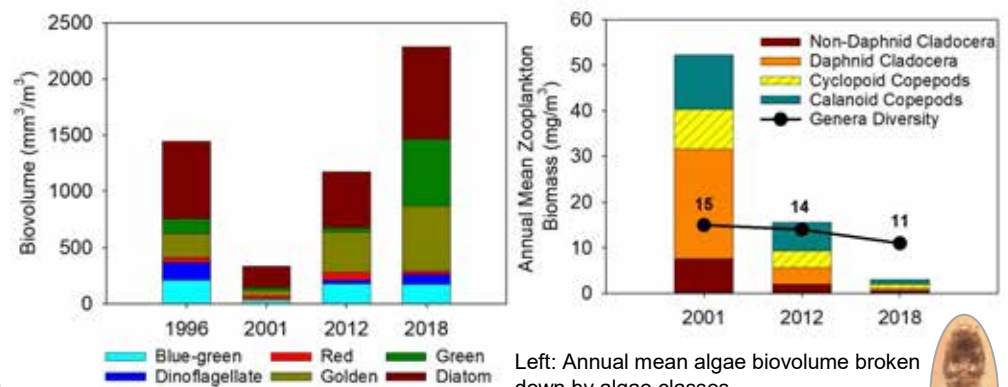
Left: Annual mean algae biovolume broken down by algae classes.

Right: Annual mean zooplankton biomass broken down into major groups, and diversity (numbers shown).

Algae and zooplankton (tiny floating or weakly swimming invertebrates that drift with water currents) form the basis of the lake food web, and both are necessary to sustain healthy fish populations. Past studies have shown moderate algae abundance with communities typical of a moderately enriched shallow lake. 2018 densities were higher than previous years. Nuisance species such as the blue-green algae *Microcystis* are present, but no surface blooms have been reported. Zooplankton biodiversity is relatively low, and 2012 and 2018 surveys have shown drastic reductions in population density and biomass. This warrants further monitoring as ripple effects may occur through the food web, such as increased algae production, and decreased fish populations.

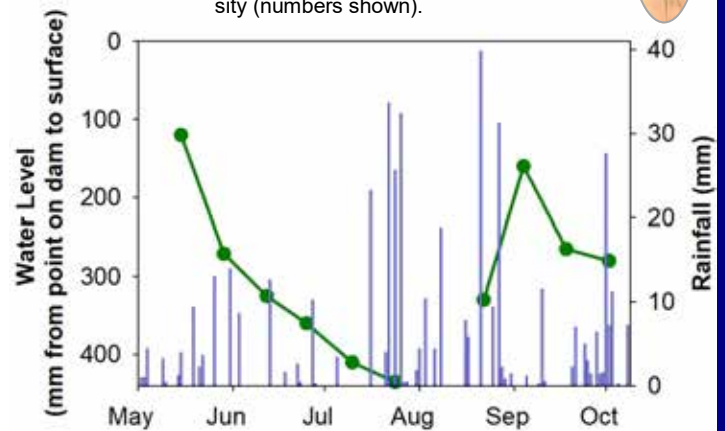
Bass Lake water levels for 2018 (green points) measured biweekly. Also shown is daily rainfall from the Orillia climate station (blue bars).

Bass Lake water levels are regulated by a small stop-log dam at the outlet to the North River (northwest end of the lake) which is managed by the Bass Lake Ratepayers Association. Stop logs are put in place in the spring and removed in the fall, or as needed. Water level limits are set by the Ministry of Natural Resources and Forestry (MNR). Water levels are typically high in spring and fall.

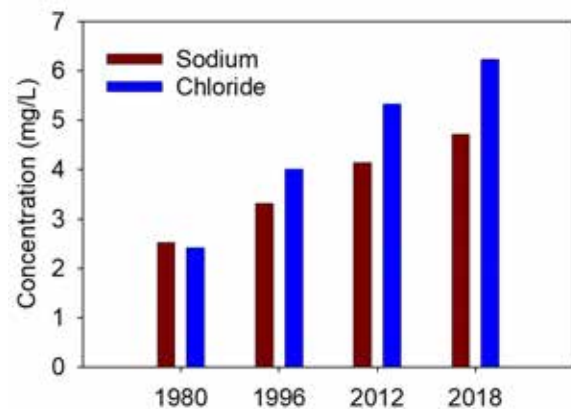
Annual mean sodium and chloride concentrations for Bass Lake.

The most common source of sodium and chloride in lakes is from winter application of de-icing salts. Chlorides can also enter waterways from septic effluent. Concentrations of sodium and chloride have been steadily increasing in Bass Lake and the North River, however sodium has not exceeded the Ontario Ministry of Health and Long-Term Care guideline (20 mg/L) in the lake. Chloride levels are well below the CCME guideline for protecting aquatic life (120 mg/L), however upward trends warrant continued monitoring.

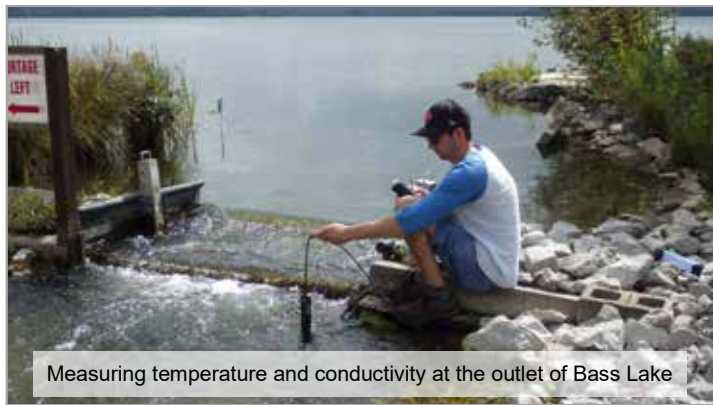
Measuring temperature and conductivity at the outlet of Bass Lake

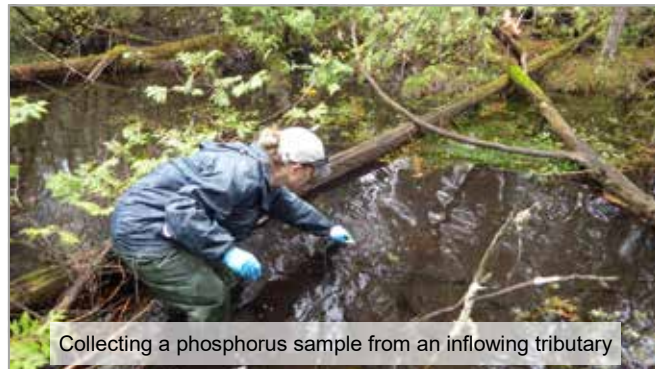
Collecting a phosphorus sample from an inflowing tributary
