Deanlea Beach Investigation

Severn Sound Environmental Association

Prepared by: Aisha Chiandet

For: The Township of Tiny

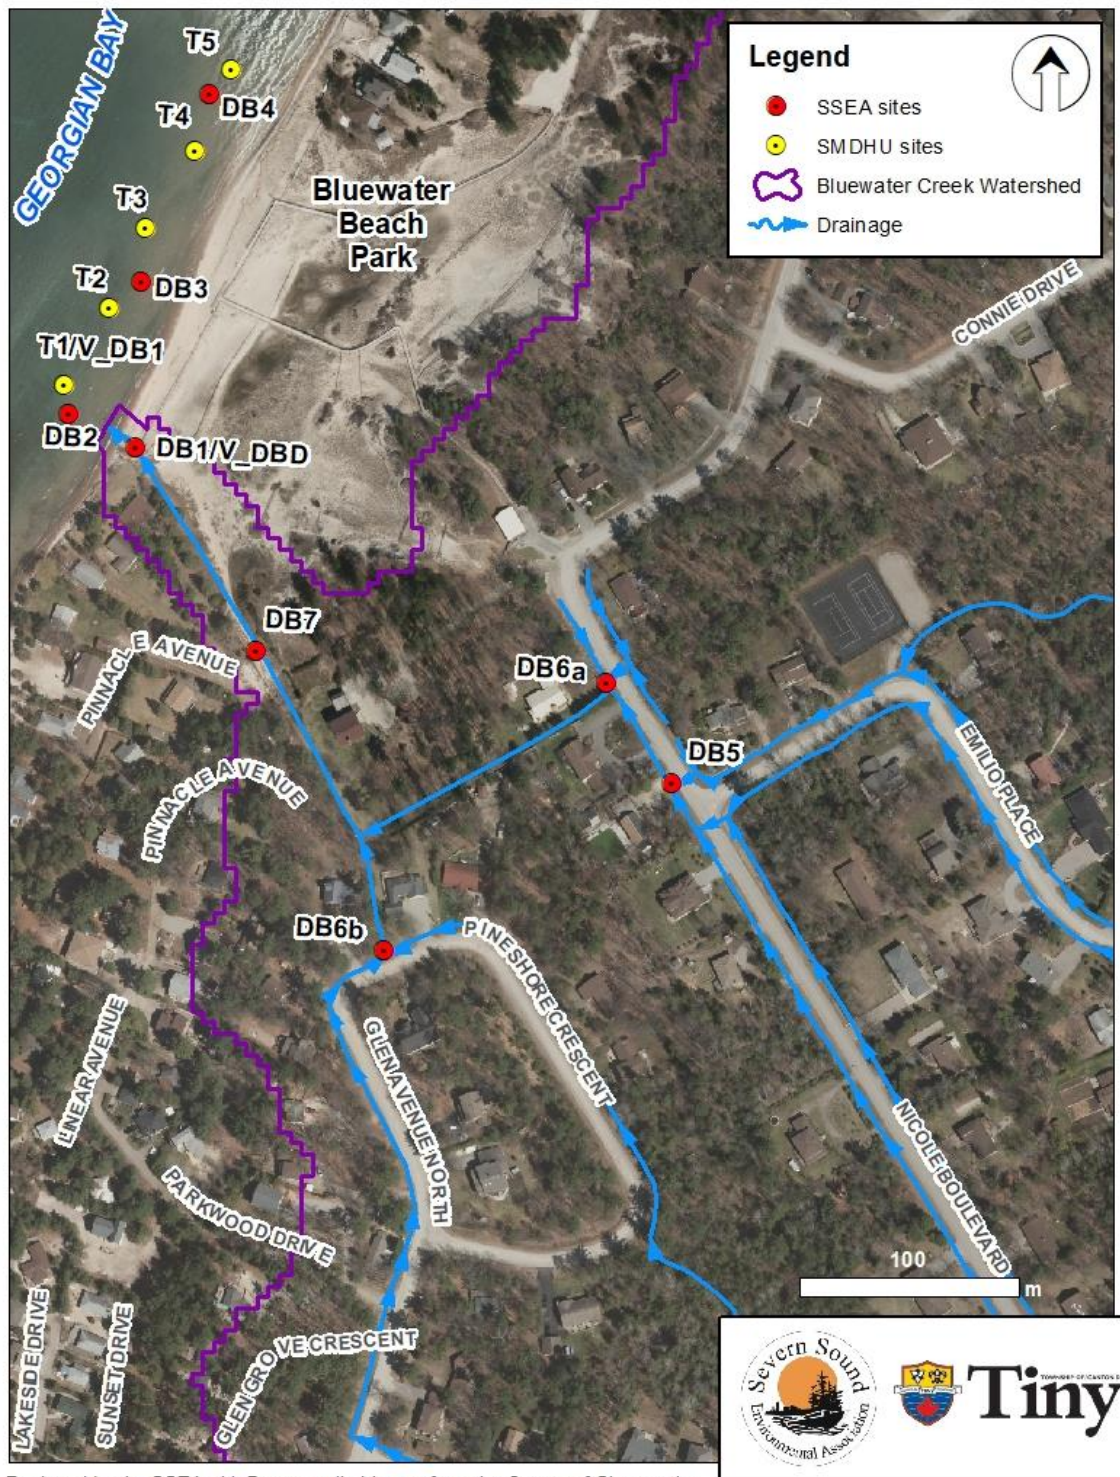
Figure 4. Map showing locations sampled by SSEA (red, DB1-7) and the SMDHU (yellow, T1-5). FOTSA volunteer sampling locations that approximately overlap with SSEA or SMDHU monitoring are also labelled (V_DB1 and V_DBD). Flow directions are depicted by the blue arrows. Ortho-imagery was taken in 2016 at a resolution of 20 cm.

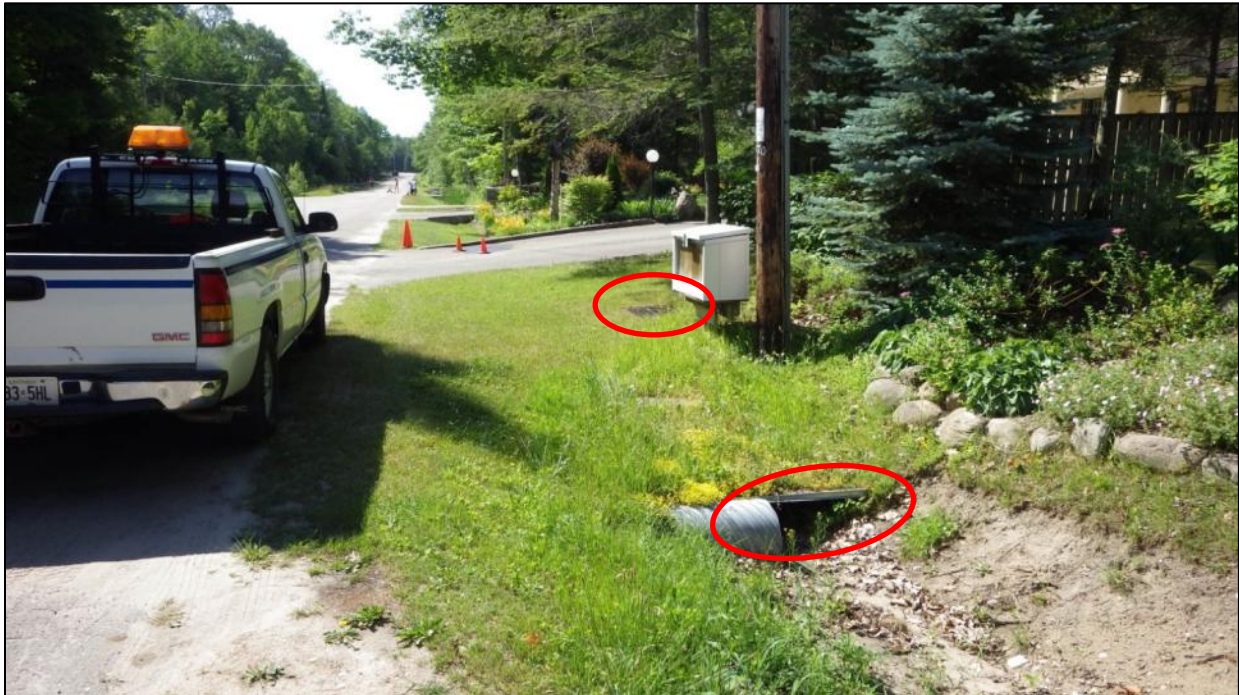
Jul 6 DB6a - Confluence of road ditch from both sides of road. After entering the rectangular culvert (foreground), the drainage disappears to manhole (circled) and onward to DB7.

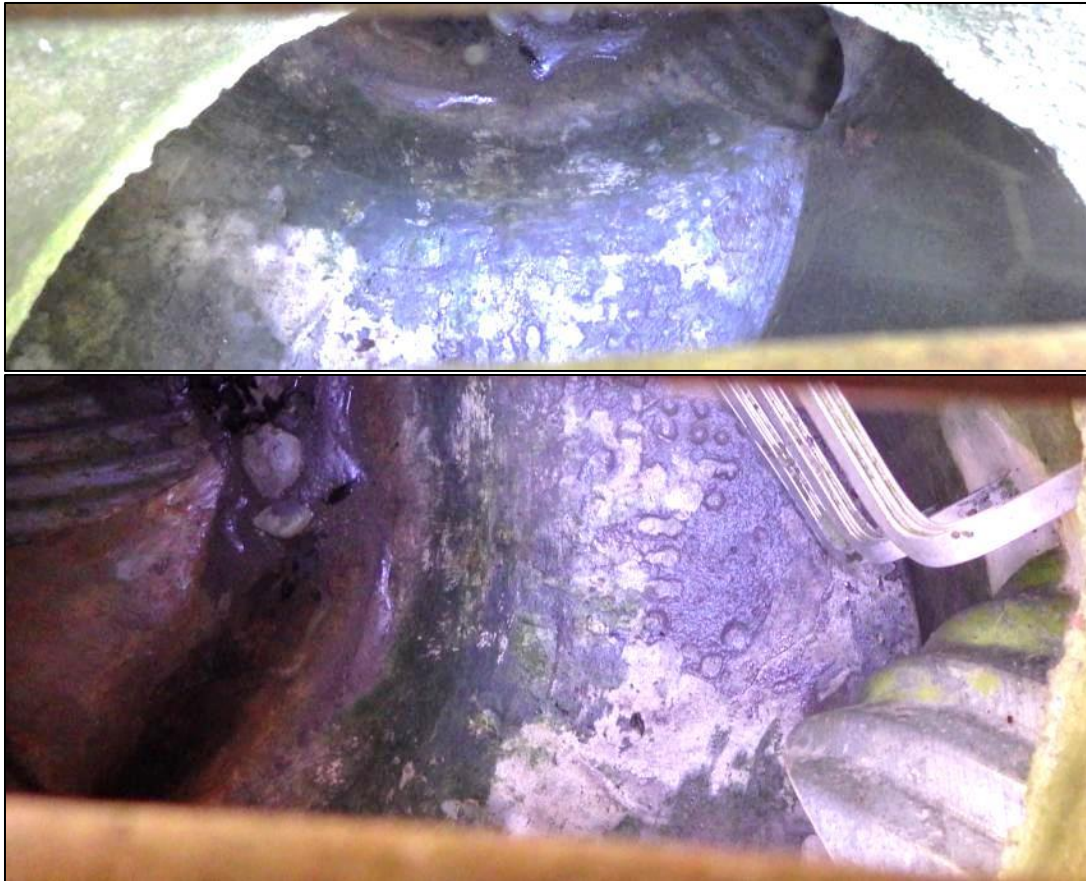
Jul 6 manhole downstream of DB6a - Water could be seen through manhole cover on both dry days (Jul 6 and Aug 3). Flow observed in culvert coming from DB5 direction (culvert in bottom photo). No flow observed in culvert coming from across the road, opposite DB6a (culvert in top photo).

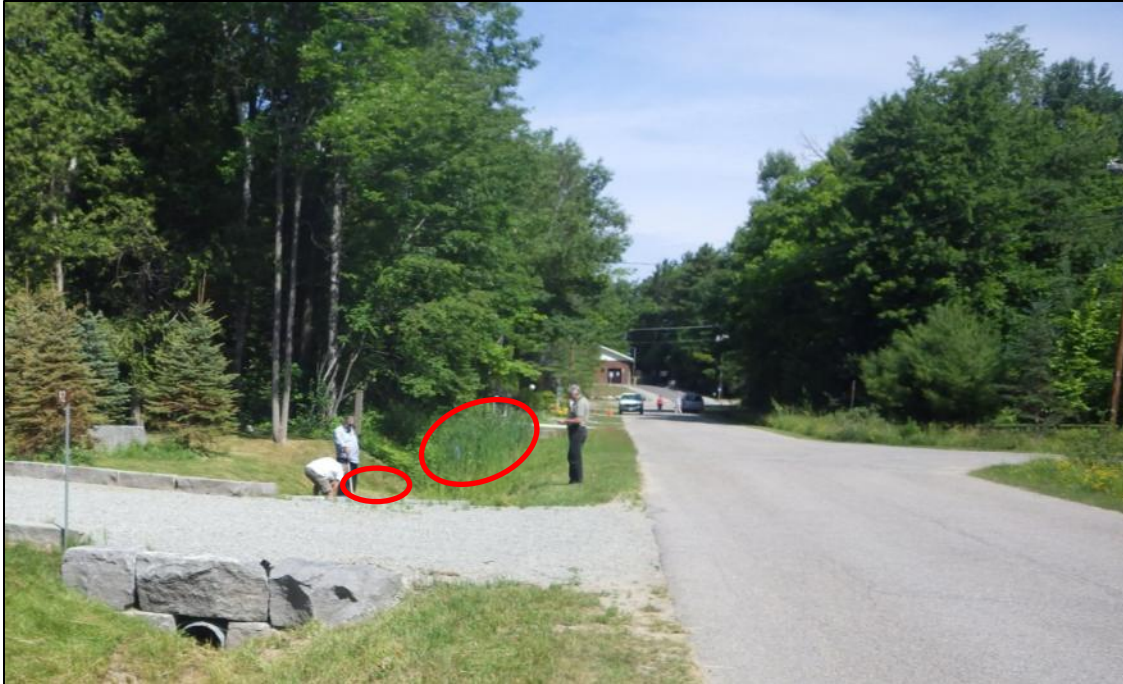
Jul 6 upstream of DB5 - Sump pump discharge on left, wet spot at right; both contributing to flow at DB5 during this dry period.

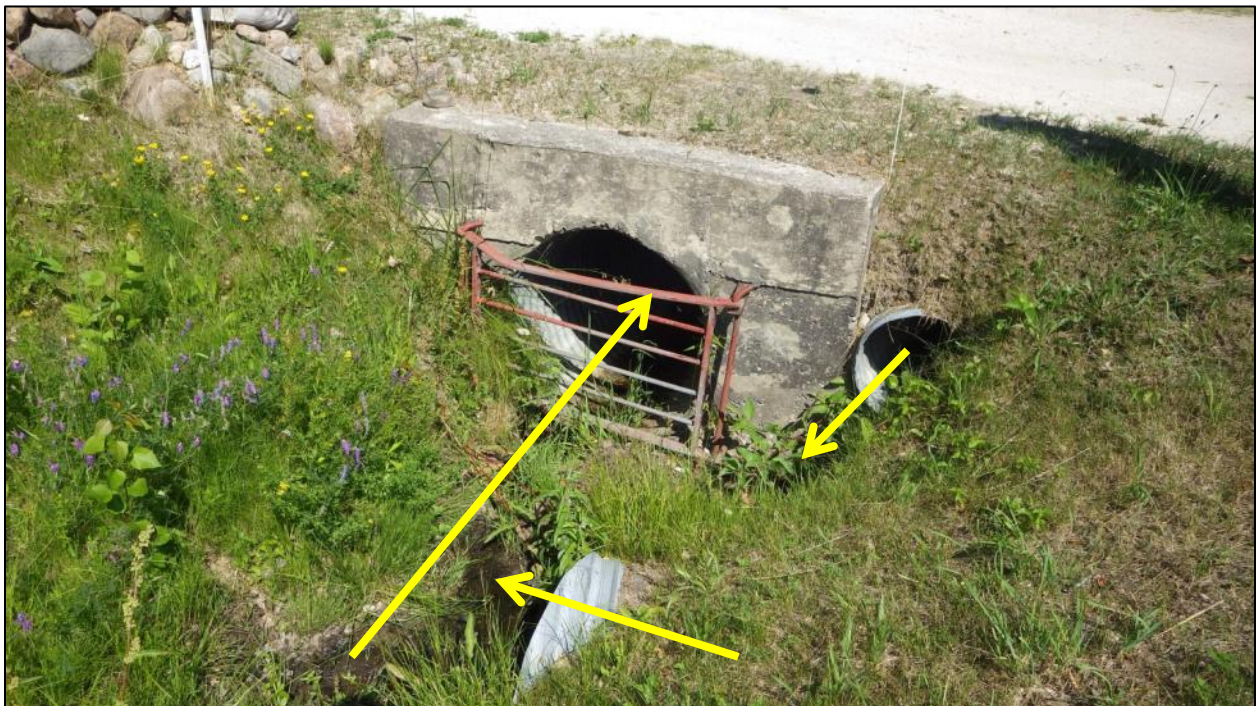
Jul 6 DB5 – Confluence showing overflow ditch culvert which flows in at this location (upper right culvert, dry), road crossing culvert (bottom, water seen flowing in during this dry period) and main culvert that goes to the manhole downstream of DB6a (upper left culvert, small amount of flow).

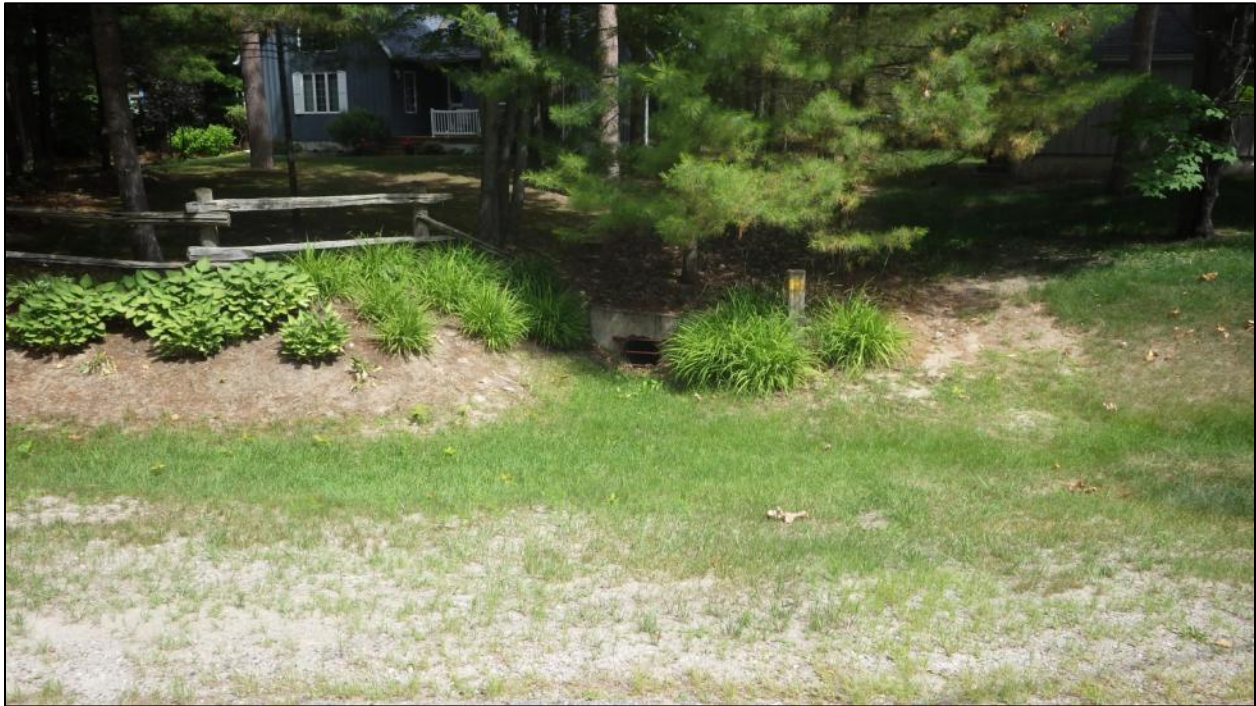
Jul 6 DB6b – No flowing or standing water coming into culvert, which would flow to DB7.

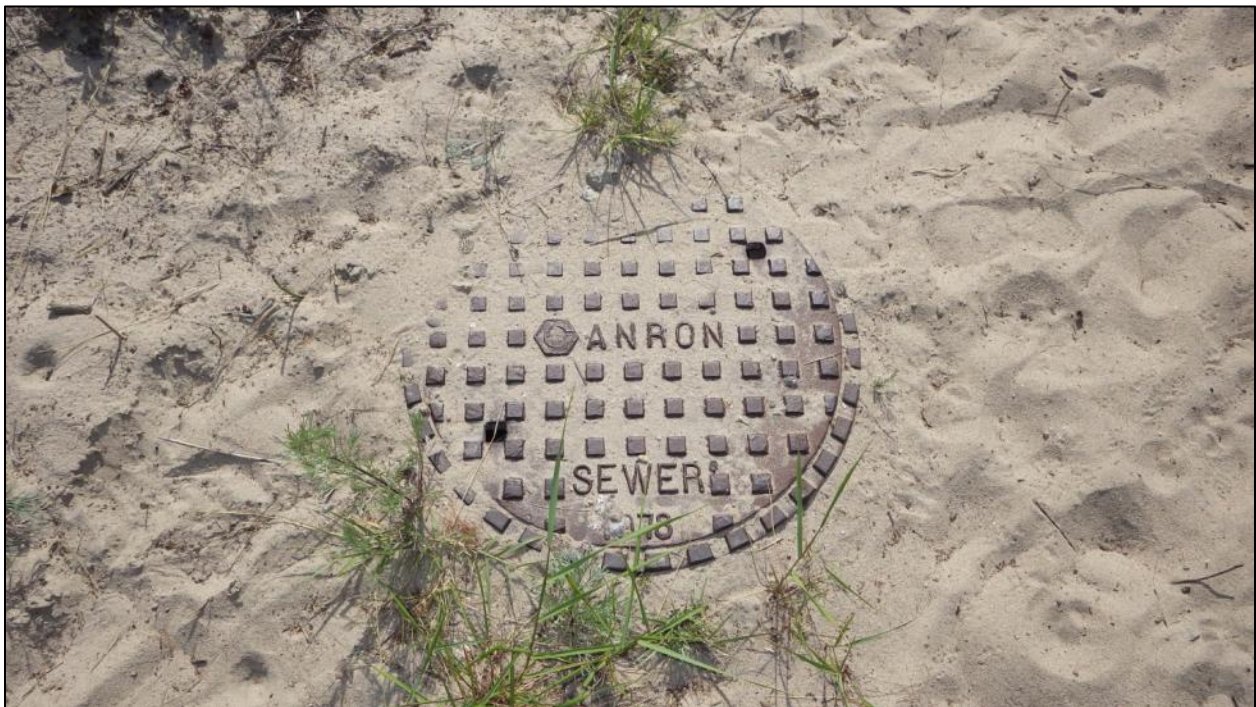
Jul 6 DB7 –Could not hear running water through manhole cover on beach just upstream of DB1 during dry period.

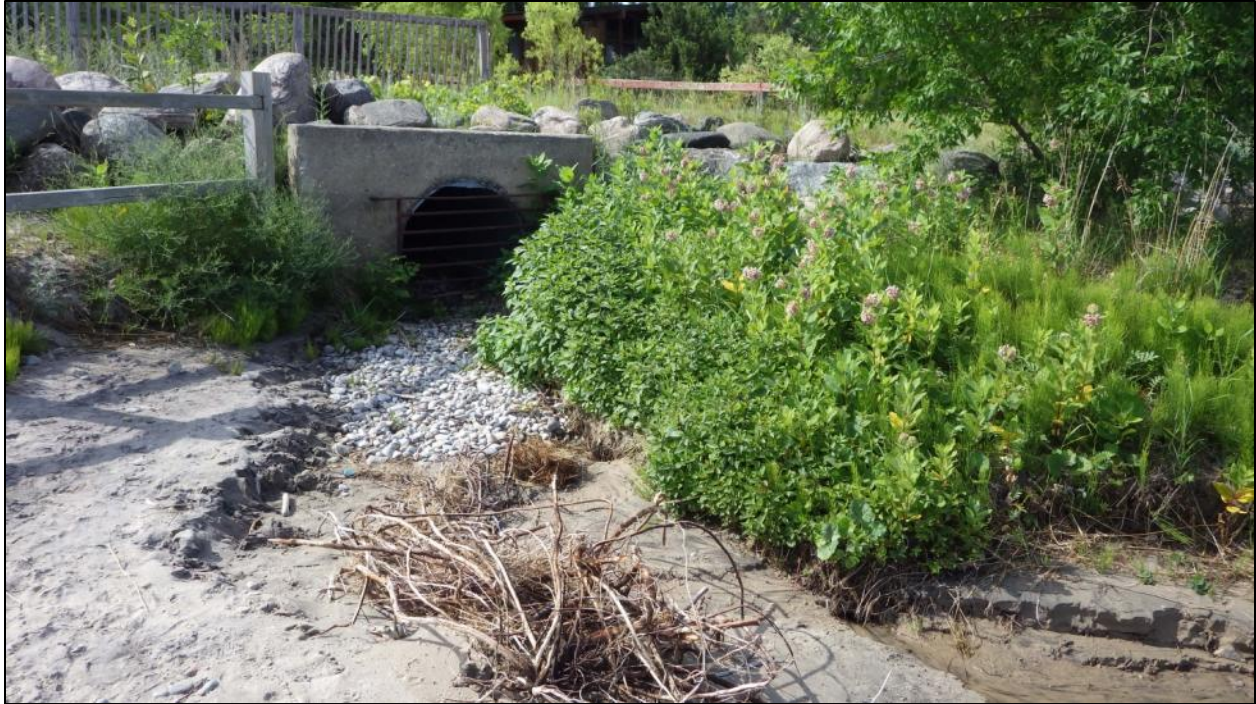
Jul 6 DB1 – A small amount of flow always discharges from the outlet, sometimes pools on beach.

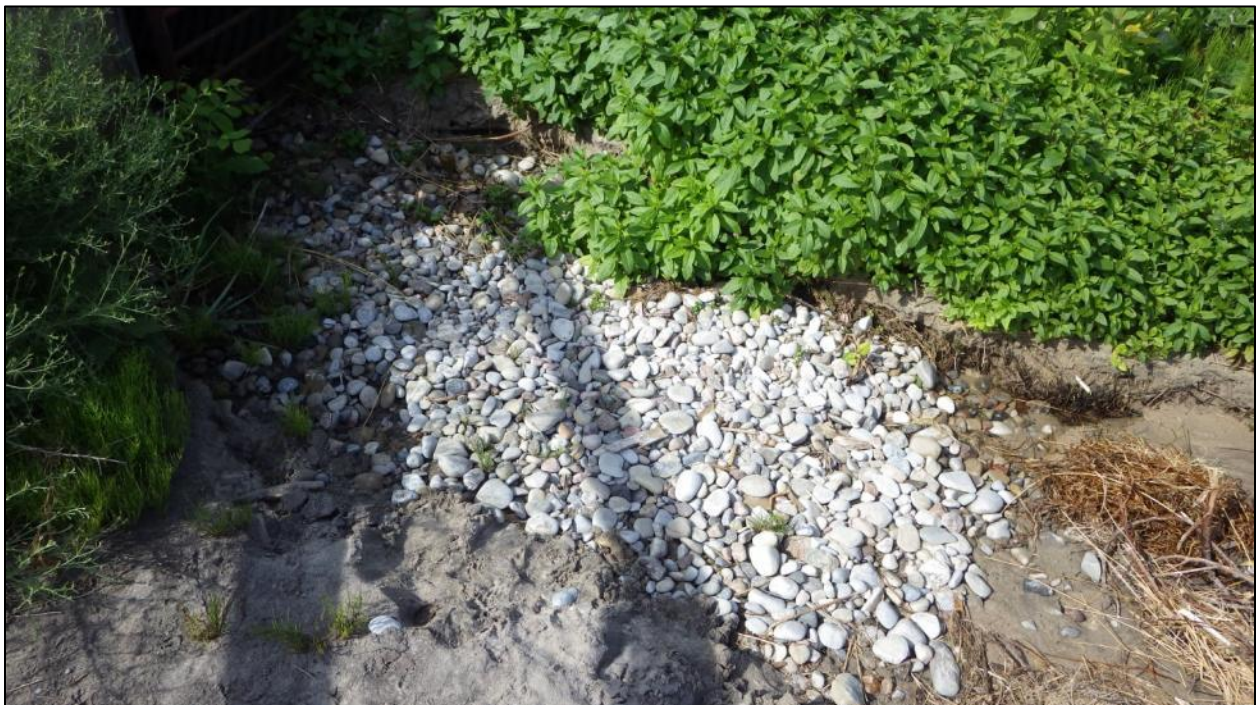
Jul 6 DB1 - River rock has been added at the outlet and inside the culvert (source of river rock unknown).

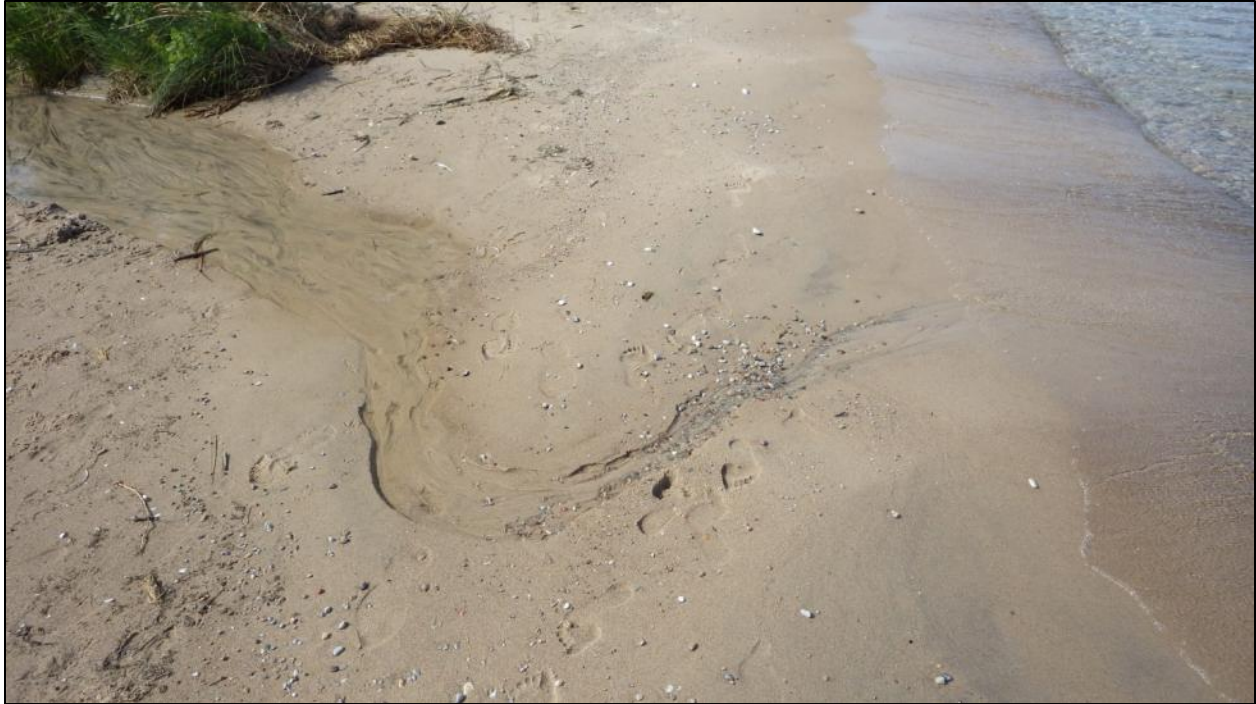
Jul 6 DB1 –Stream sometimes seeps into the sand and doesn't flow directly to the lake via overland flow.

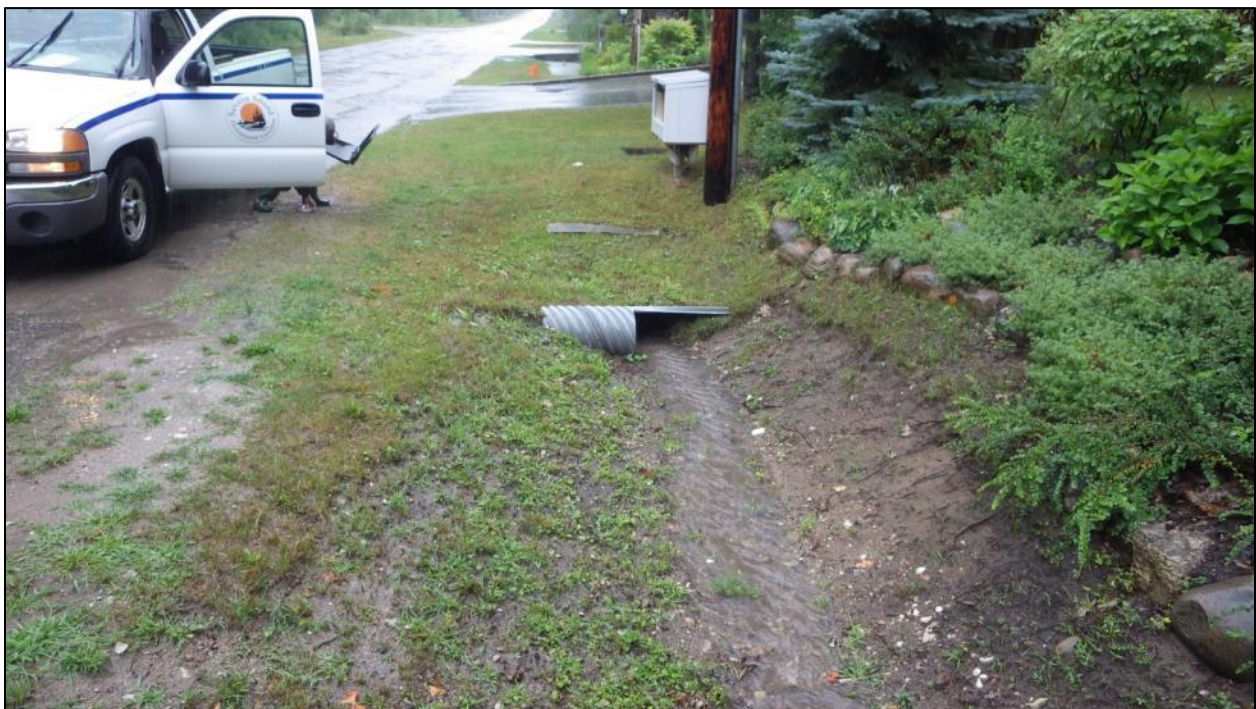
Aug 16 DB6a – Steady runoff to manhole during storm event.

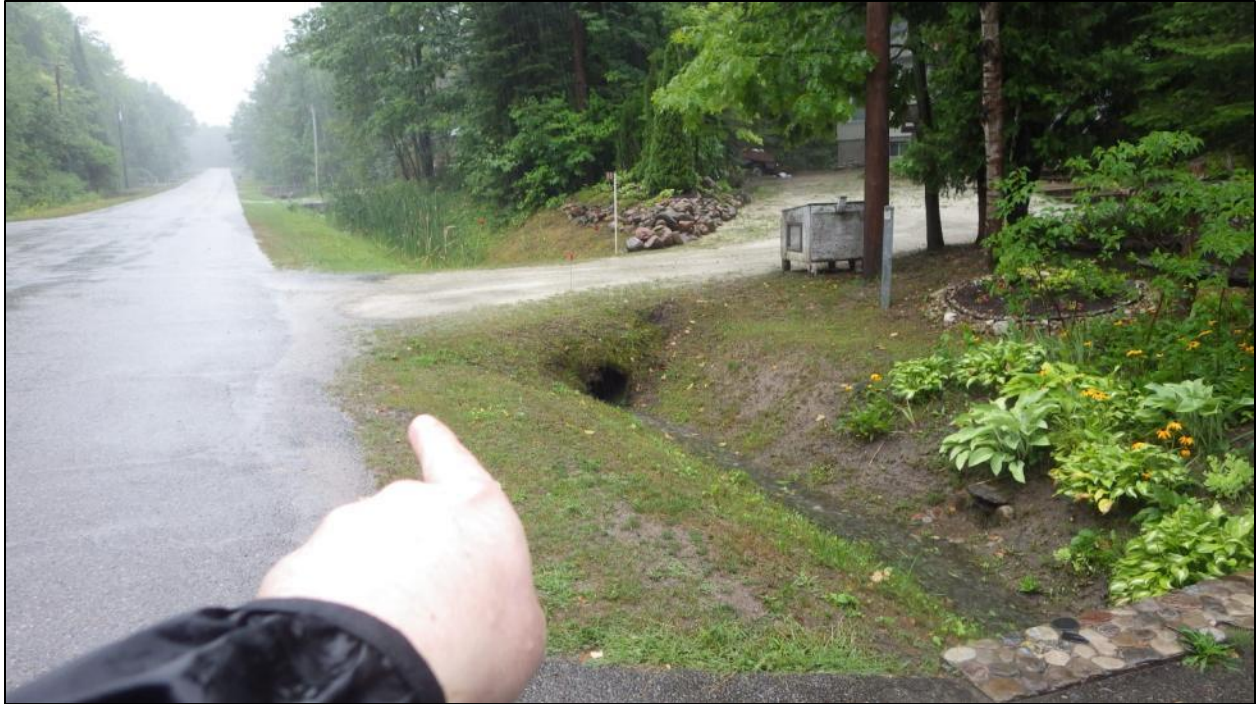
Aug 16 downstream of DB5 - Backflow towards DB5 (underground flow goes opposite way to DB6a).

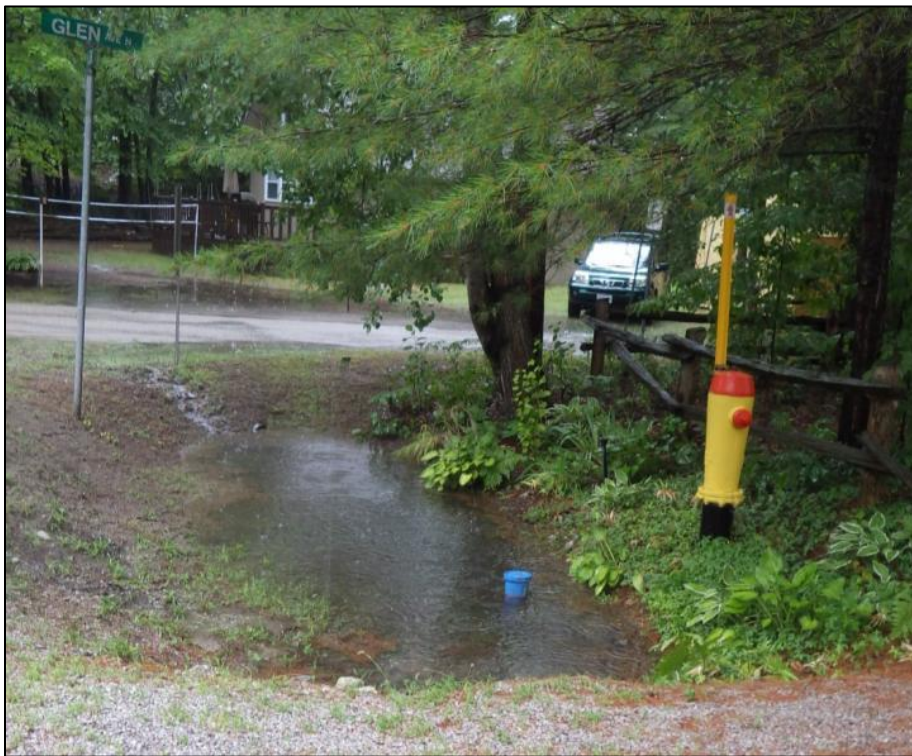
Aug 16 upstream of DB6b - Water pooling upstream and not flowing through ditch to DB6b (connecting driveway culvert was higher than water level, thus not allowing water through). Pooling was due to excessive rainfall received.

During the rain event, stream flows were high at DB5 and DB6a, however there was still no flow at DB6b. Based on observations, a driveway culvert along a ditch leading to DB6b was too high to allow water to flow, and following excessive rainfall, caused pooling in the ditch. Due to the predominantly sandy soil, this pooled water likely infiltrated and travelled towards the lake as subsurface (i.e. shallow groundwater) flow. During the storm, the discharge at the outlet was $0.18 \text{ m}^3/\text{s}$. Discharge was $0.10 \text{ m}^3/\text{s}$ at DB5 compared to $0.01 \text{ m}^3/\text{s}$ at DB6a.

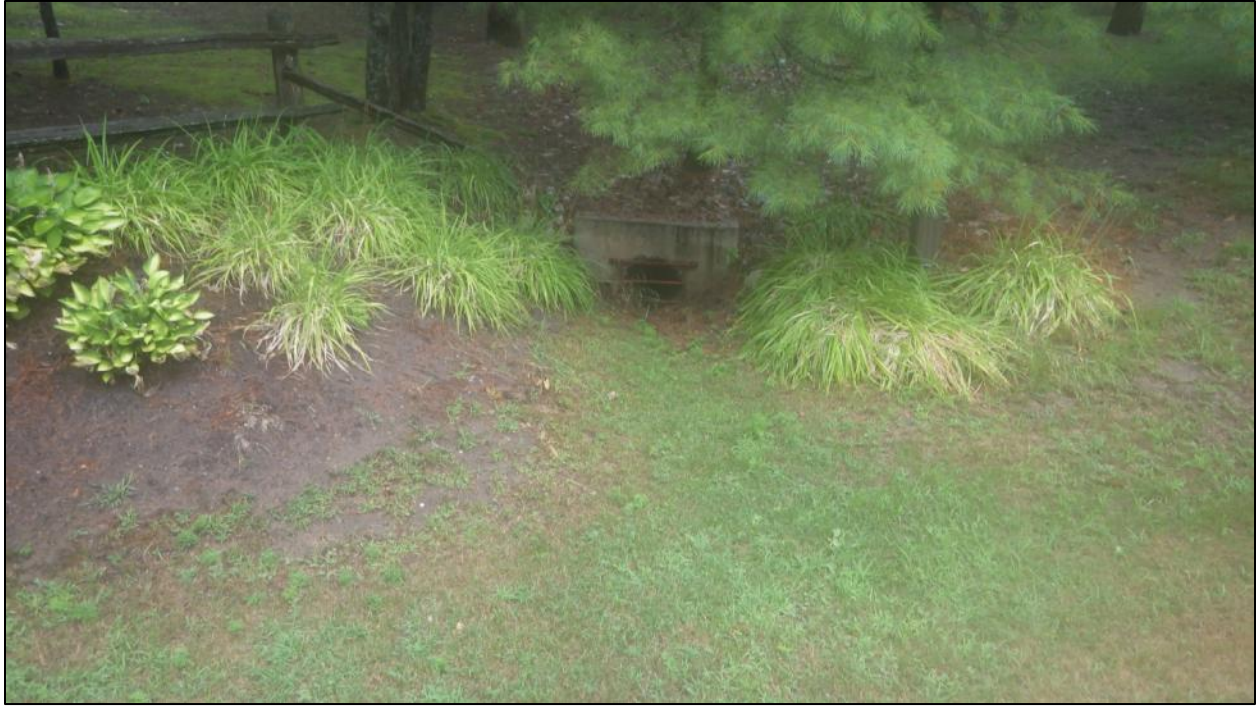
Aug 16 DB6b - No flow entering culvert despite very heavy rainfall.

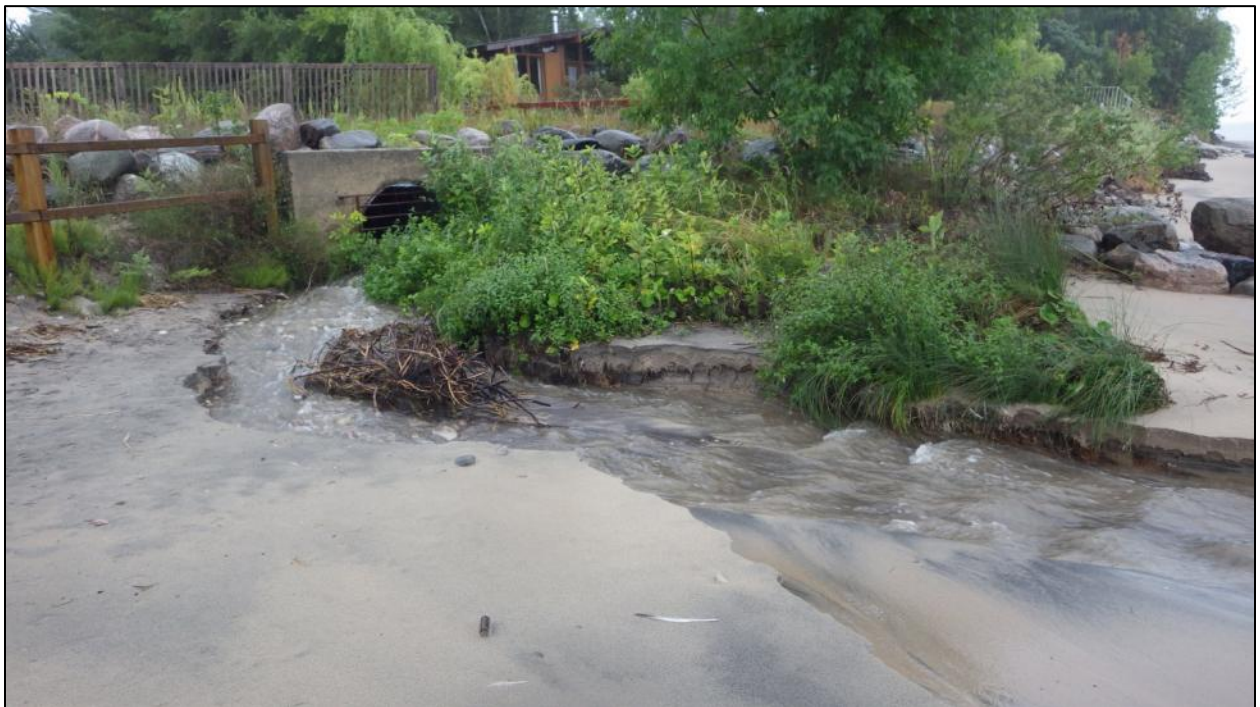
Aug 16 DB1 – Heavy rains caused large stormwater flows to discharge at the outlet, creating significant channelling; very dynamic channel.

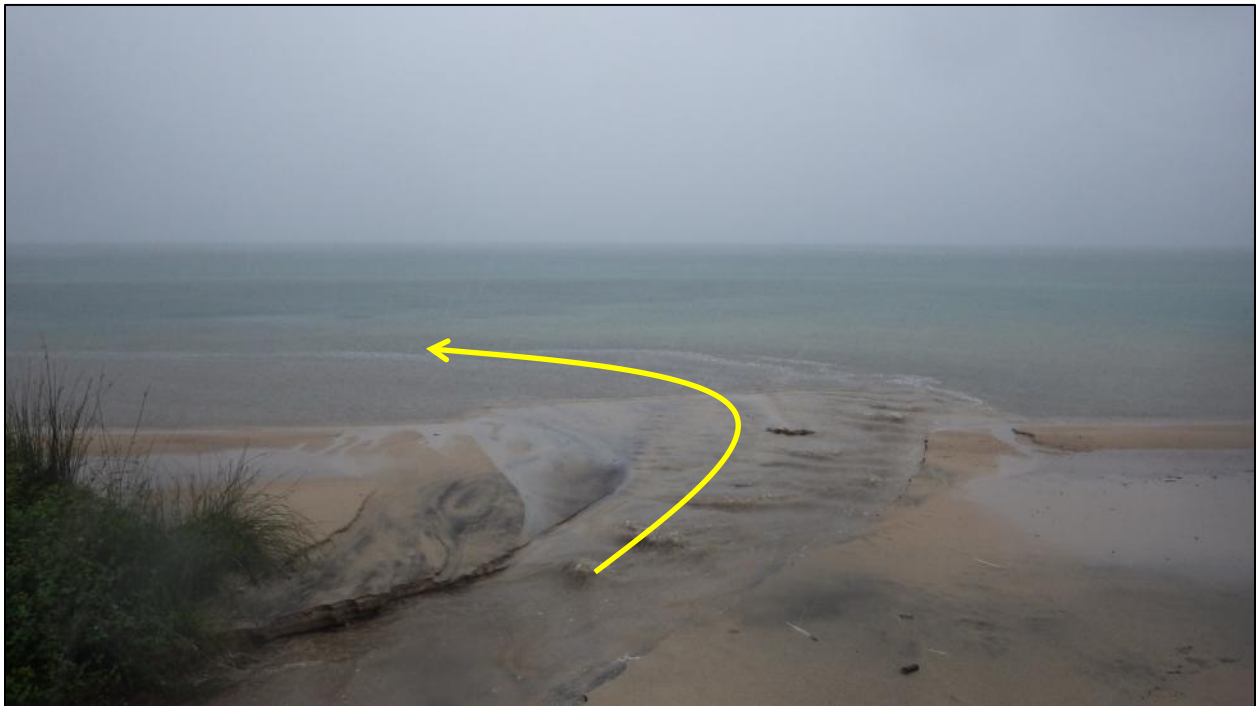
The rainstorm that was captured during sampling on Aug 16 created a plume that flowed south, away from the public beach. This flow direction was likely due to shoreline currents that carried the plume in this direction. Winds were offshore during this time. Due to the similarity in water temperature between the plume and the open water on Aug 16, the plume likely dispersed rapidly into the bay. The stream plume could travel in either direction depending on wind and current conditions, making the effect of each rain event difficult to predict, however the predominant along-shore current direction is southward.

Aug 16 DB1 - Visible plume heading away from the public beach area (southward).

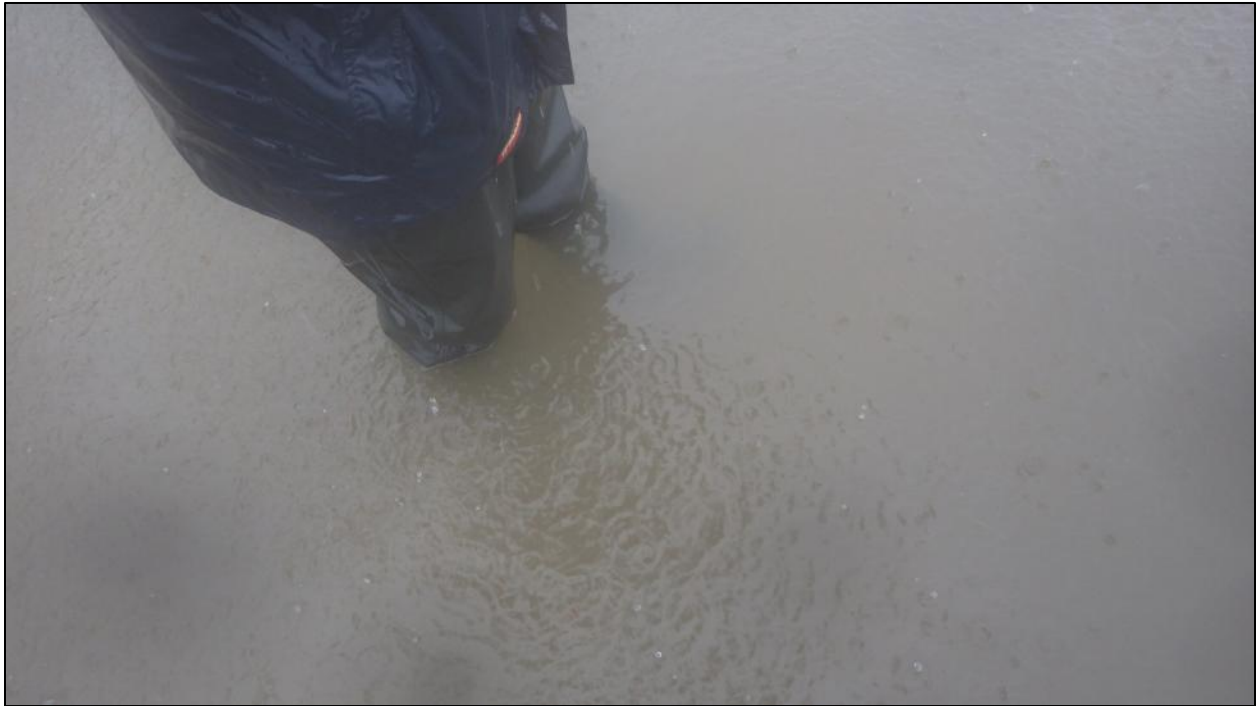
Aug 16 DB2 - Beach near outlet shows high turbidity.

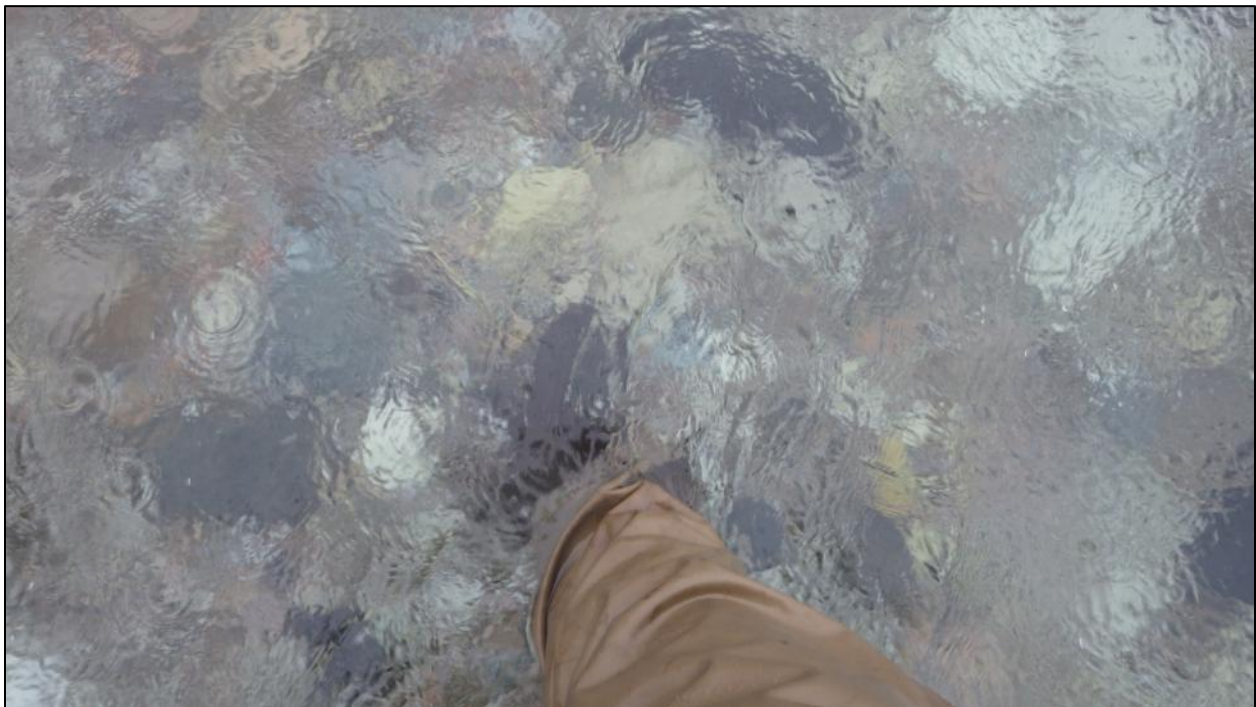
Aug 16 DB4 - Beach at north end shows no turbidity.

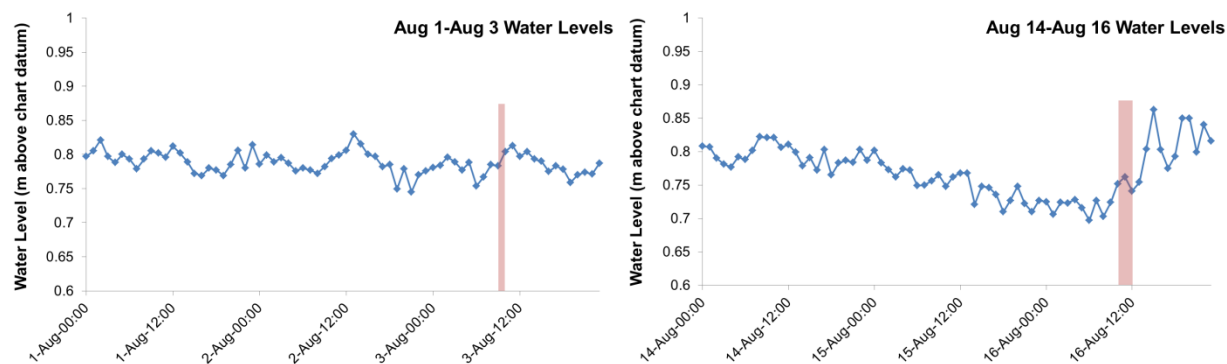
Figure 5. Water levels (m above chart datum of 176 m.a.s.l.) measured at Collingwood Harbour before and during the dry sampling period (left) and storm sampling period (right). Shaded bars indicate the exact sampling times.

steadily, indicating movement into Nottawasaga Bay (Figure 5, right). The circulation pattern of the bay is complex, but this sustained wind and resulting water movement likely contributed to southward along-shore pattern as water was carried NNW across the bay and then circled back around.

In the 24 hr previous to sampling on Aug 3, Georgian Bay was oscillating over a period of 6 hours on average and fluctuating between 0.745-0.830 m above datum (Figure 5, left). This represents smaller water fluctuation events.

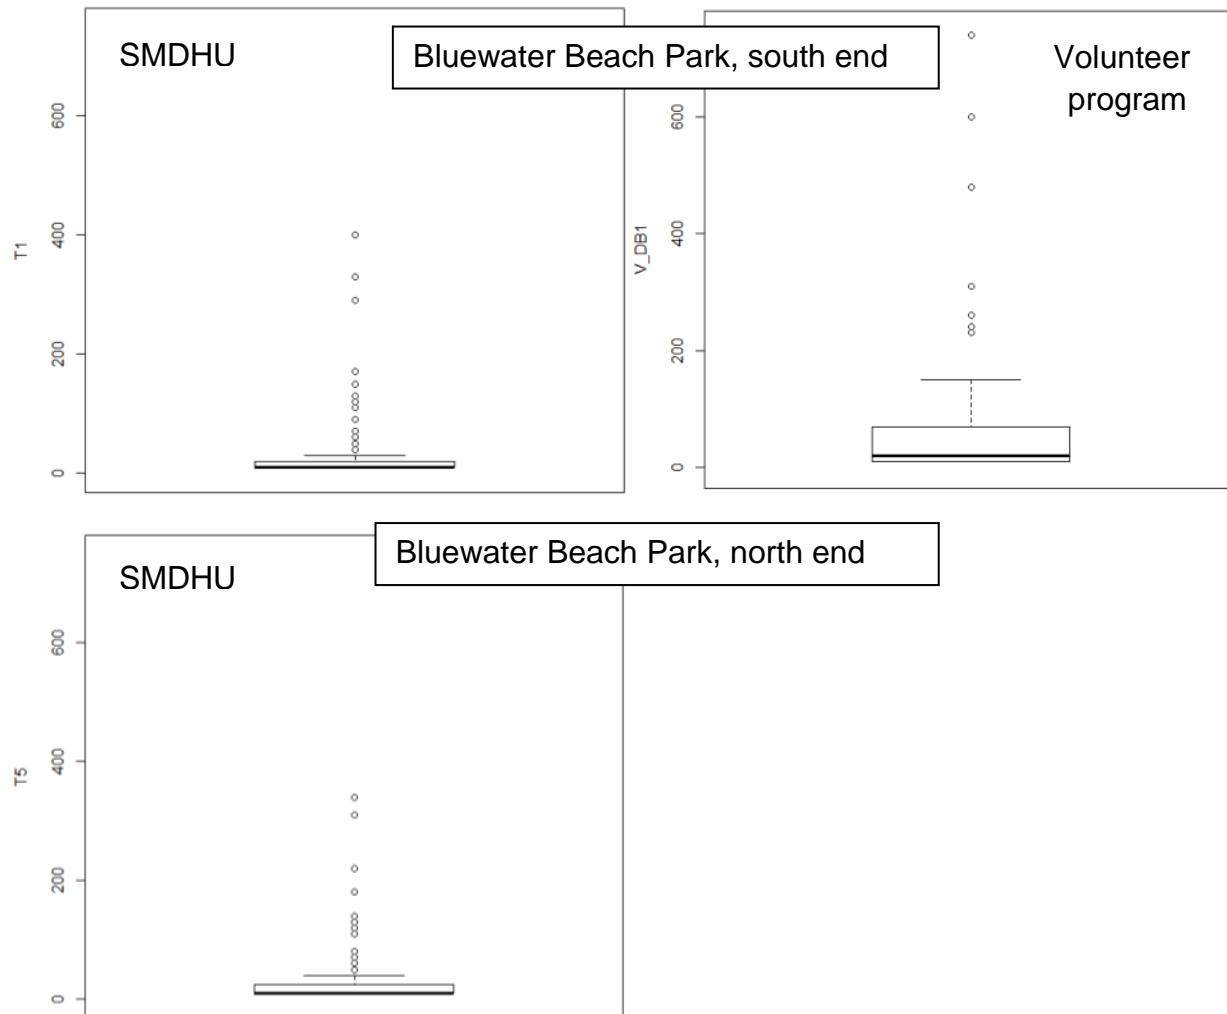
Figure 6. Boxplots showing the spread of *E. coli* data (CFU/100 mL) at the south (top) and north (bottom) end sampling locations from the SMDHU (left, 2003-16) and volunteer (right, 2001-16) sampling programs. The volunteer program does not have a comparable location at the north end of the beach.

Statistical tests comparing the south end of the beach (where the storm outlet discharges) to the north end of the beach showed that the south end did not have higher *E. coli* densities according to the health unit data (Wilcoxon test, $p= 0.74$; data from 2003-2016) (Figure 6). The south end had higher *E. coli* densities according to the volunteer sampling data compared to the health unit data at the south end, although this difference was not statistically different (Wilcoxon test, $p= 0.40$; data from T1 and V_DB1 in 2001-2016). Samples collected by the volunteer program at station V_DB1 were collected in the same location and at the same depth (1.0-1.5m deep) as the health unit station T1. The discrepancy in bacteria densities may be a result of a bias due to data availability. The volunteer program had data for 2001-2002 (higher densities occurred) where the health unit did not, and the volunteer program did not have data for every other year starting in 2007 (lower densities occurred) where the health unit did. It should be noted that while the Township will review independent testing, it will only recognize and respond to results from the health unit.

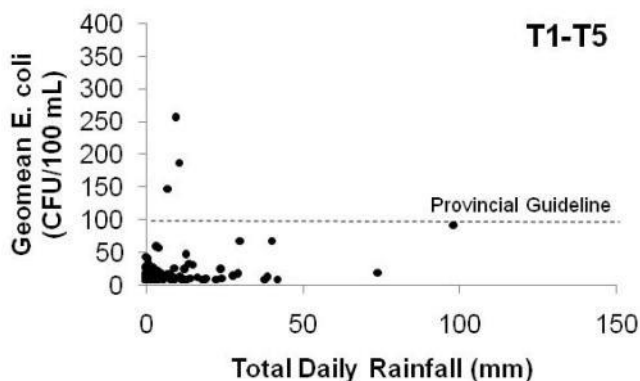
Figure 7. Geomean *E. coli* density using health unit data for T1-T5 from 2005-2016 vs. total daily rainfall from the SSEA rain gauge at Balm Beach. Also shown is the provincial guideline of 100 CFU/100 mL.

To determine the relationship between rainfall and *E. coli* densities, data was used from the SSEA rain gauge along with *E. coli* data from the health unit. Kendall's tau correlation test showed a weak but non-significant relationship between rainfall and overall geomean *E. coli* ($p=0.08$, Figure 7) and between rainfall and *E. coli* density close to the outlet at T1 and V_DB1 ($p=0.08$ and 0.06 , Figure 8). Note that results from an individual location are not compared to the provincial guideline since the protocol is to use a geomean of at least 5 sites per sample to represent overall quality at a public beach. In this case it is useful to look at data from samples taken in front of the storm outlet to determine the influence of rain events on bacteria load from this source. Based on overall beach results from the health unit, and results from in front of the outlet, there does not appear to be a strong relationship between bacterial densities and rainfall at
