# LITTLE LAKE (Midland) CONDITIONS UPDATE

Sample Date: Aug 31, 2021  
Next Sample: Sept 14, 2021  
(weather permitting)

# LITTLE LAKE SEASONAL WATER QUALITY TRENDS

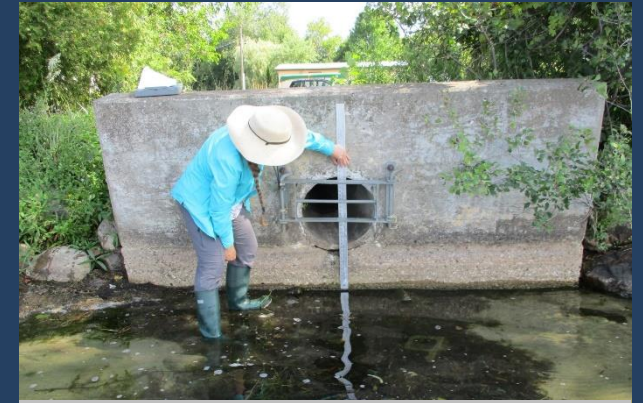
Readings taken at the McMurty Dr outflow structure indicate that levels are the lowest they've been all season. Lower levels are normal for late August.

Little Lake outflow on McMurty Dr.

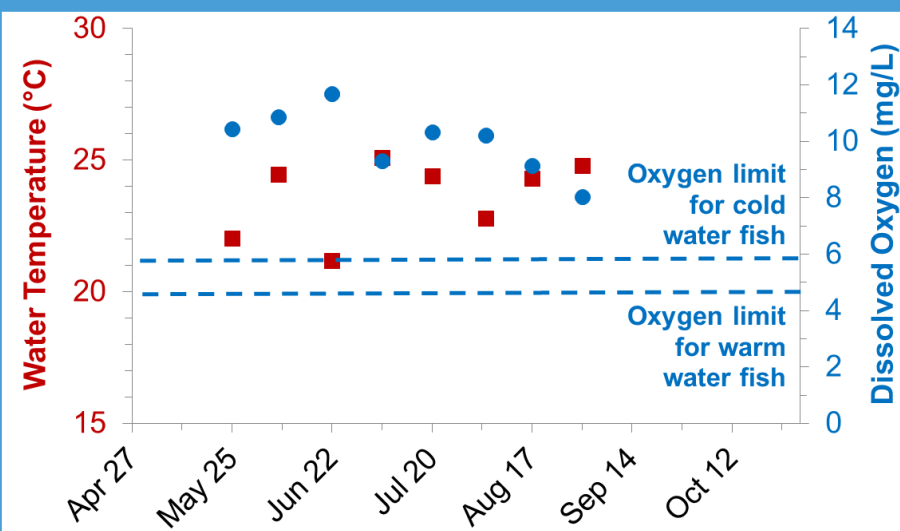
## Surface Temperature & Bottom Water Dissolved Oxygen

Oxygen levels have remained above the Provincial Water Quality Objectives for cold and warm water fish, although high temperatures may cause stress.

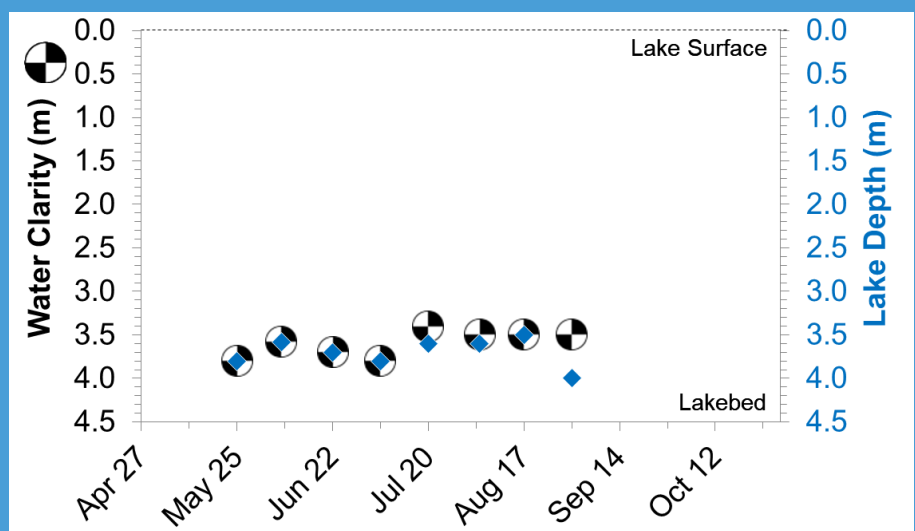
## Water Clarity & Lake Depth

Water clarity in Little Lake is considered good if the lakebed is visible. This wasn't the case on July 20<sup>th</sup> & Aug 31<sup>st</sup> due to interference from aquatic plants.

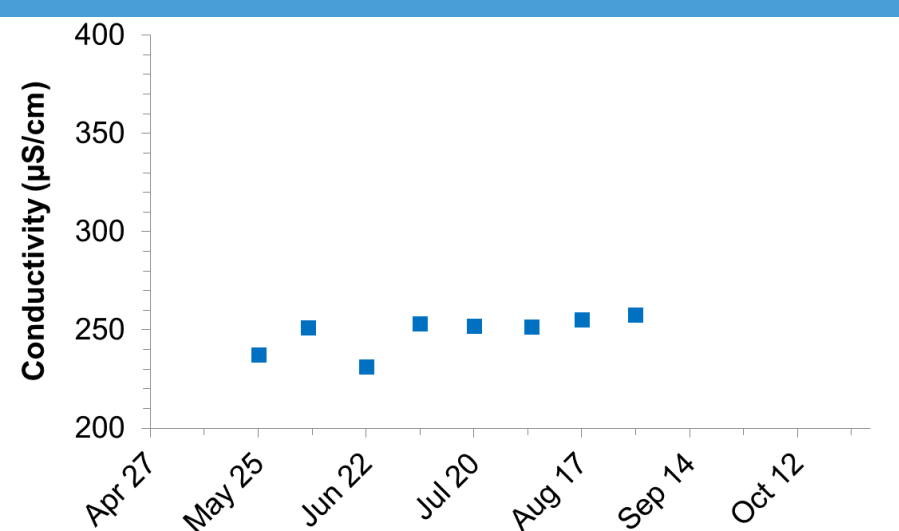
## Surface Water Conductivity

Conductivity indicates the amount of dissolved material in the water. Values are lower than other inland lakes in the area like Orr Lake.

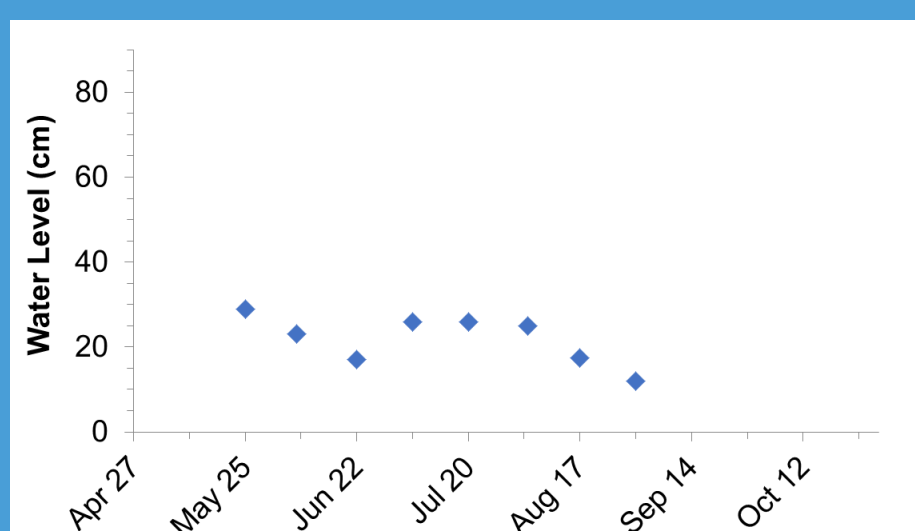
## Little Lake Water Levels (McMurty Dr. Outflow)

Little Lake water levels are closely linked to recent rainfall. Water levels are not managed, however the Town maintains the outflow structure.

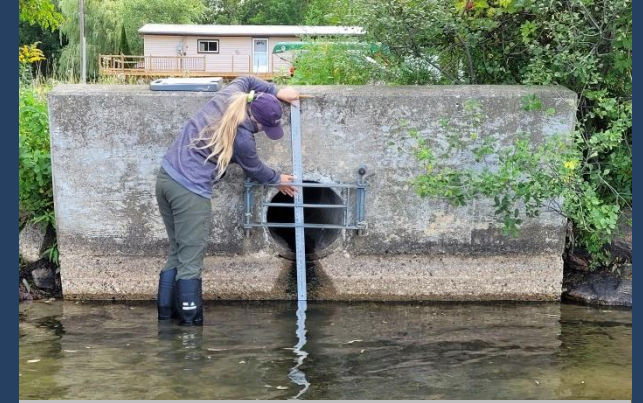
Readings taken at the McMurty Dr outflow structure indicate that levels have increased slightly since Aug 31. Lower levels are normal for this time of year.

Little Lake outflow on McMurty Dr.

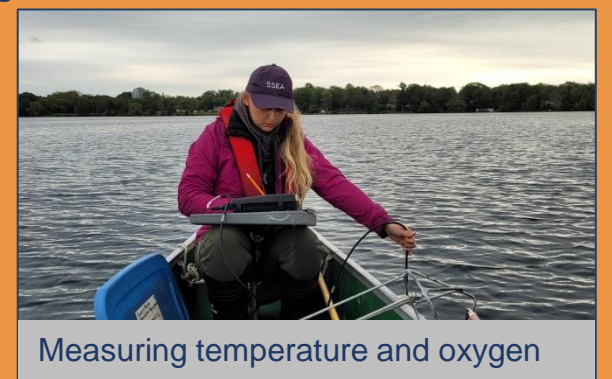
Measuring temperature and oxygen

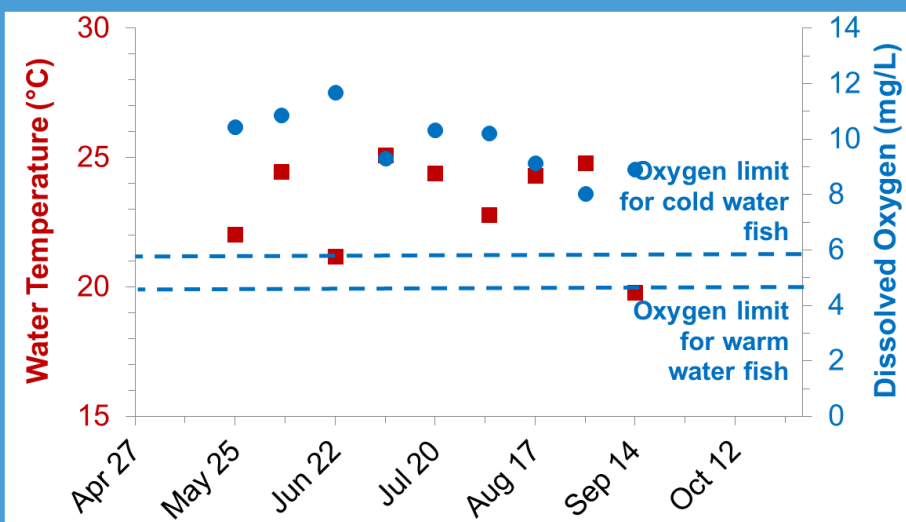
## Surface Temperature & Bottom Water Dissolved Oxygen

Oxygen levels have remained above the Provincial Water Quality Objectives for cold and warm water fish, and temperatures are now starting to cool off.

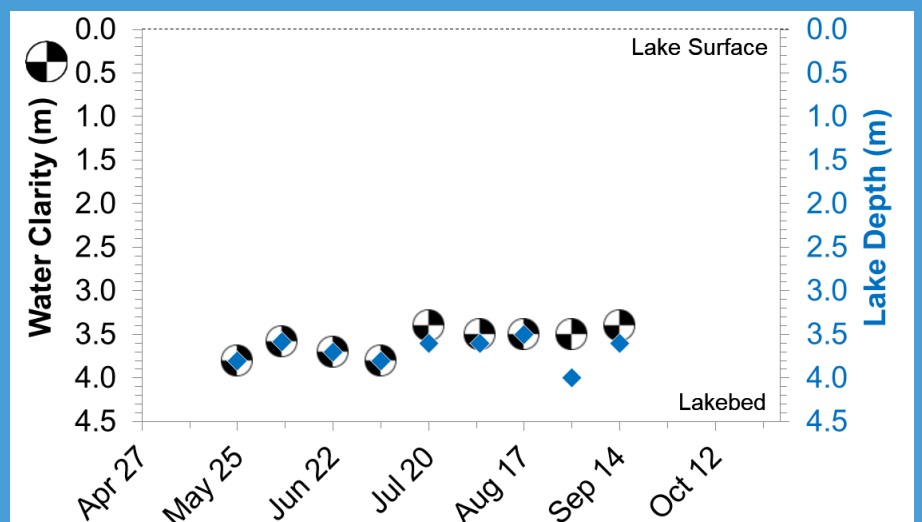
## Water Clarity & Lake Depth

Water clarity in Little Lake is considered good if the lakebed is visible. This wasn't the case on July 20<sup>th</sup> & Aug 31<sup>st</sup> due to interference from aquatic plants.

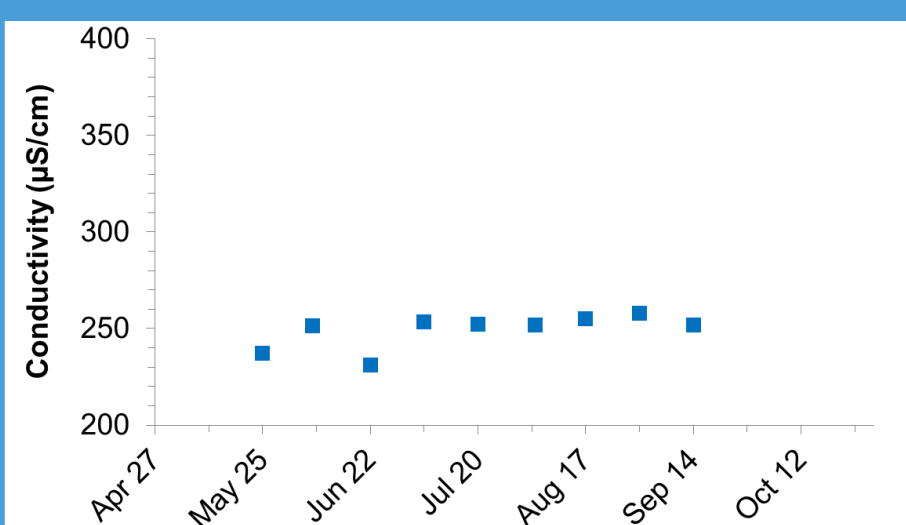
## Surface Water Conductivity

Conductivity indicates the amount of dissolved material in the water. Values are lower than other inland lakes in the area like Orr Lake.

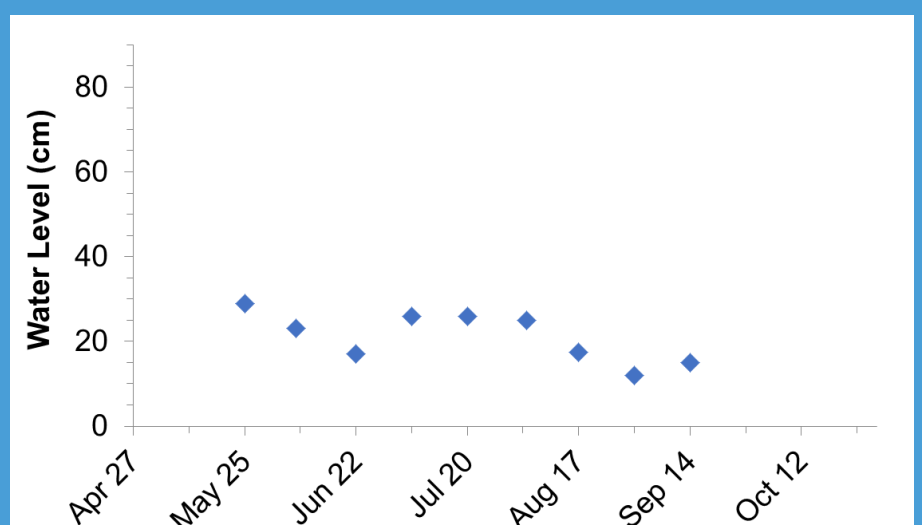
## Little Lake Water Levels (McMurty Dr. Outflow)

Little Lake water levels are closely linked to recent rainfall. Water levels are not managed, however the Town maintains the outflow structure.

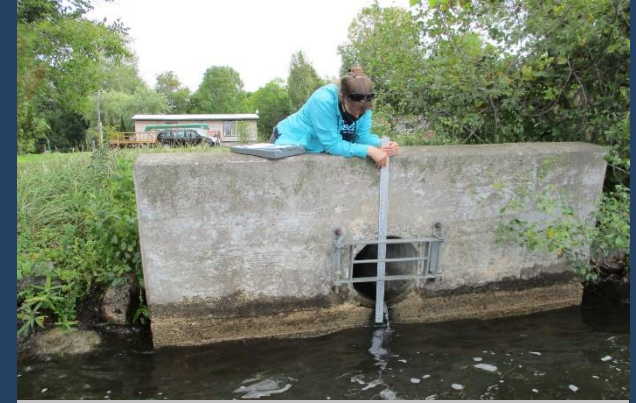
Readings taken at the McMurty Dr outflow structure indicate that levels have increased since Sept 14. Recent rainfall caused an increase in levels.

Little Lake outflow on McMurty Dr.

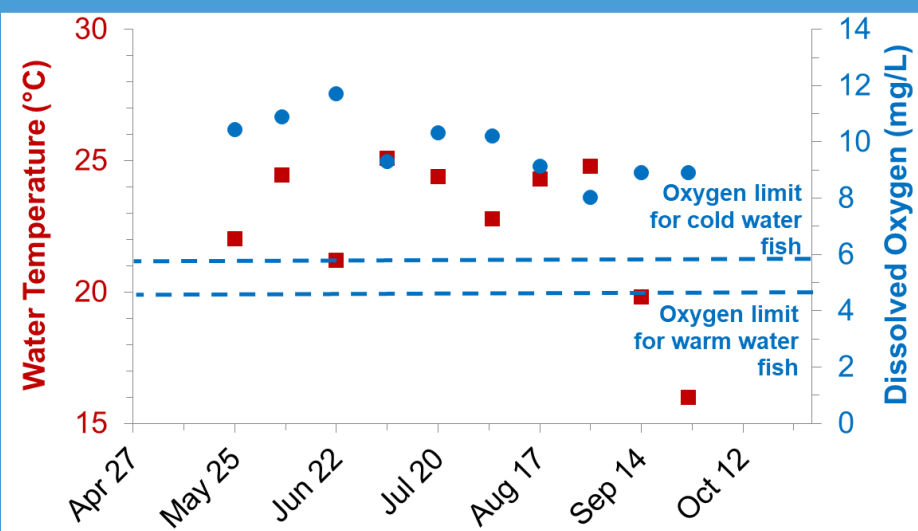
## Surface Temperature & Bottom Water Dissolved Oxygen

Oxygen levels have remained above the Provincial Water Quality Objectives for cold and warm water fish, even during periods of high temperatures.

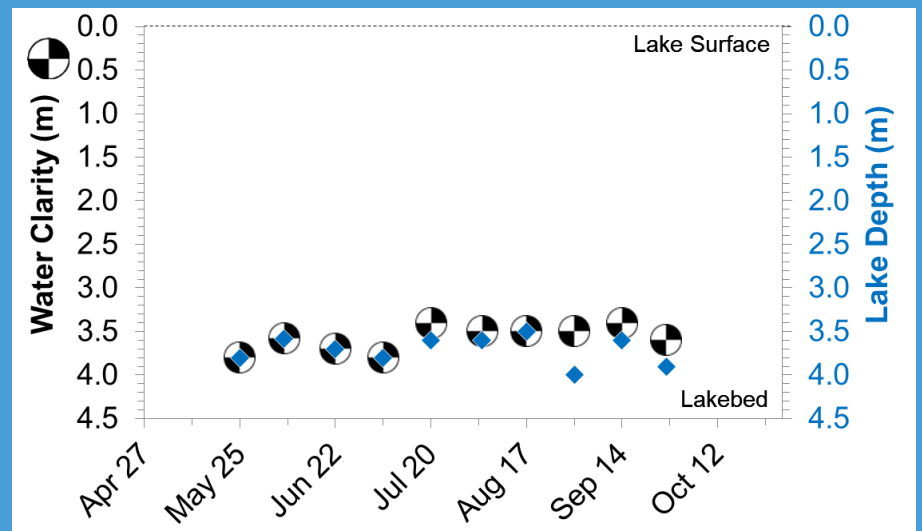
## Water Clarity & Lake Depth

Water clarity is considered good if the lakebed is visible. There were several times this wasn't the case due to aquatic plants obscuring the lakebed.

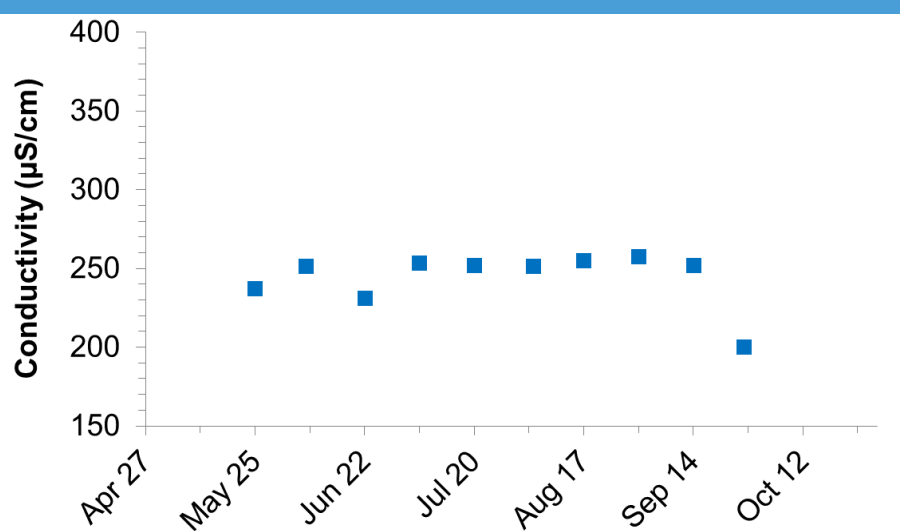
## Surface Water Conductivity

Conductivity indicates the amount of dissolved material in the water. Values are lower than other inland lakes in the area like Orr Lake.

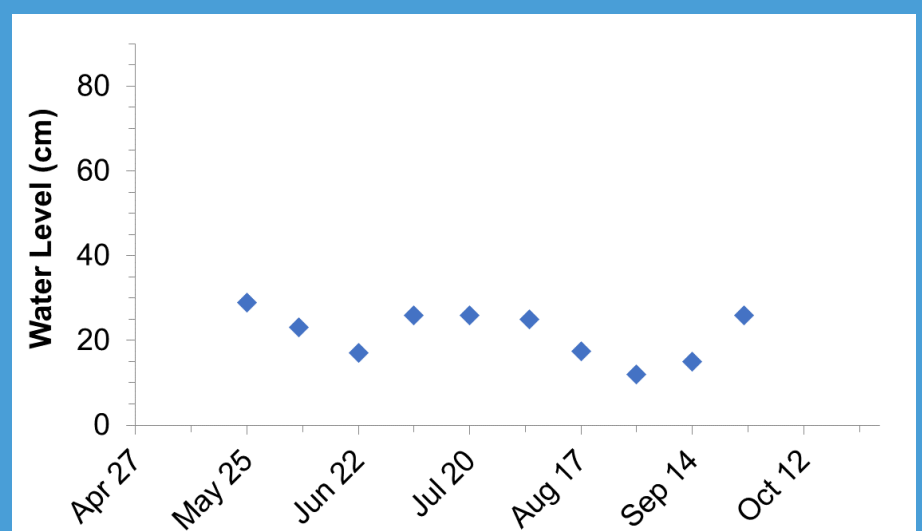
## Lake Water Levels at McMurty Dr. Outflow

Little Lake water levels are closely linked to recent rainfall. Water levels are not managed, however the Town maintains the outflow structure.

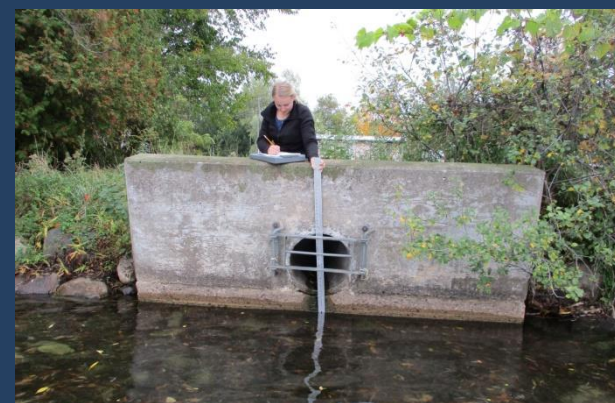
Readings taken at the McMurty Dr outflow structure indicate that levels have decreased slightly since Sept 27.

Little Lake outflow on McMurty Dr.

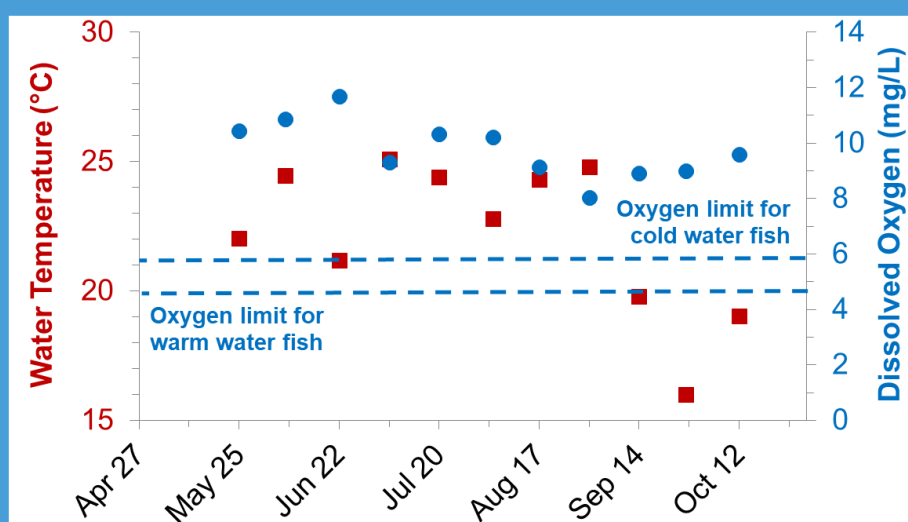
## Surface Temperature & Bottom Water Dissolved Oxygen

Oxygen levels have remained above the Provincial Water Quality Objectives for cold and warm water fish, even during periods of high temperatures.

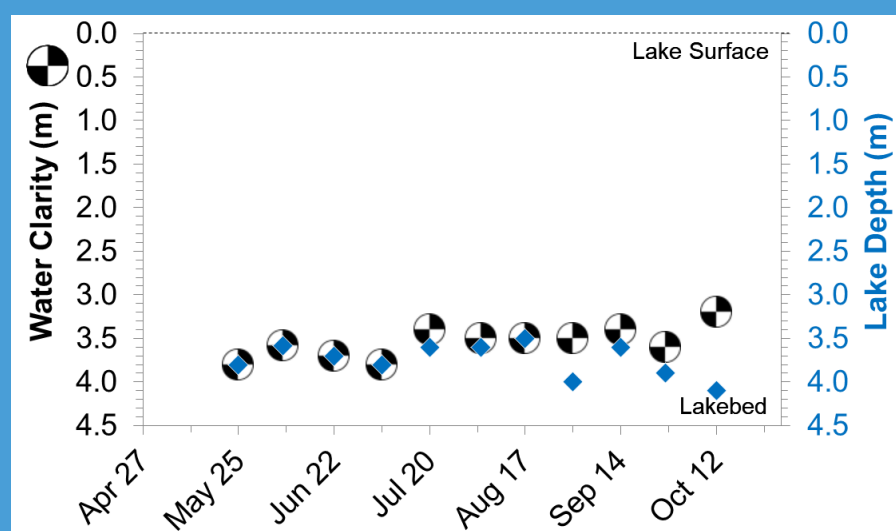
## Water Clarity & Lake Depth

Water clarity is considered good if the lakebed is visible. There were several times this wasn't the case due to aquatic plants obscuring the lakebed.

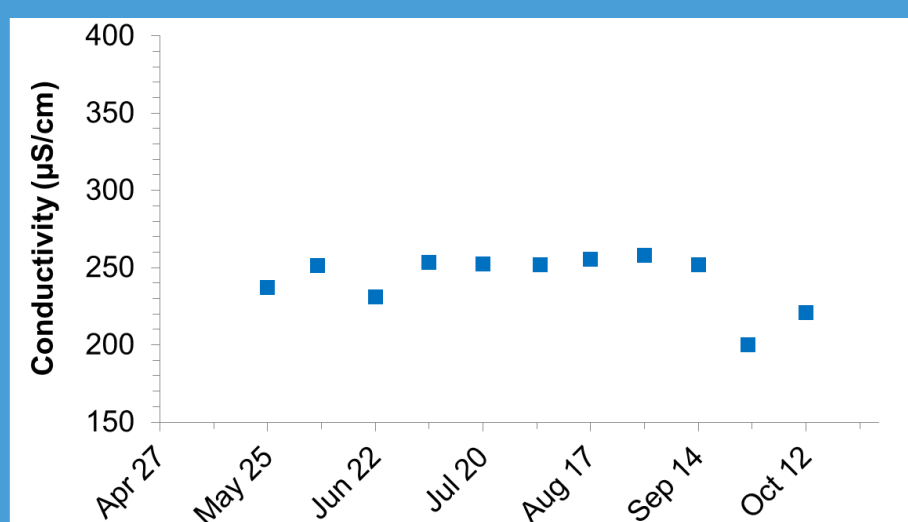
## Surface Water Conductivity

Conductivity indicates the amount of dissolved material in the water. Values dropped recently with increased rainfall, which has a dilution effect.

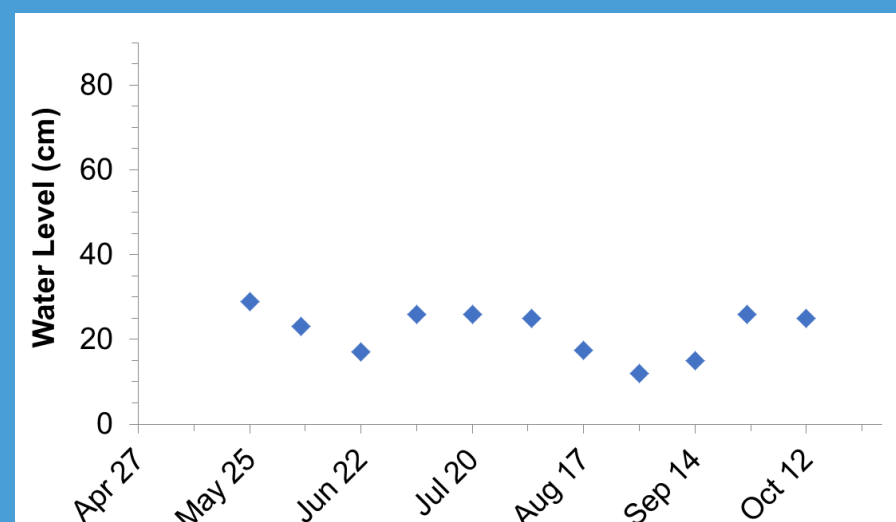
## Lake Water Levels at McMurty Dr. Outflow

Little Lake water levels are closely linked to recent rainfall. Water levels are not managed, however the Town maintains the outflow structure.
