LITTLE LAKE (Midland) CONDITIONS UPDATE

Sample Date: May 4, 2022
Next Sample: May 17, 2022
(weather permitting)

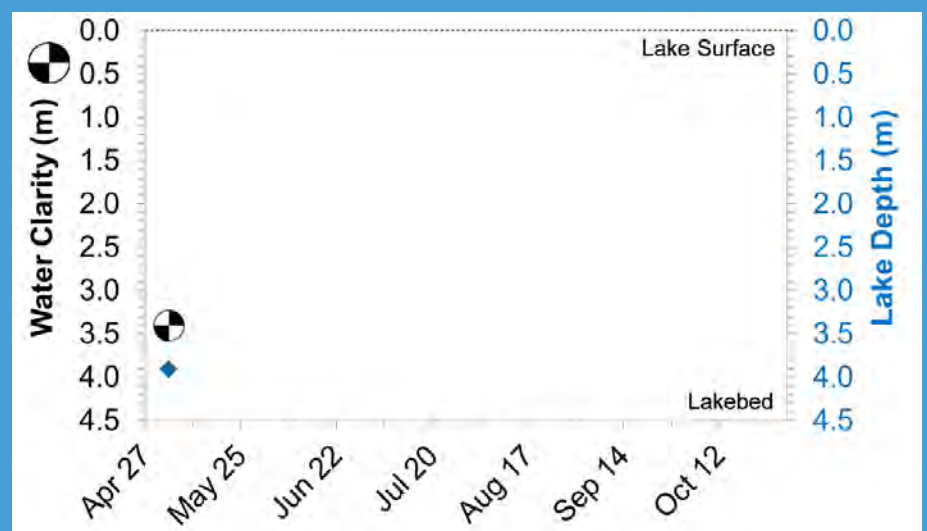
Water Clarity & Lake Depth

Water clarity is considered good if the lakebed is visible. The lakebed was not visible on the first sample day of 2022, but was visible in May of 2021.

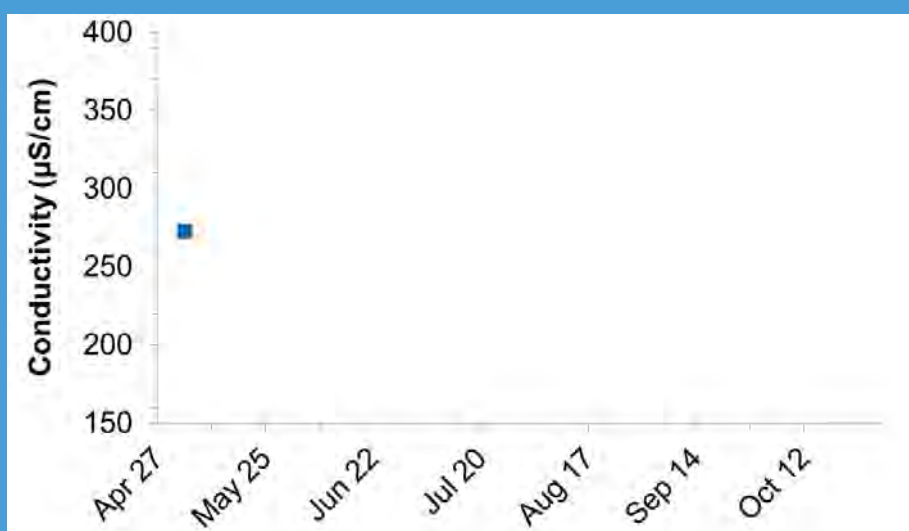
Surface Water Conductivity

Conductivity indicates the amount of dissolved material in the water. Value are higher than in May of last year.

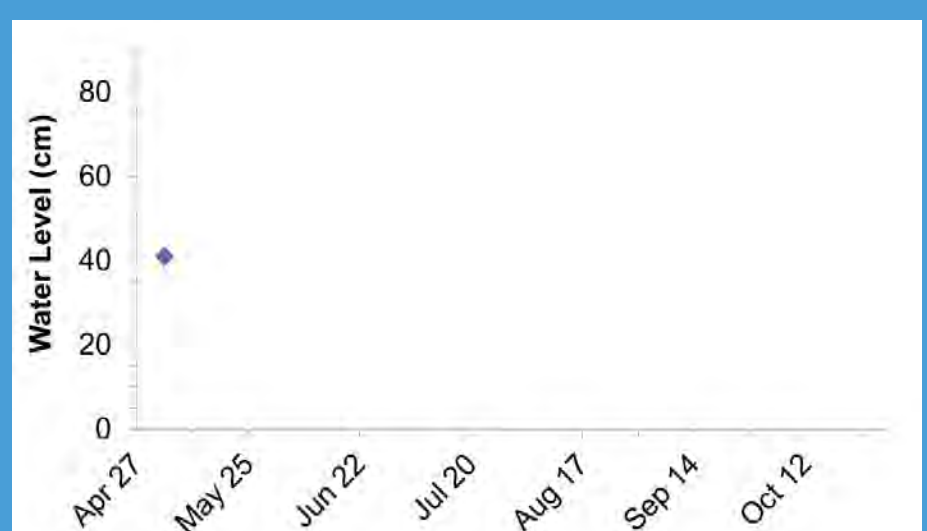
Lake Water Levels at McMurty Dr. Outflow

Little Lake water levels are closely linked to recent rainfall. Water levels are not managed, however the Town maintains the outflow structure.

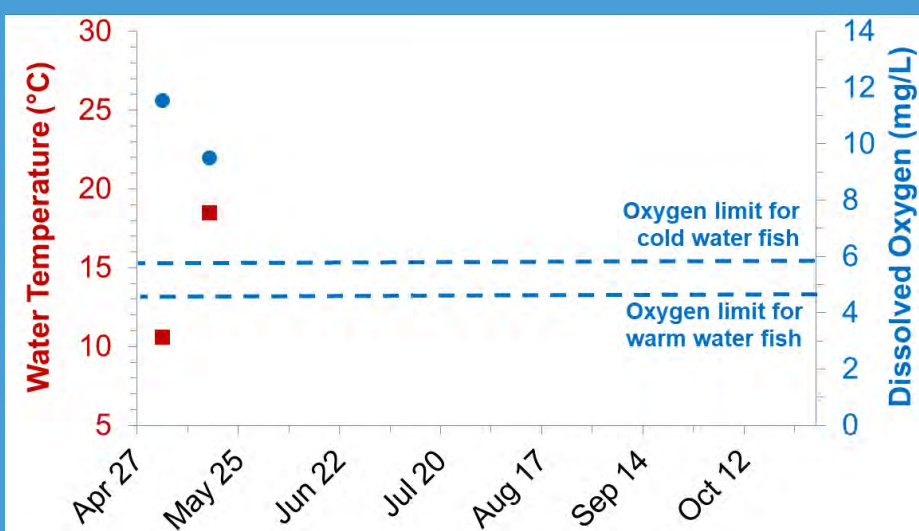
Surface Temperature & Bottom Water Dissolved Oxygen

Oxygen levels have remained above the Provincial Water Quality Objectives for cold and warm water fish

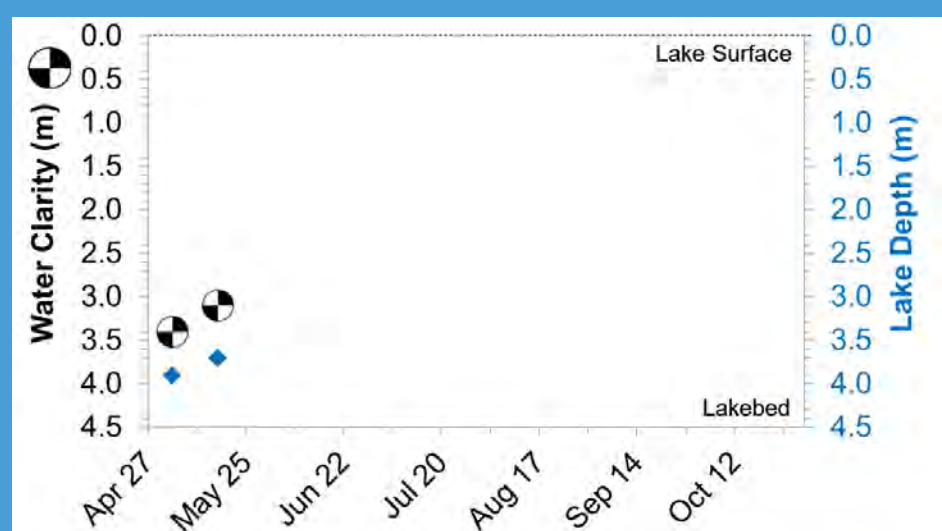
Water Clarity & Lake Depth

Water clarity is considered excellent if the lakebed is visible. So far this season the lake bed has not been visible.

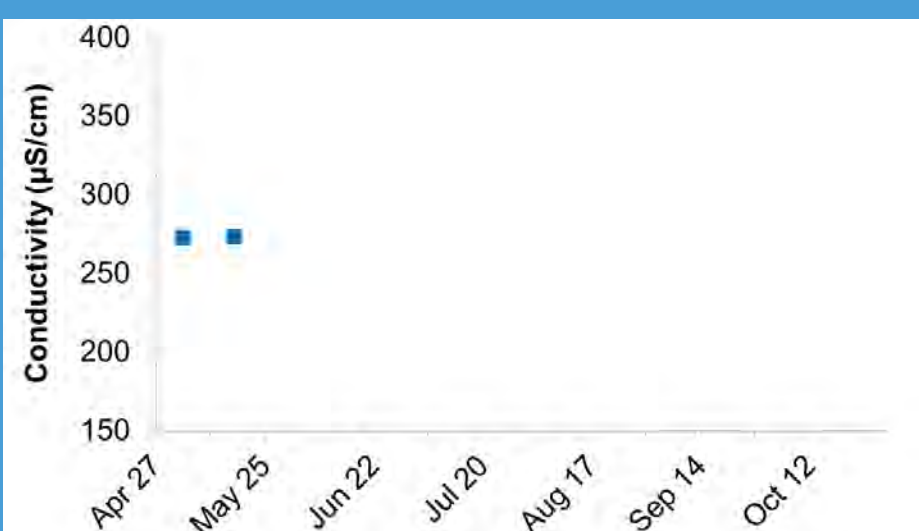
Surface Water Conductivity

Conductivity indicates the amount of dissolved material in the water. Values are lower than other inland lakes in the area like Orr Lake.

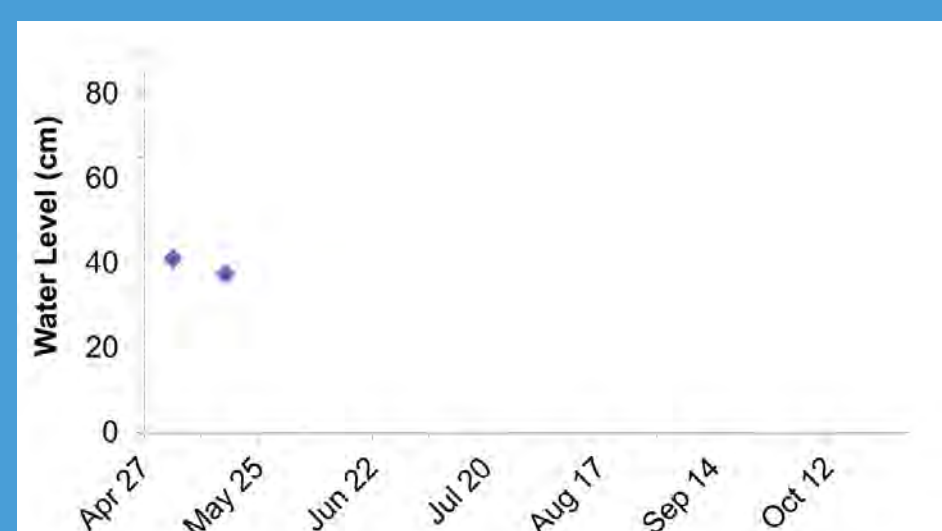
Lake Water Levels at McMurty Dr. Outflow

Little Lake water levels are closely linked to recent rainfall. Water levels are not managed, however the Town maintains the outflow structure.

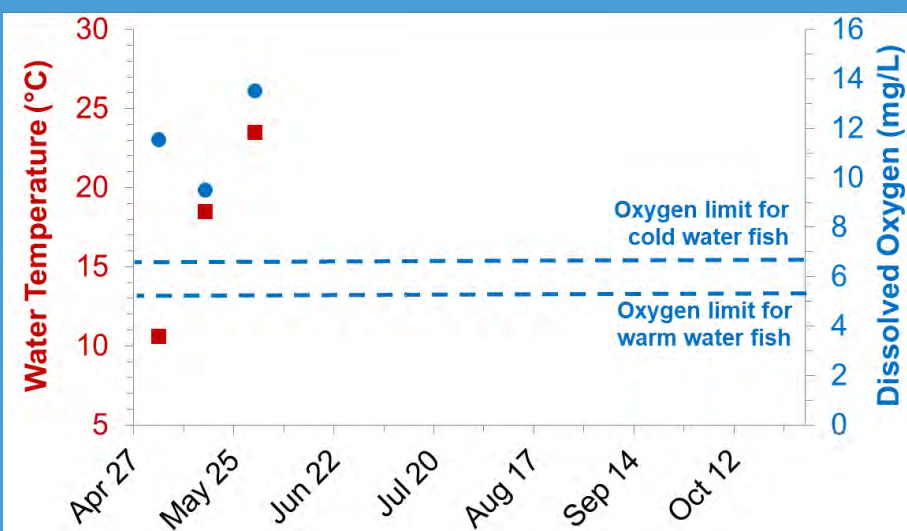
Surface Temperature & Bottom Water Dissolved Oxygen

Oxygen levels have remained above the Provincial Water Quality Objectives for cold and warm water fish.

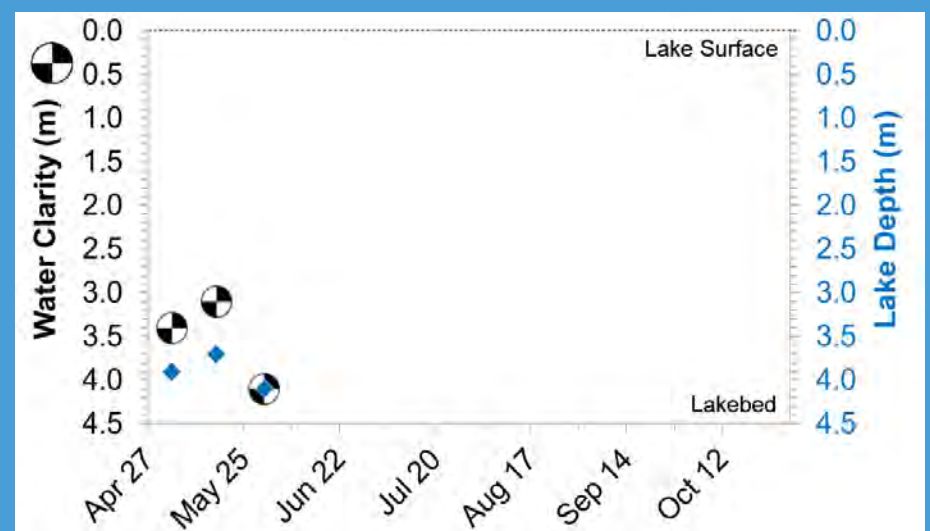
Water Clarity & Lake Depth

Water clarity is considered good if the lakebed is visible. The lakebed was visible on May 31st. Sediment and algae can contribute to lower clarity.

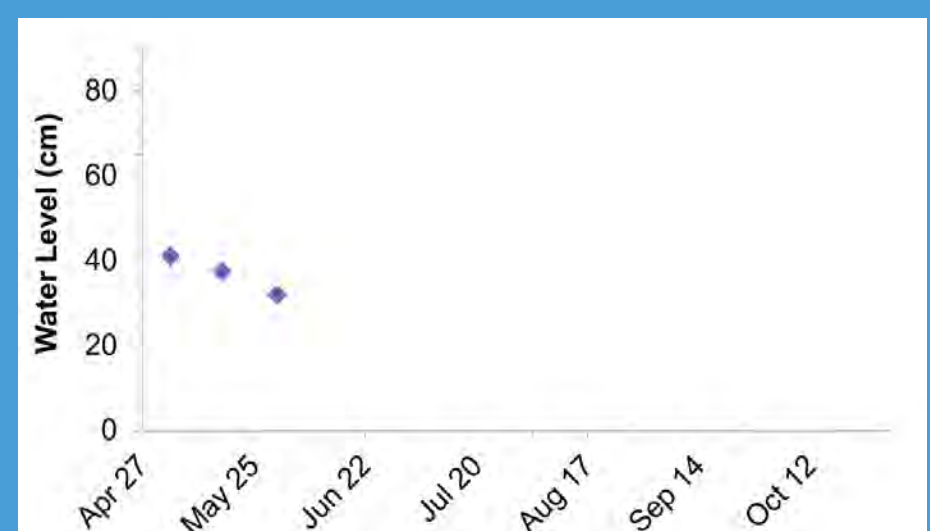
Lake Water Levels at McMurty Dr. Outflow

Little Lake water levels are closely linked to recent rainfall. Water levels are not managed, however the Town maintains the outflow structure.

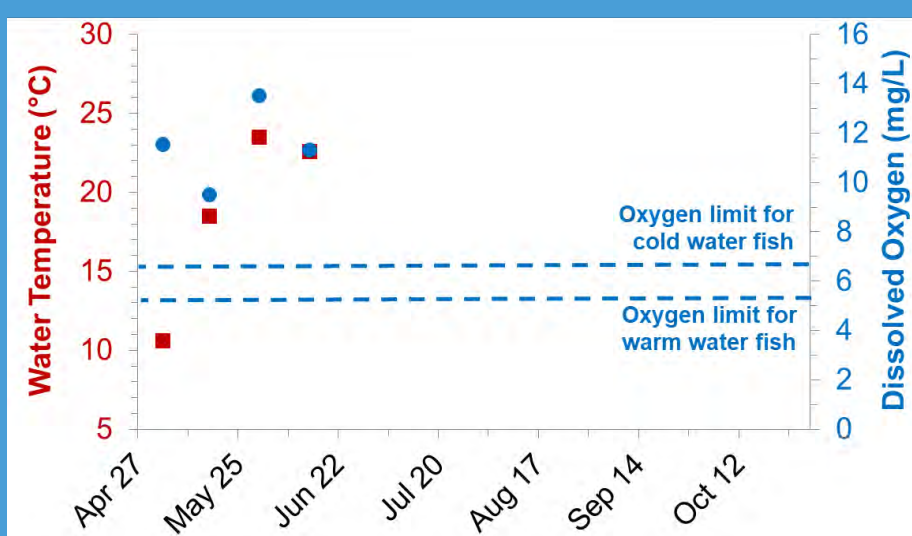
Surface Temperature & Bottom Water Dissolved Oxygen

Oxygen levels have remained above the Provincial Water Quality Objectives for cold and warm water fish, even as temperatures are warming.

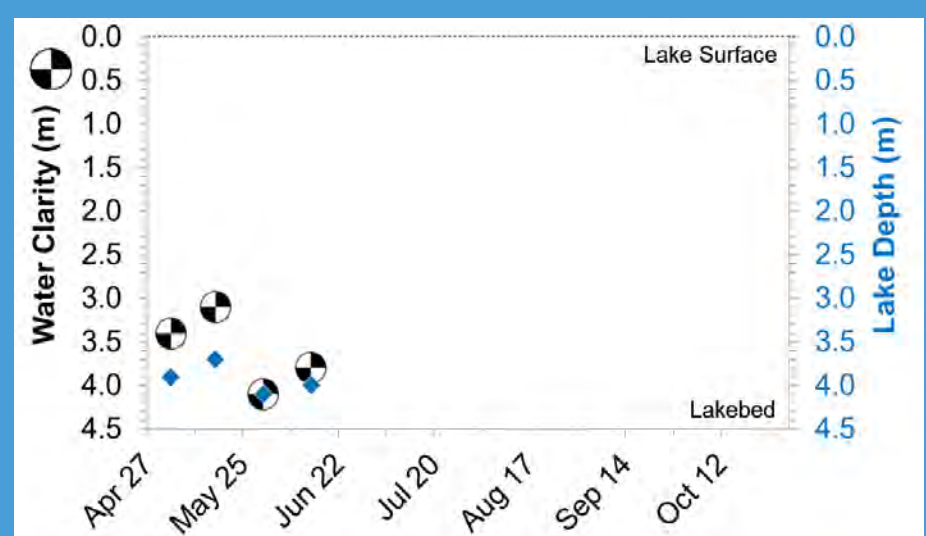
Water Clarity & Lake Depth

Water clarity is considered excellent if the lakebed is visible. Plant growth impeding lake bed visibility. The lakebed was last visible on May 31st.

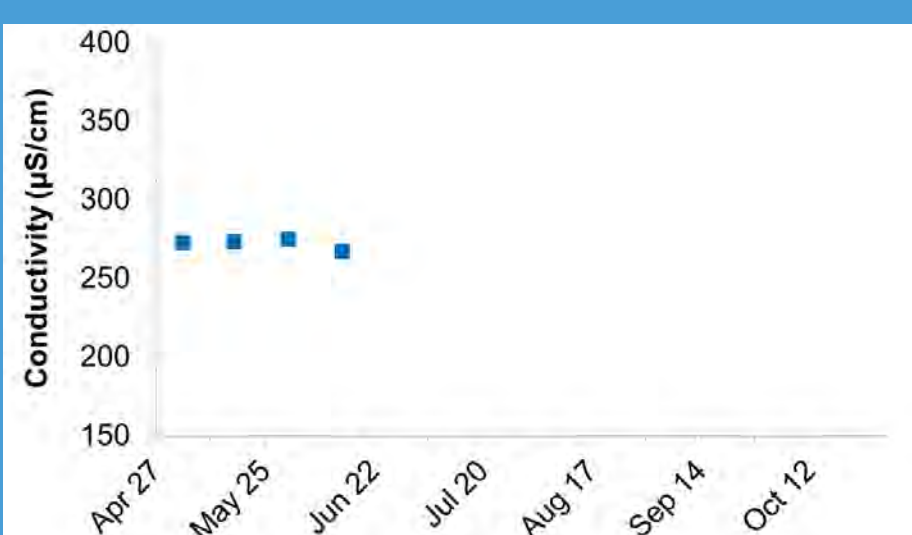
Surface Water Conductivity

Conductivity indicates the amount of dissolved material in the water. Value have been consistent over the season so far.

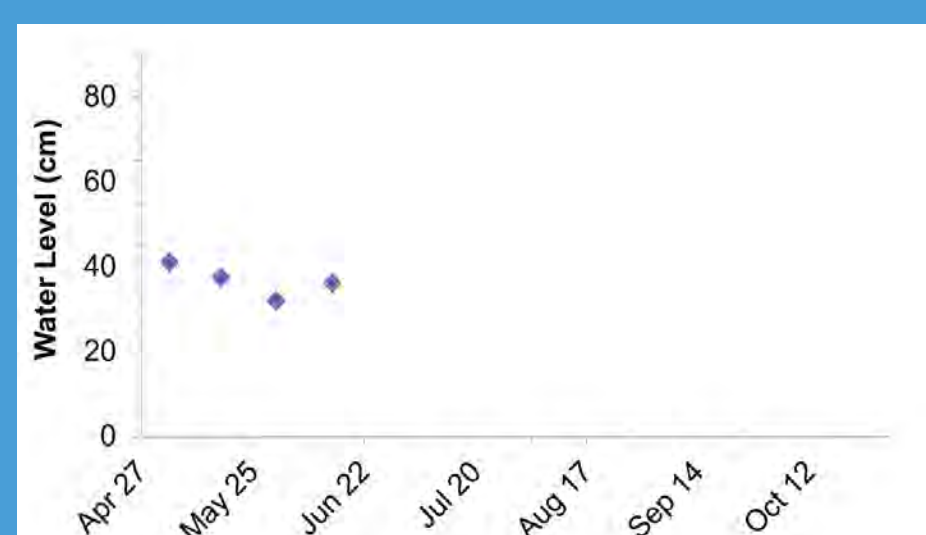
Lake Water Levels at McMurty Dr. Outflow

Little Lake water levels are closely linked to recent rainfall. Water levels are not managed, however the Town maintains the outflow structure.

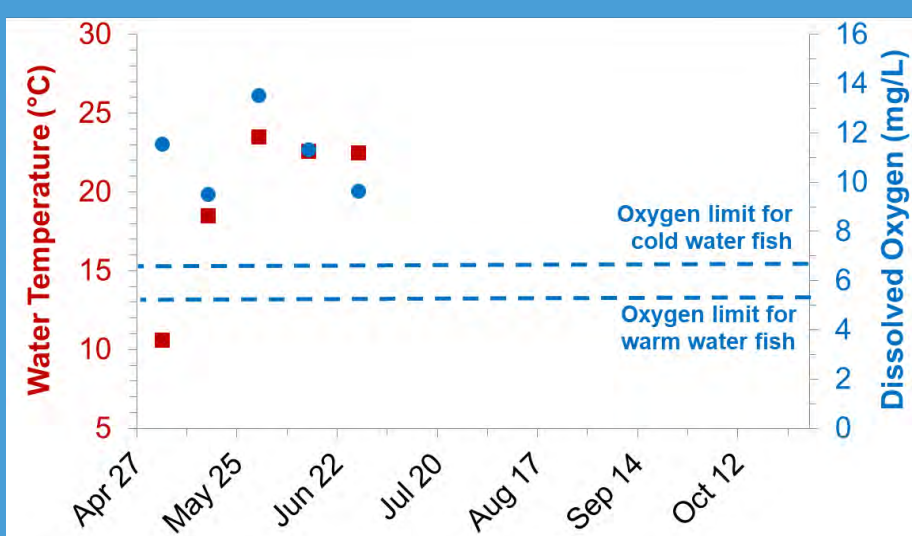
Surface Temperature & Bottom Water Dissolved Oxygen

Oxygen levels have remained above the Provincial Water Quality Objectives for cold and warm water fish.

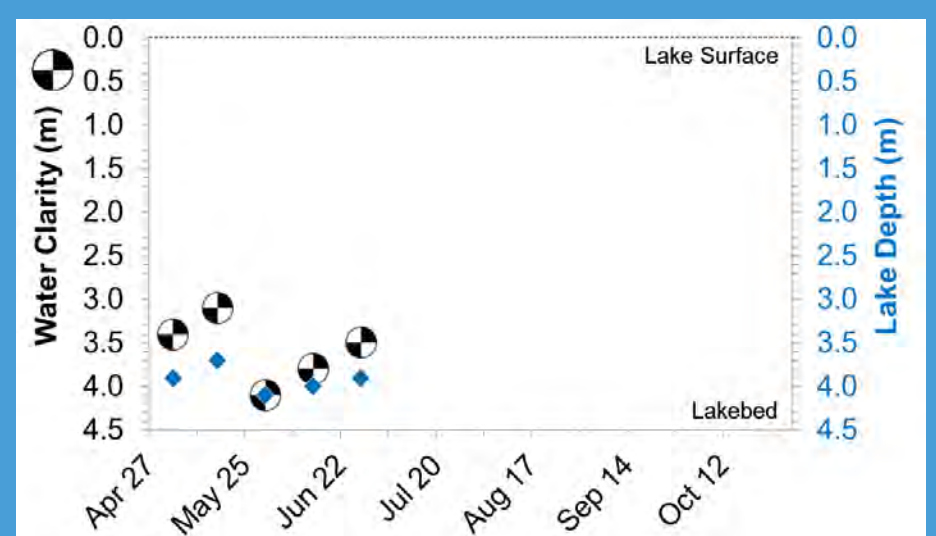
Water Clarity & Lake Depth

Water clarity is considered excellent if the lakebed is visible. Plant growth impeded lake bed visibility. The lakebed was last visible on May 31st.

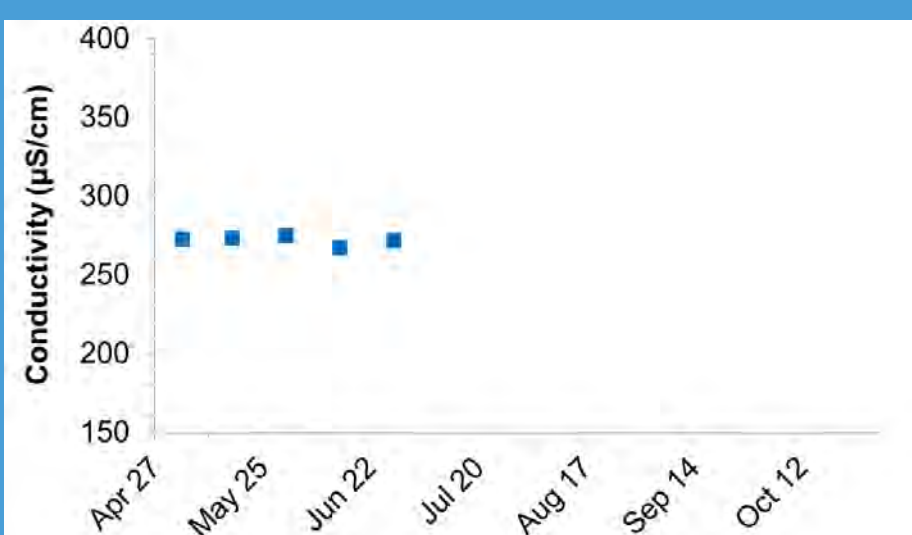
Surface Water Conductivity

Conductivity indicates the amount of dissolved material in the water. Value have been consistent over the season so far.

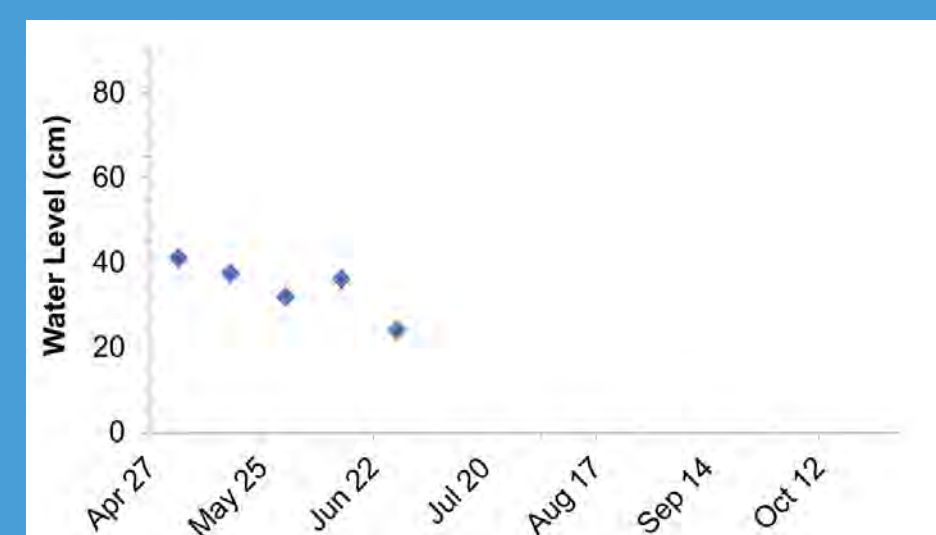
Lake Water Levels at McMurty Dr. Outflow

Little Lake water levels are closely linked to recent rainfall. Water levels are not managed, however the Town maintains the outflow structure.

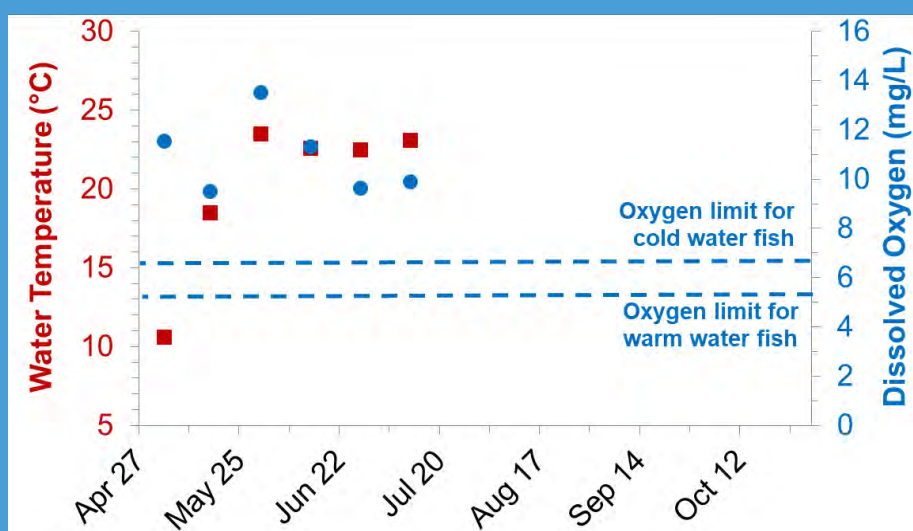
Surface Temperature & Bottom Water Dissolved Oxygen

Oxygen levels have remained above the Provincial Water Quality Objectives for cold and warm water fish.

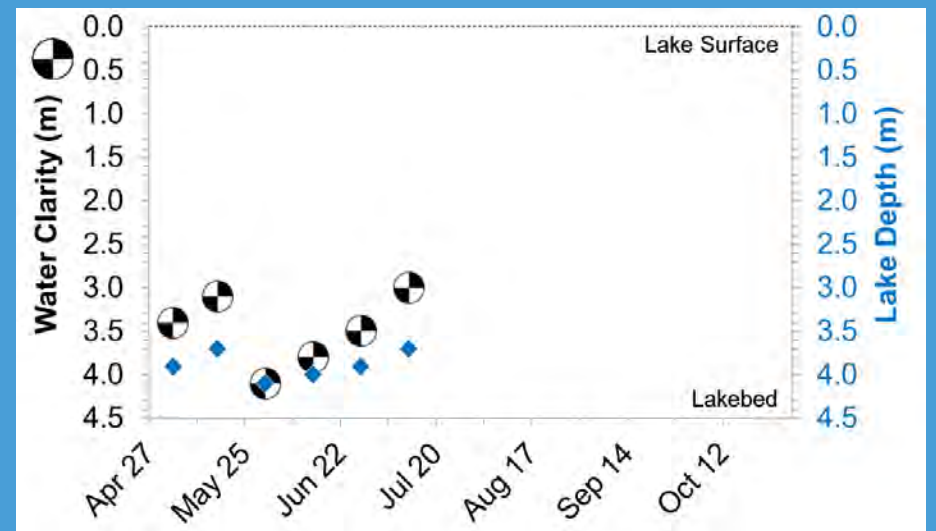
Water Clarity & Lake Depth

Water clarity is considered excellent if the lakebed is visible. Plant growth impeded lake bed visibility. The lakebed was last visible on May 31st.

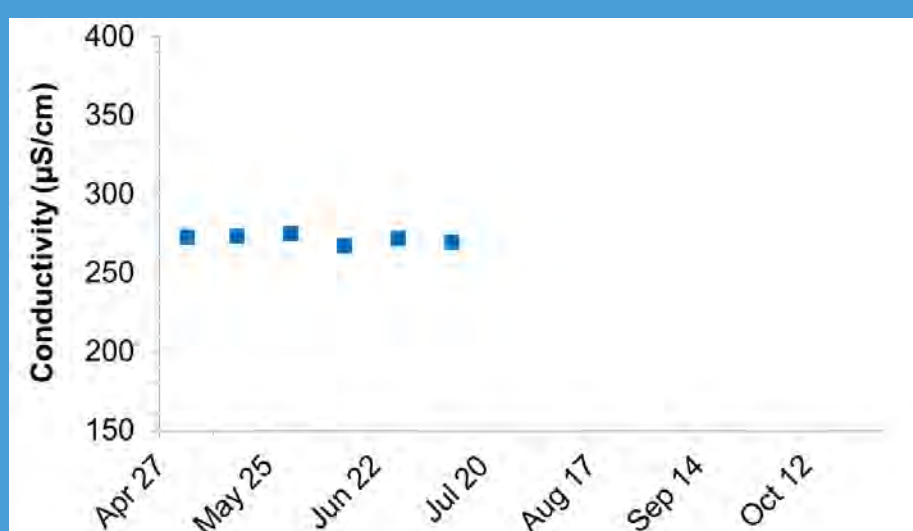
Surface Water Conductivity

Conductivity indicates the amount of dissolved material in the water. Values have been consistent over the season so far.

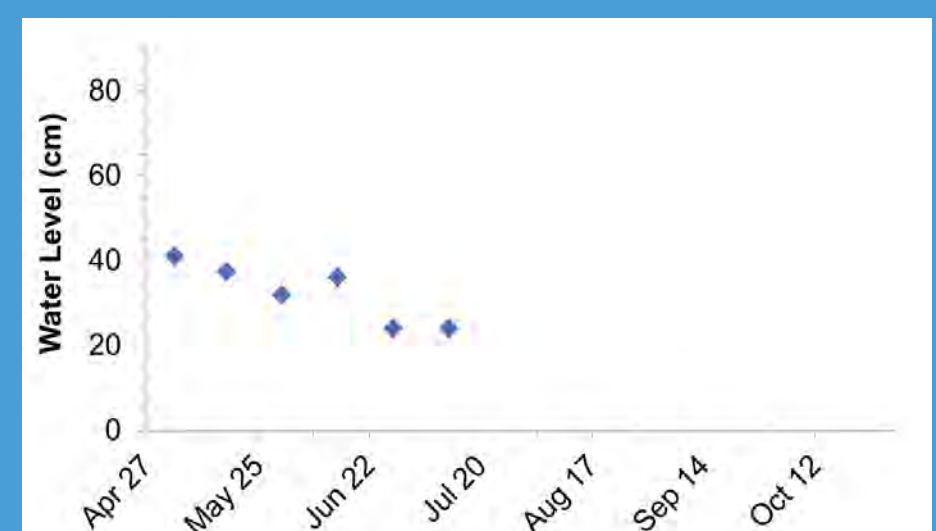
Lake Water Levels at McMurty Dr. Outflow

Little Lake water levels are closely linked to recent rainfall. Water levels are not managed, however the Town maintains the outflow structure.

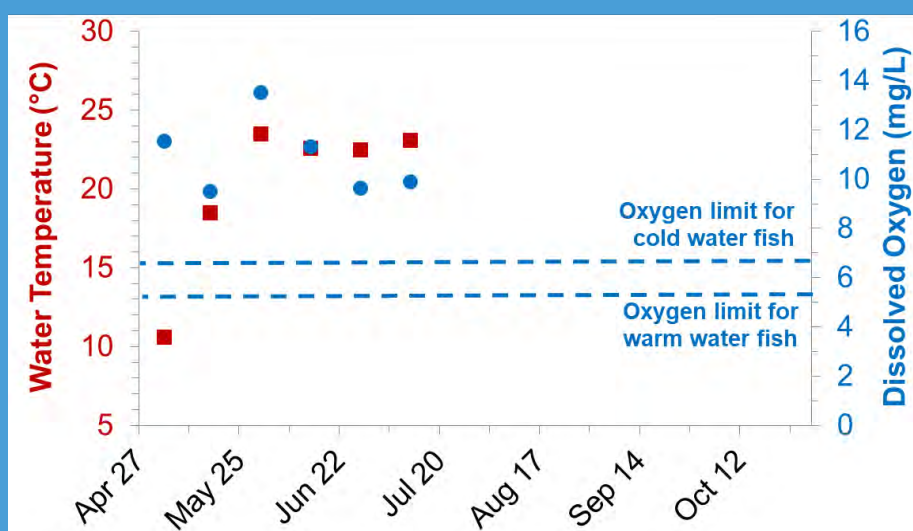
Surface Temperature & Bottom Water Dissolved Oxygen

Oxygen levels have remained above the Provincial Water Quality Objectives for cold and warm water fish.

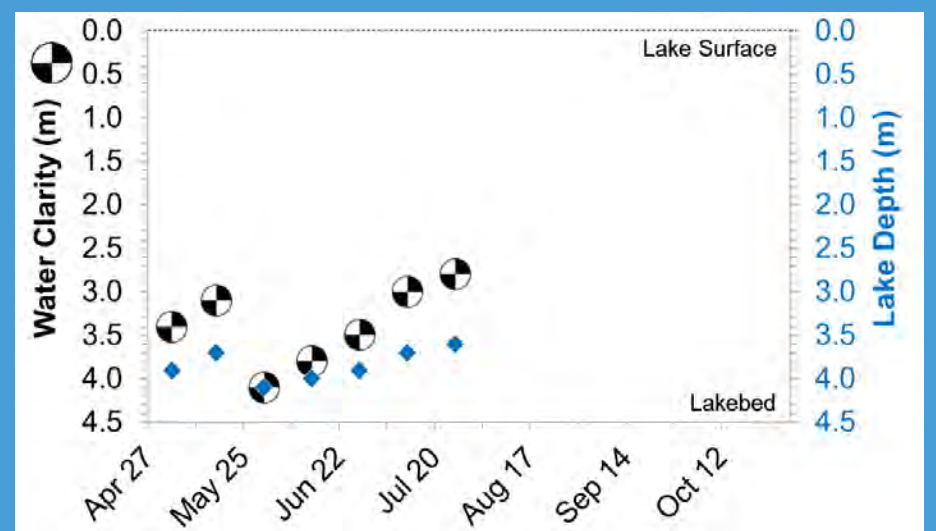
Water Clarity & Lake Depth

Water clarity is considered excellent if the lakebed is visible. Plant growth impeded lake bed visibility. The lakebed was last visible on May 31st.

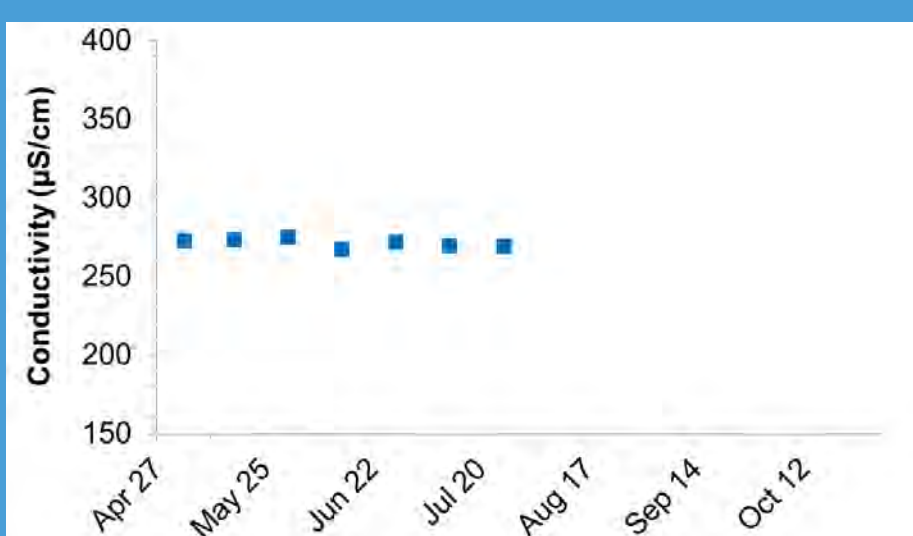
Surface Water Conductivity

Conductivity indicates the amount of dissolved material in the water. Values have been consistent over the season so far.

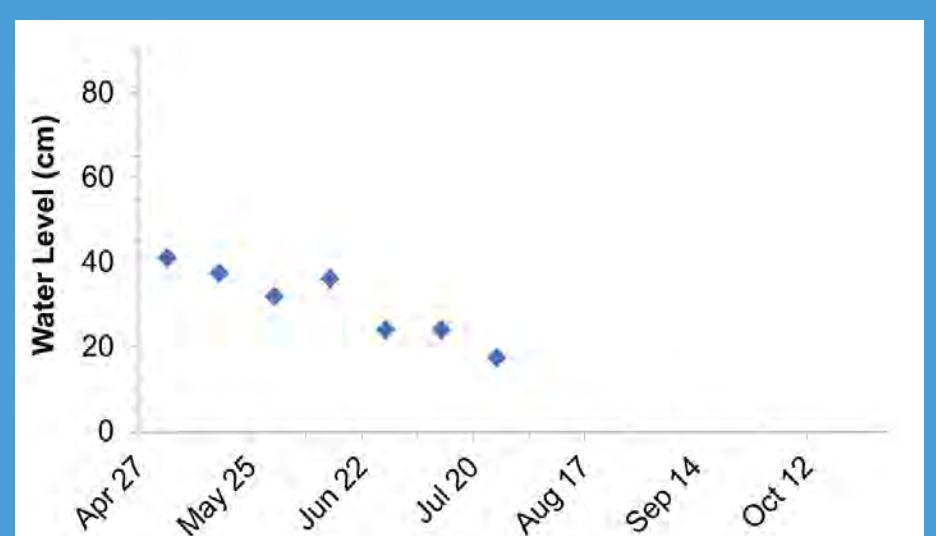
Lake Water Levels at McMurdy Dr. Outflow

Little Lake water levels are closely linked to recent rainfall. Water levels are not managed, however the Town maintains the outflow structure.

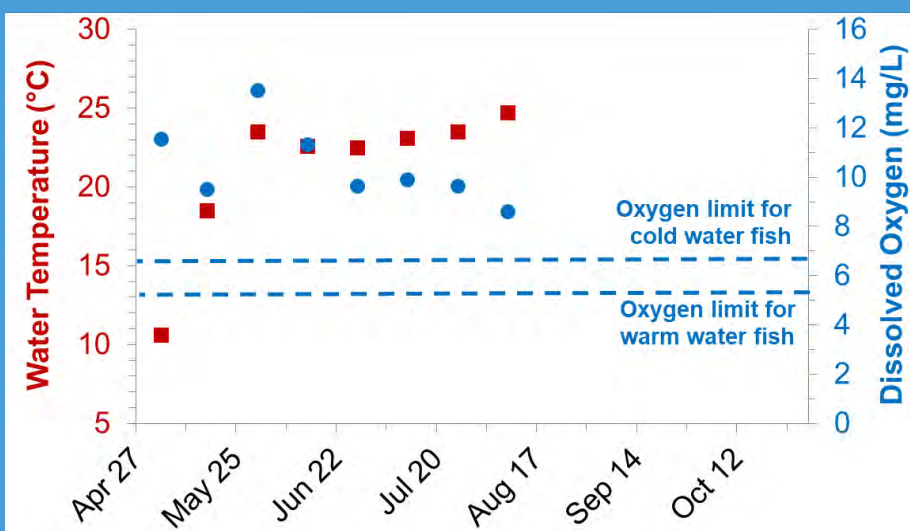
Surface Temperature & Bottom Water Dissolved Oxygen

Oxygen levels have remained above the Provincial Water Quality Objectives for cold and warm water fish, despite warming water temperatures.

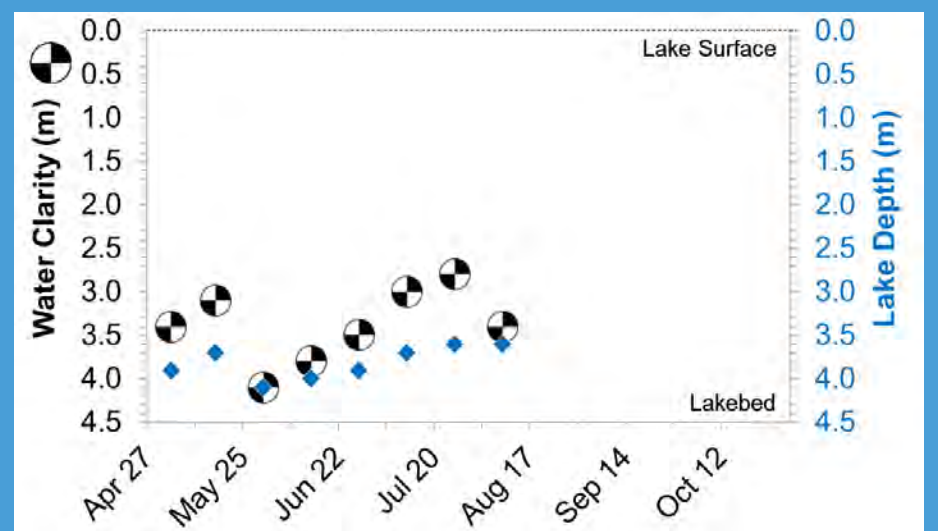
Water Clarity & Lake Depth

Water clarity is considered excellent if the lakebed is visible. Plant growth impeded lake bed visibility. The lakebed was last visible on May 31st.

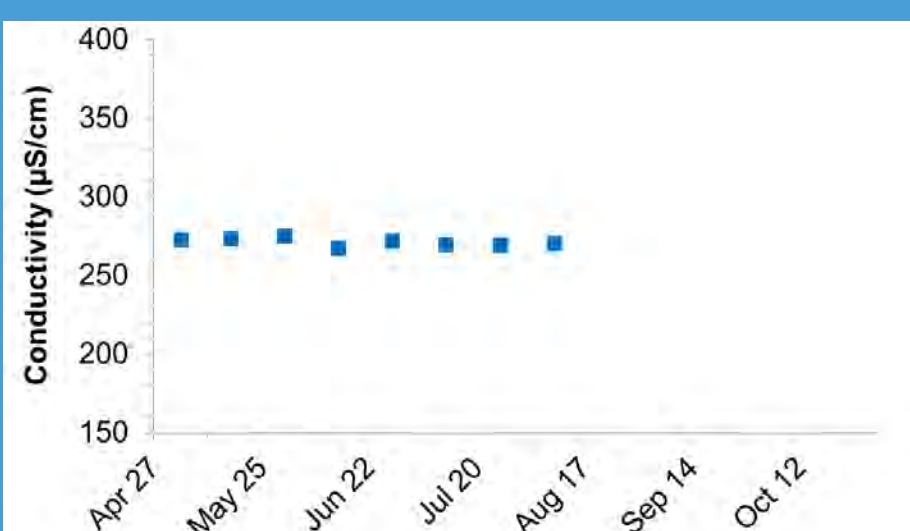
Surface Water Conductivity

Conductivity indicates the amount of dissolved material in the water. Values have been consistent over the season so far.

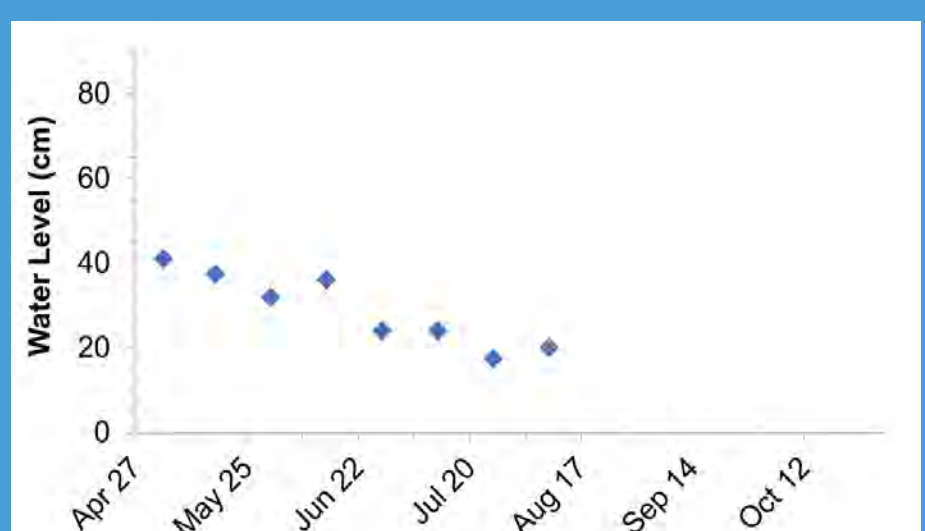
Lake Water Levels at McMurty Dr. Outflow

Little Lake water levels are closely linked to recent rainfall. Water levels are not managed, however the Town maintains the outflow structure.

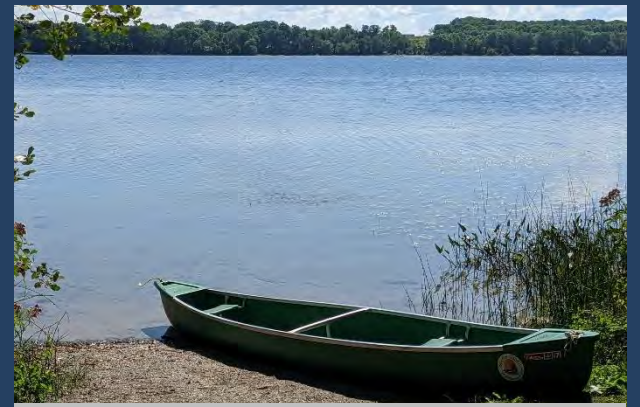
Water clarity is good when lakebed is visible. Water clarity has decreased slightly since August 9th and is mainly impeded by plant growth.

View from Little Lake boat launch

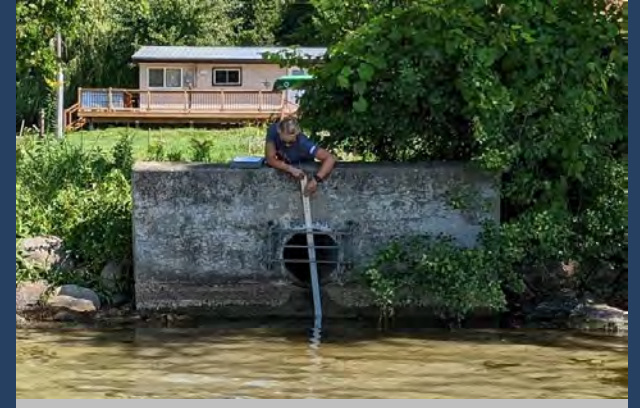
Readings taken at the McMurty Dr outflow structure indicate that levels have decreased since August 9th.

Little Lake outflow on McMurty Dr.

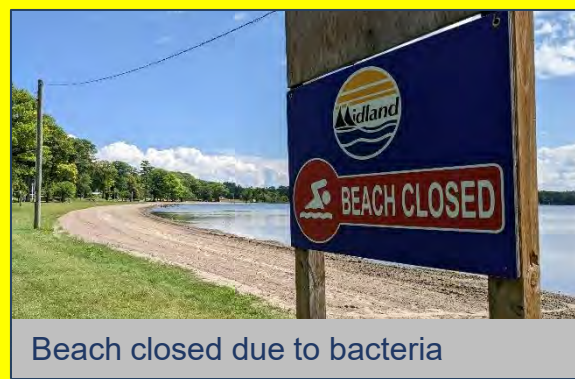
Beach closed due to bacteria

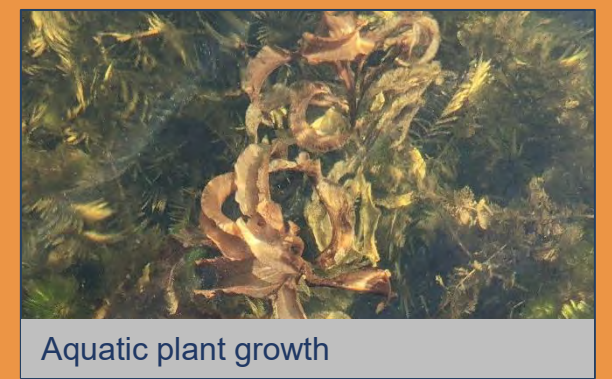
Aquatic plant growth

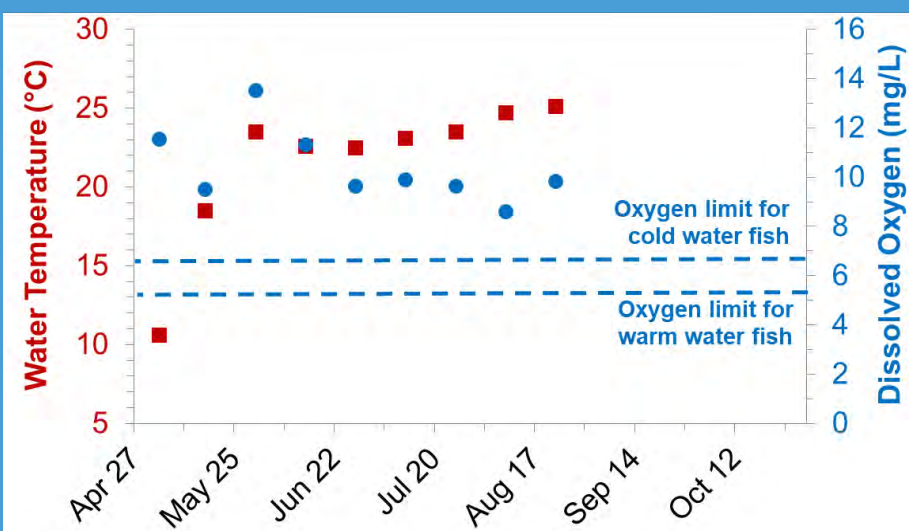
Surface Temperature & Bottom Water Dissolved Oxygen

Oxygen levels have remained above the Provincial Water Quality Objectives for cold and warm water fish, despite warming water temperatures.

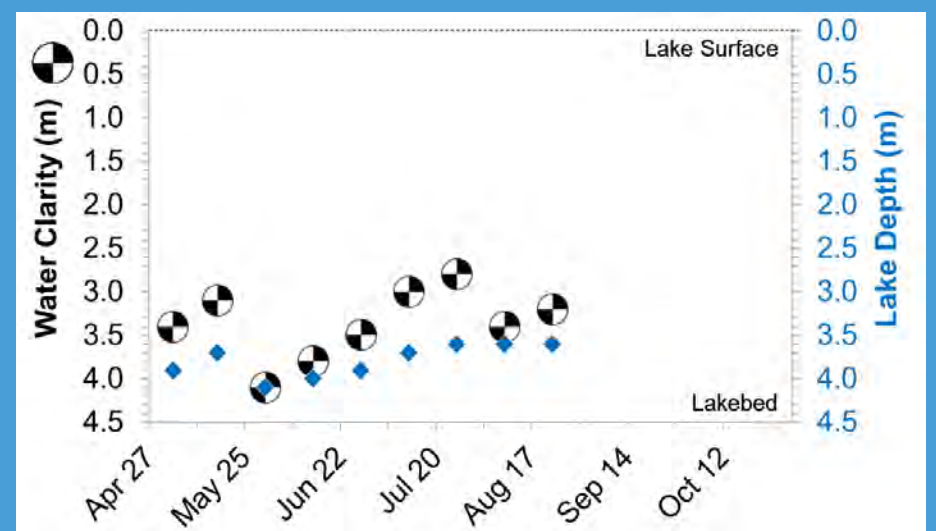
Water Clarity & Lake Depth

Water clarity is considered excellent if the lakebed is visible, which last occurred May 31st. Plant growth has impeded lake bed visibility.

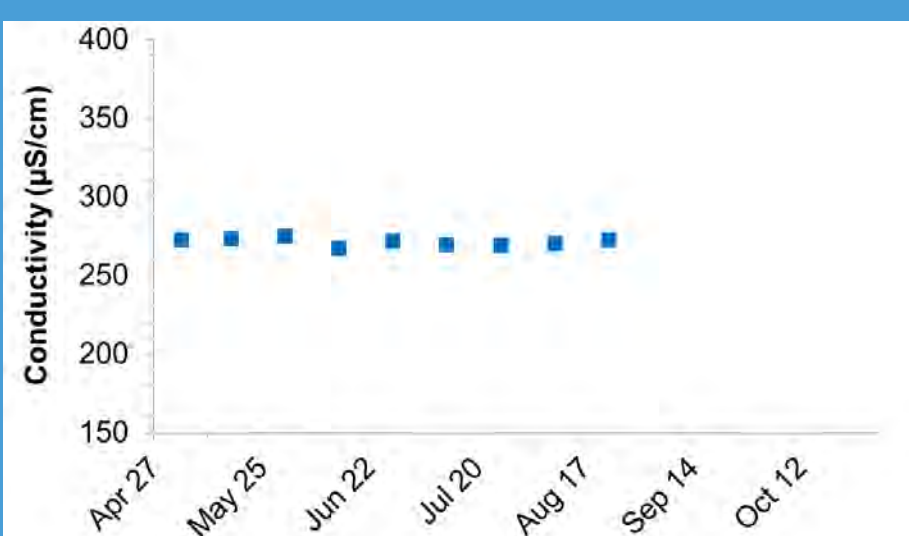
Surface Water Conductivity

Conductivity indicates the amount of dissolved material in the water. Values have been consistent over the season so far.

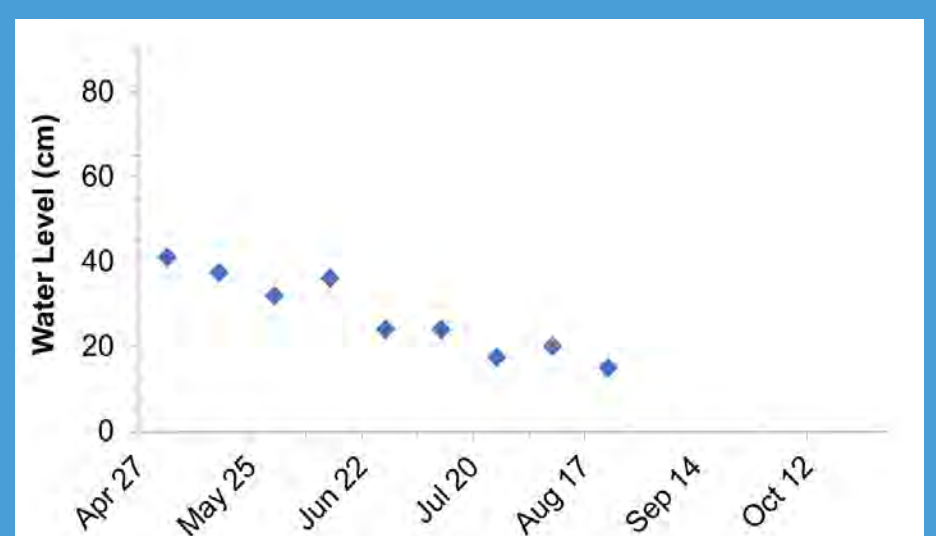
Lake Water Levels at McMurty Dr. Outflow

Little Lake water levels are closely linked to recent rainfall. Water levels are not managed, however the Town maintains the outflow structure.

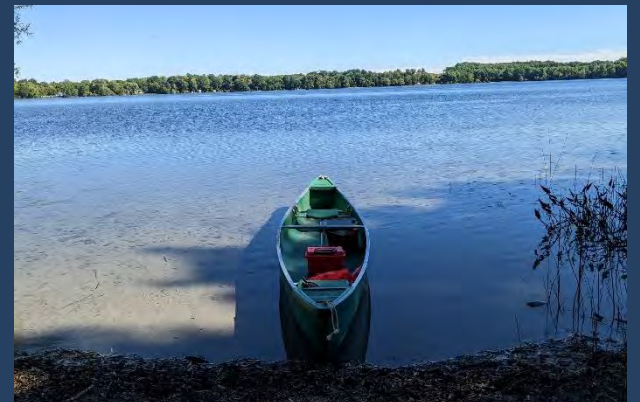
Water clarity is good when lakebed is visible. Water clarity has increased from August 23rd and the lakebed is now visible.

View from Little Lake boat launch

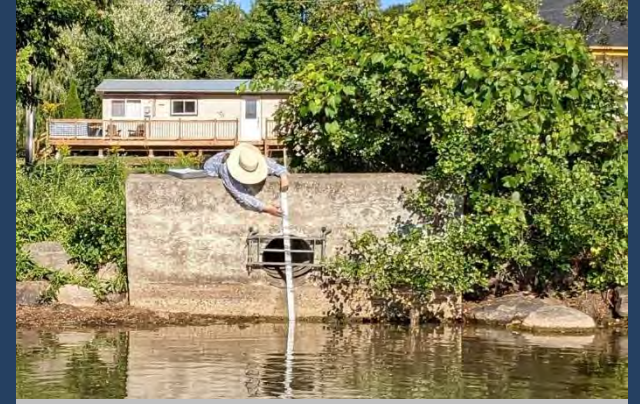
Readings taken at the McMurty Dr outflow structure indicate that levels have decreased steadily since early August.

Little Lake outflow on McMurty Dr.

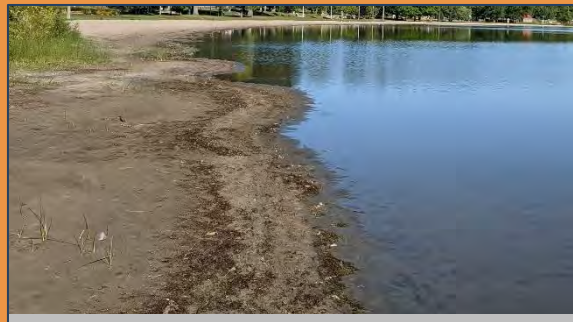
Plant material washed up onshore

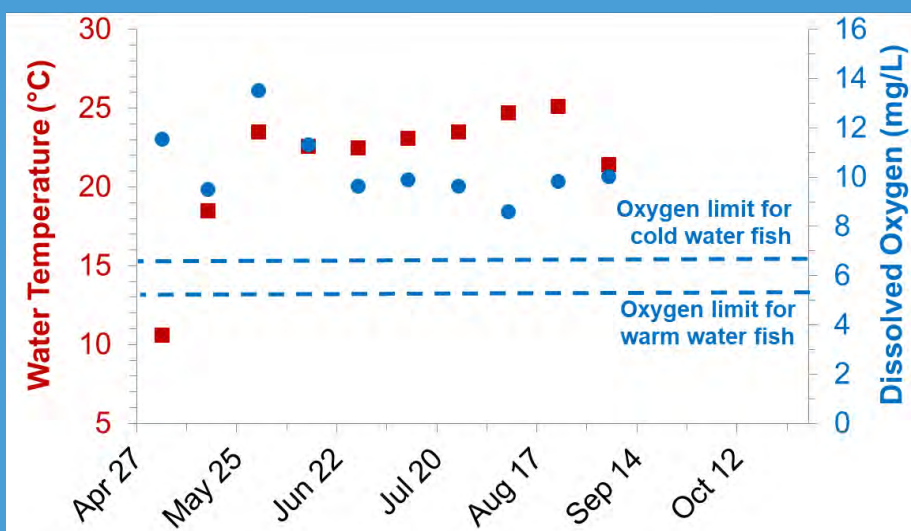
Surface Temperature & Bottom Water Dissolved Oxygen

Oxygen levels have remained above the Provincial Water Quality Objectives for cold and warm water fish.

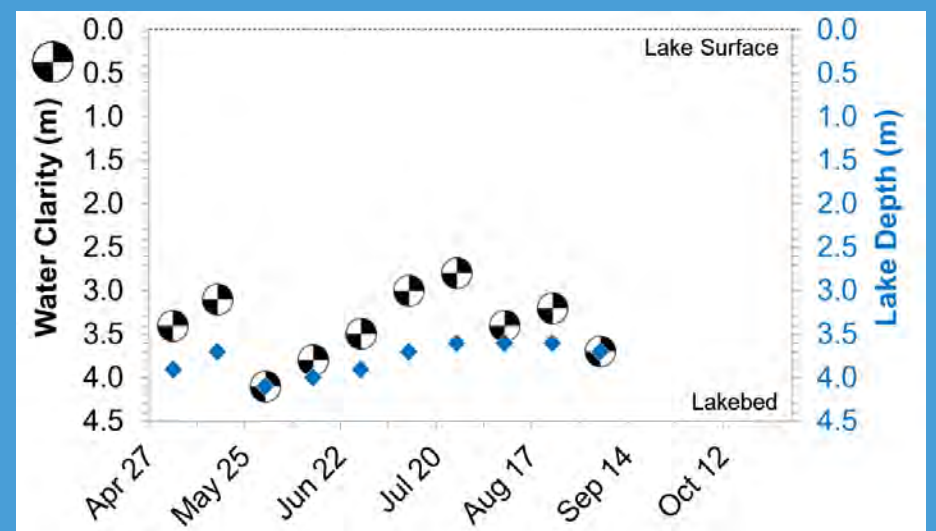
Water Clarity & Lake Depth

Water clarity is considered excellent if the lakebed is visible. Water clarity has increased since the last update, making the lakebed visible.

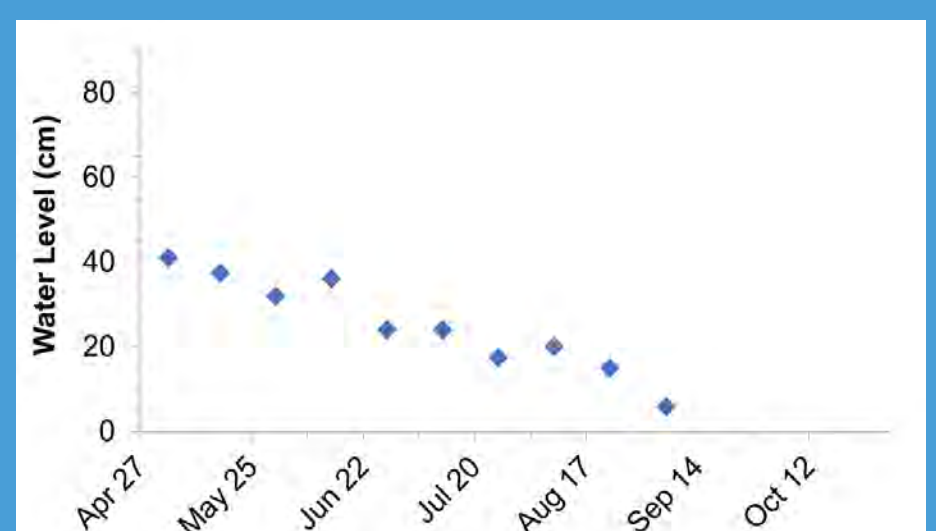
Lake Water Levels at McMurty Dr. Outflow

Little Lake water levels are closely linked to recent rainfall. Water levels are not managed, however the Town maintains the outflow structure.

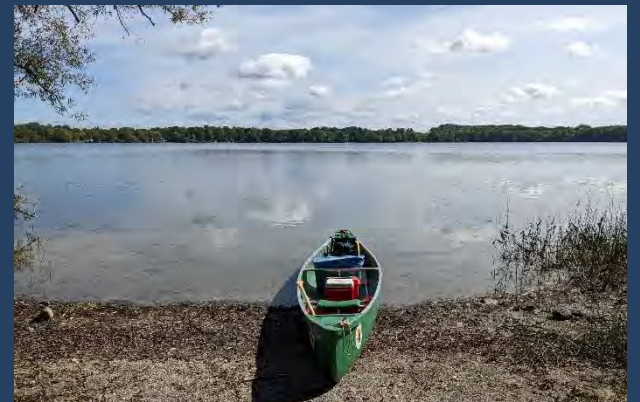
Water clarity is good when lakebed is visible. Water clarity has remained stable since September 6th and the lakebed is still visible.

View from Little Lake boat launch

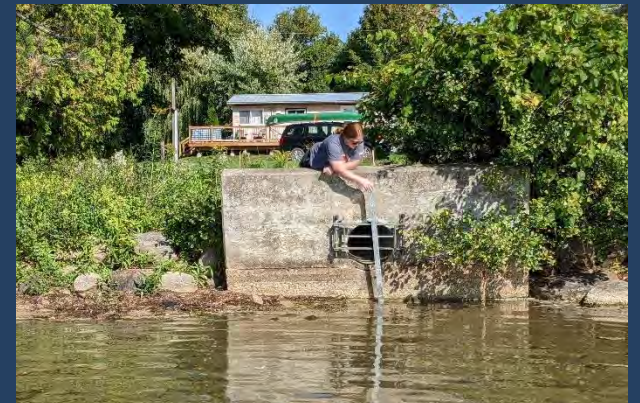
Readings taken at the McMurty Dr outflow structure indicate that levels have decreased steadily since early August.

Little Lake outflow on McMurty Dr.

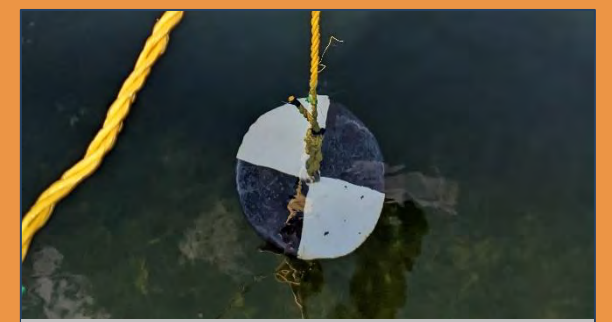
Measuring water clarity

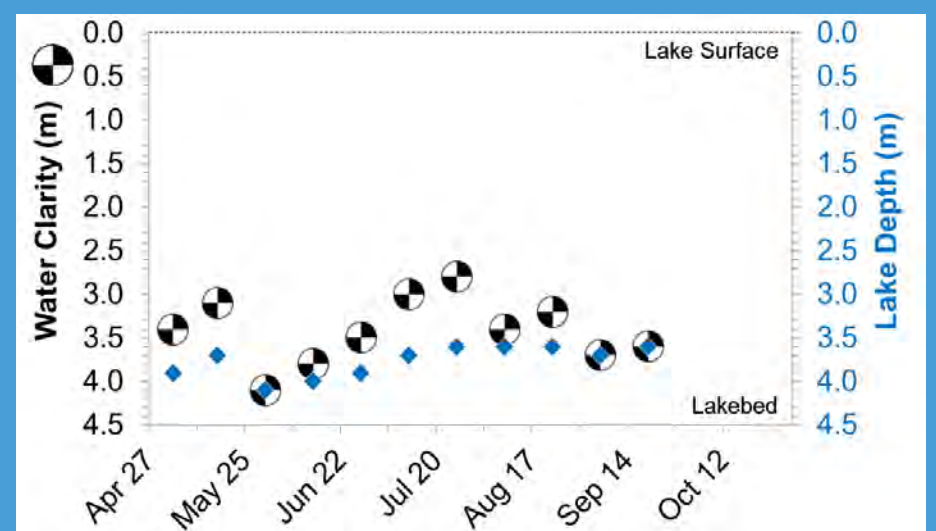
Water Clarity & Lake Depth

Water clarity is considered excellent if the lakebed is visible. Water clarity has remained stable with the lakebed still visible.
