LITTLE LAKE (Midland) CONDITIONS UPDATE

Sample Date: May 4, 2022
Next Sample: May 17, 2022
(weather permitting)

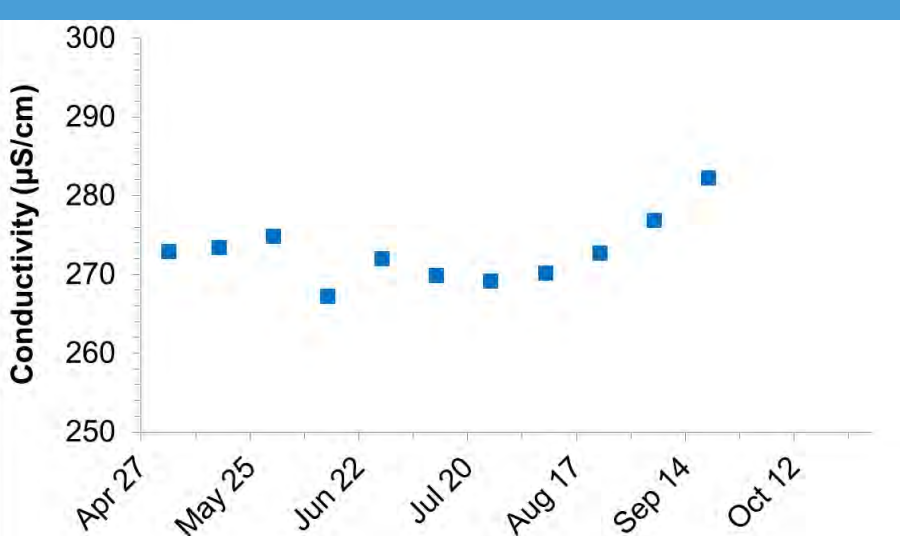
Surface Water Conductivity

Conductivity is related to the concentration of dissolved material in the water. Values have risen slightly, possibly due to a decrease in lake volume.

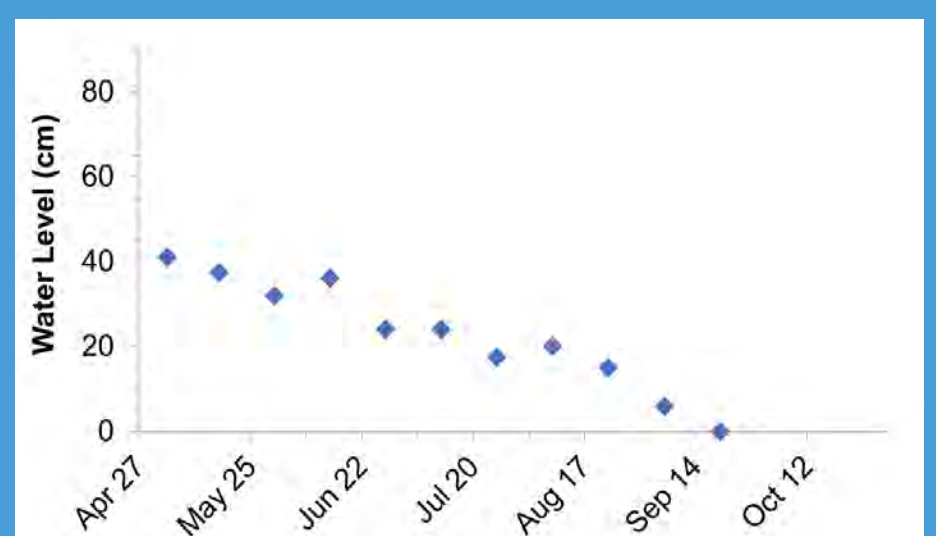
Lake Water Levels at McMurty Dr. Outflow

Little Lake water levels are closely linked to recent rainfall. Water levels are not managed, however the Town maintains the outflow structure.

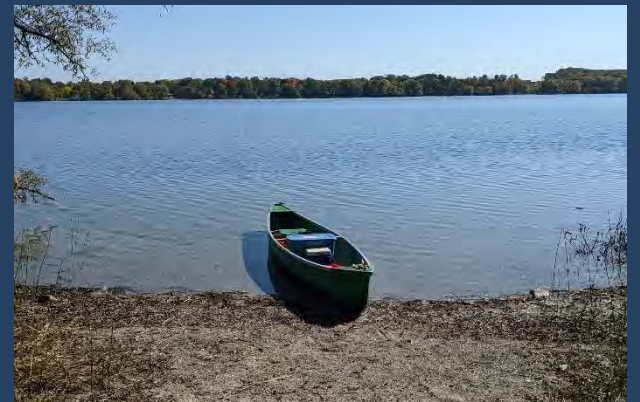
Water clarity is good when lakebed is visible. Water clarity has remained stable since September 6th and the lakebed is still visible.

View from Little Lake boat launch

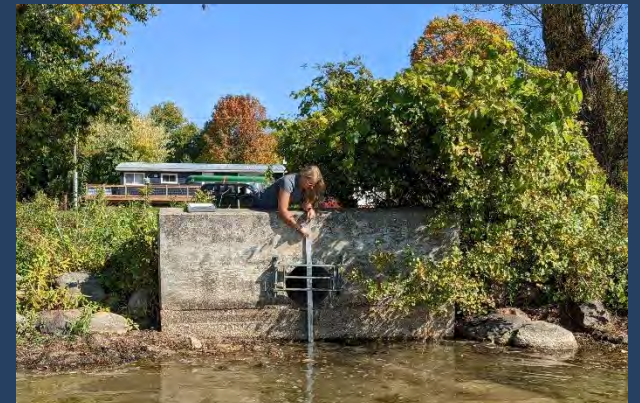
Readings taken at the McMurty Dr. outflow structure indicate that levels have increased since the last update on September 20th.

Little Lake outflow on McMurty Dr.

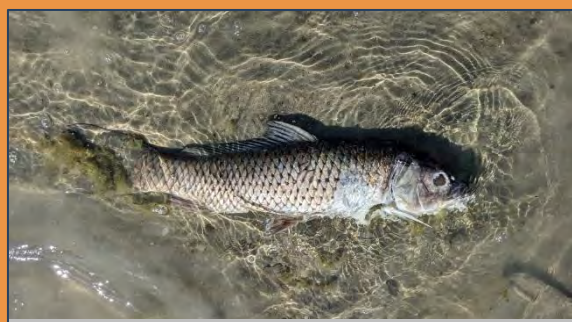
Dead Carp found near shoreline

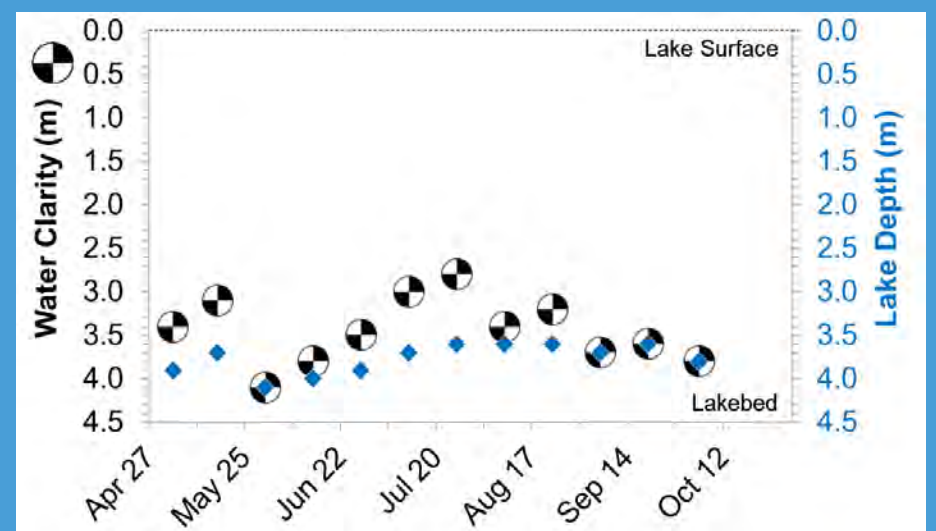
Water Clarity & Lake Depth

Water clarity is considered excellent if the lakebed is visible. Water clarity has remained stable since Aug 31st, with the lakebed still visible.

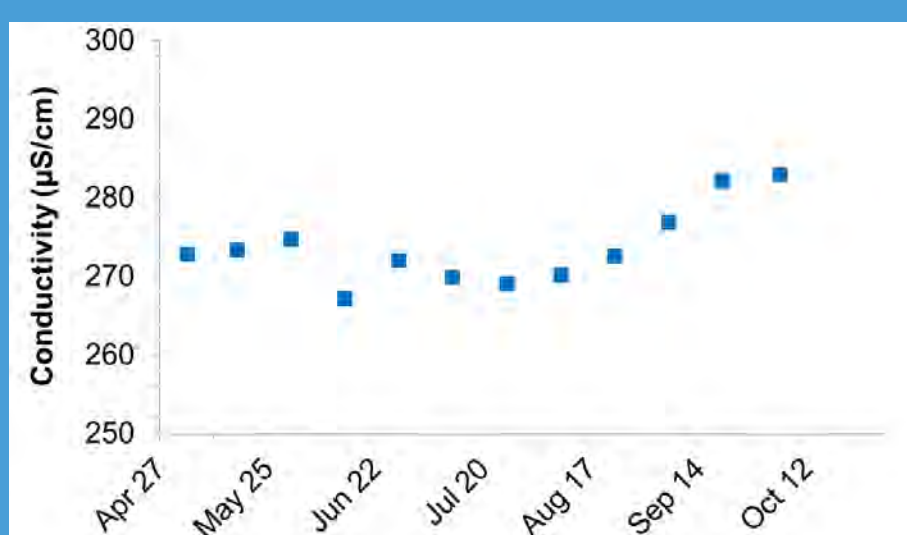
Surface Water Conductivity

Conductivity is related to the concentration of dissolved material in the water. Values have risen slightly, possibly due to a reduction in lake volume.

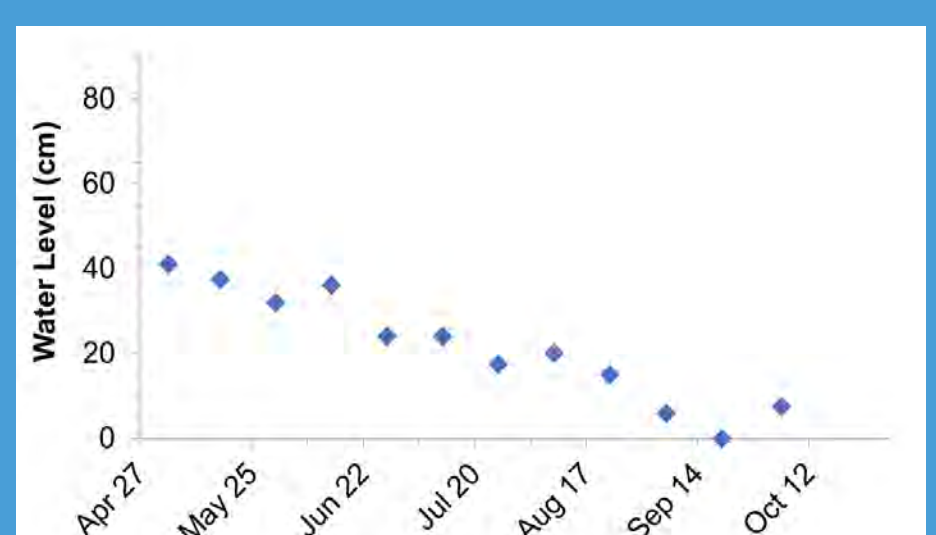
Lake Water Levels at McMurty Dr. Outflow

Little Lake water levels are closely linked to recent rainfall. Water levels are not managed, however the Town maintains the outflow structure.
