# **ORR LAKE CONDITIONS UPDATE**

# **July 19 2021**

# **ORR LAKE SEASONAL WATER QUALITY TRENDS**

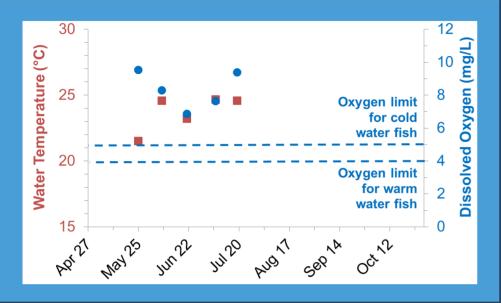
# Surface Temperature & Bottom Water Dissolved Oxygen

Oxygen levels have remained above the Provincial Water Quality Objectives for cold and warm water fish, although high temperatures may cause stress.

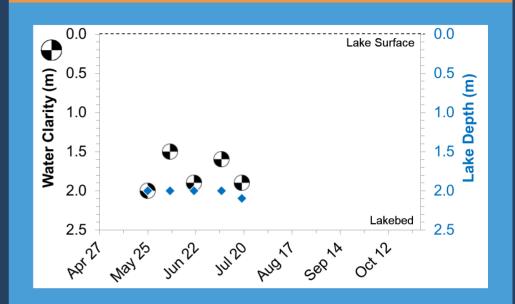
### **Water Clarity & Lake Depth**

Water clarity is considered good if the lakebed is visible. This has so far only been the case on May 25<sup>th</sup>. Algae and sediment contribute to low clarity.

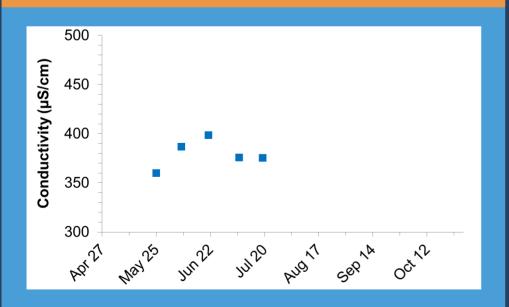
## **Surface Water Conductivity**

Conductivity indicates the amount of dissolved material in the water. Values are higher than other inland lakes in the area but similar to Bass Lake.

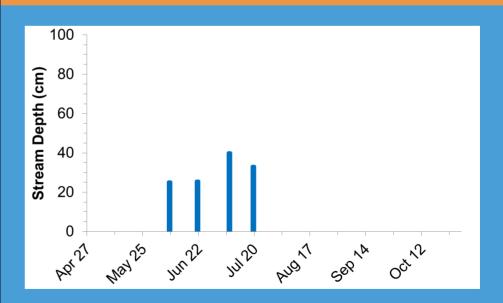
# Wye River Stream Depth (Baseline Rd.)

Wye River levels are closely linked to recent rainfall and the number logs in at the Orr Lake dam.

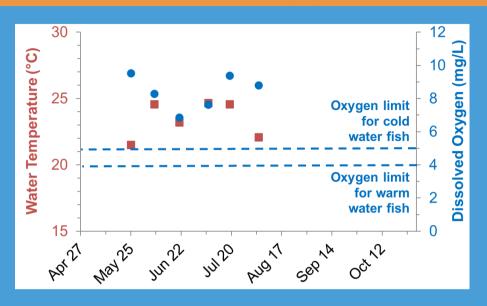
# Surface Temperature & Bottom Water Dissolved Oxygen

Oxygen levels have remained above the Provincial Water Quality Objectives for cold and warm water fish, although high temperatures may cause stress.

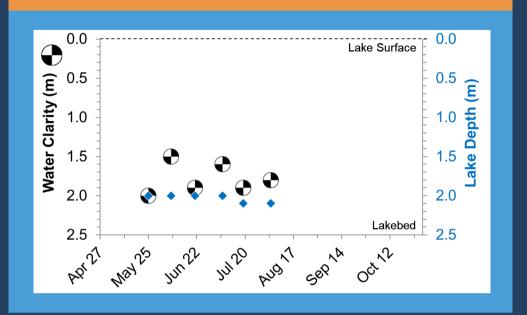
## **Water Clarity & Lake Depth**

Water clarity is considered good if the lakebed is visible. This has so far only been the case on May 25<sup>th</sup>. Algae and sediment contribute to low clarity.

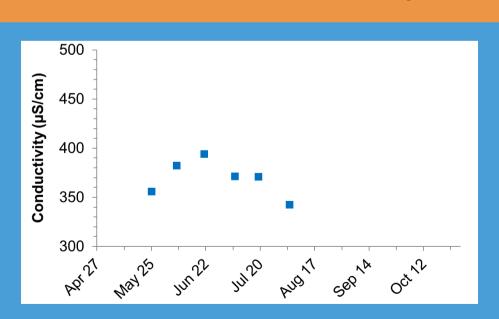
### **Surface Water Conductivity**

Conductivity indicates the amount of dissolved material in the water. Values are higher than other inland lakes in the area but similar to Bass Lake.

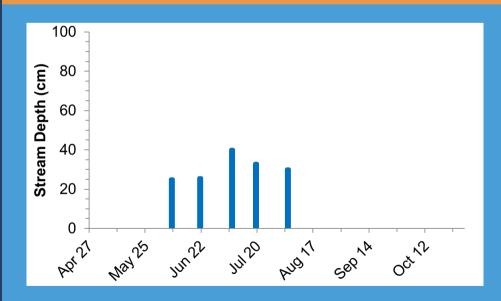
# Wye River Stream Depth (Baseline Rd.)

Wye River levels are closely linked to recent rainfall and the number logs in at the Orr Lake dam.

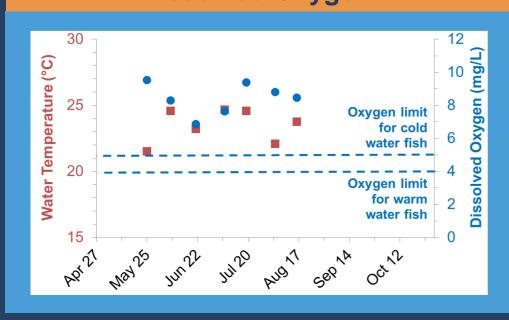
# **Surface Temperature & Bottom Water Dissolved Oxygen**

Oxygen levels have remained above the Provincial Water Quality Objectives for cold and warm water fish, although high temperatures may cause stress.

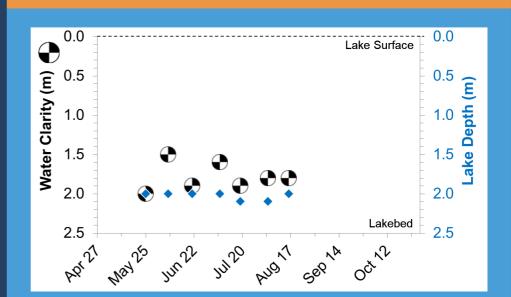
#### **Water Clarity & Lake Depth**

Water clarity is considered good if the lakebed is visible. This has so far only been the case on May 25<sup>th</sup>. Algae and sediment contribute to low clarity.

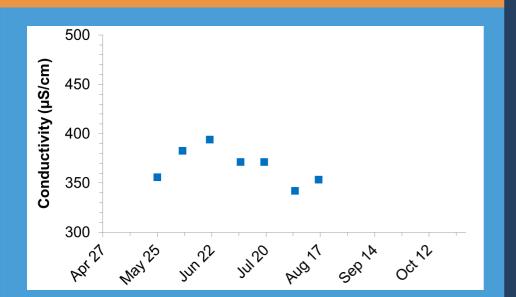
# **Surface Water Conductivity**

Conductivity indicates the amount of dissolved material in the water. Values are higher than other inland lakes in the area but similar to Bass Lake.

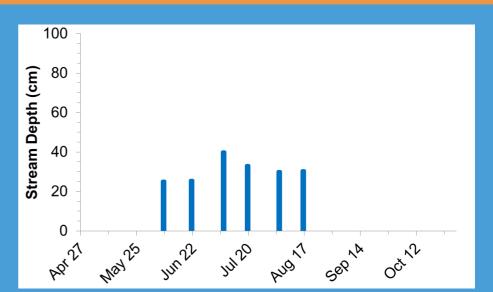
# **Wye River Stream Depth** (Baseline Rd.)

Wye River levels are closely linked to recent rainfall and the number logs in at the Orr Lake dam.

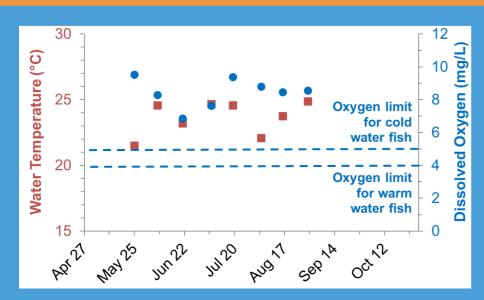
# **Surface Temperature & Bottom Water Dissolved Oxygen**

Oxygen levels have remained above the Provincial Water Quality Objectives for cold and warm water fish, although high temperatures may cause stress.

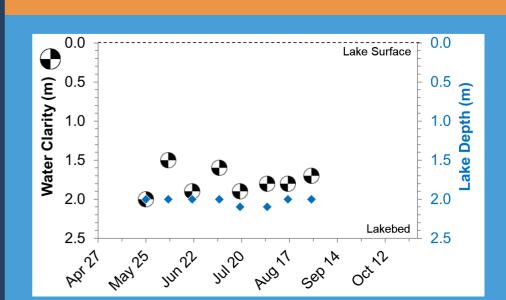
#### **Water Clarity & Lake Depth**

Water clarity is considered good if the lakebed is visible. This has so far only been the case on May 25<sup>th</sup>. Algae and sediment contribute to low clarity.

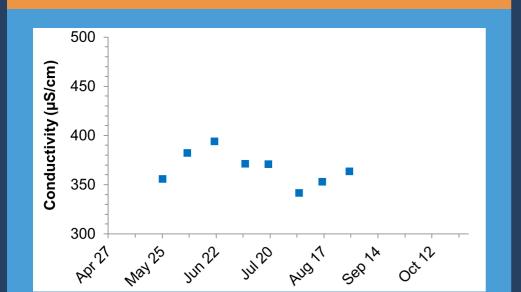
#### **Surface Water Conductivity**

Conductivity indicates the amount of dissolved material in the water. Values are higher than other inland lakes in the area but similar to Bass Lake.

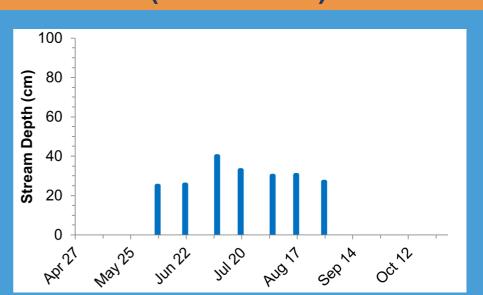
## **Wye River Stream Depth** (Baseline Rd.)

Wye River levels are closely linked to recent rainfall and the number logs in at the Orr Lake dam.

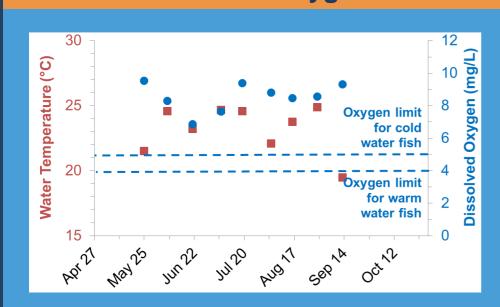
# **Surface Temperature & Bottom Water Dissolved Oxygen**

Oxygen levels have remained above the Provincial Water Quality Objectives for cold and warm water fish, and temperatures are now starting to cool off.

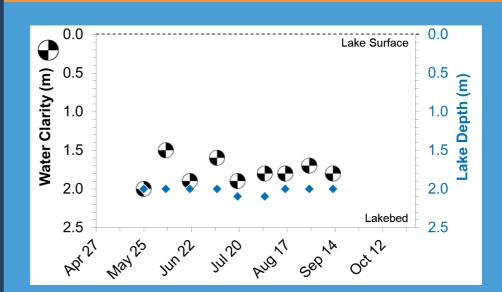
### **Water Clarity & Lake Depth**

Water clarity is considered good if the lakebed is visible. This has so far only been the case on May 25<sup>th</sup>. Algae and sediment contribute to low clarity.

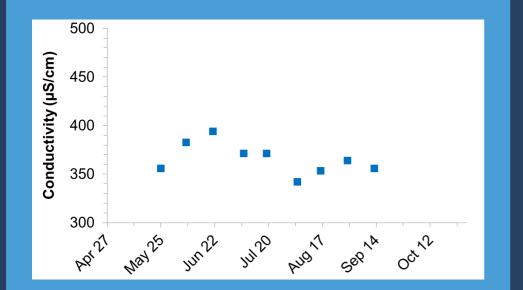
#### **Surface Water Conductivity**

Conductivity indicates the amount of dissolved material in the water. Values are higher than other inland lakes in the area but similar to Bass Lake.

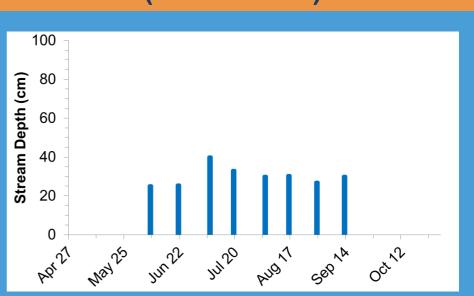
## **Wye River Stream Depth** (Baseline Rd.)

Wye River levels are closely linked to recent rainfall and the number logs in at the Orr Lake dam.

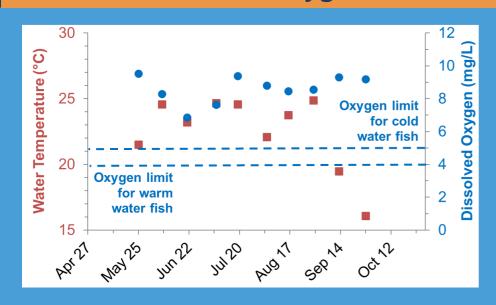
# **Surface Temperature & Bottom Water Dissolved Oxygen**

Oxygen levels have remained above the Provincial Water Quality Objectives for cold and warm water fish, even during periods of high temperatures.

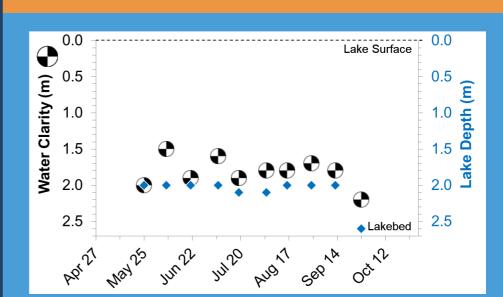
# **Water Clarity & Lake Depth**

Water clarity is considered good if the lakebed is visible. This has so far only been the case on May 25<sup>th</sup>. Algae and sediment contribute to low clarity.

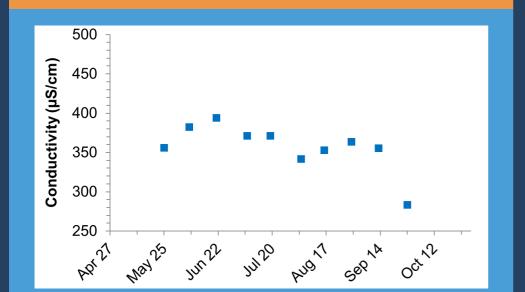
#### **Surface Water Conductivity**

Conductivity indicates the amount of dissolved material in the water. Values are higher than other inland lakes in the area but similar to Bass Lake.

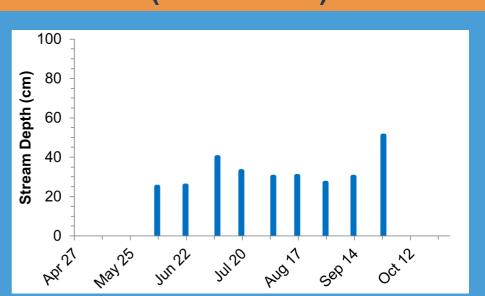
## **Wye River Stream Depth** (Baseline Rd.)

Wye River levels are closely linked to recent rainfall and the number logs in at the Orr Lake dam. Recent rain events led to higher water levels.

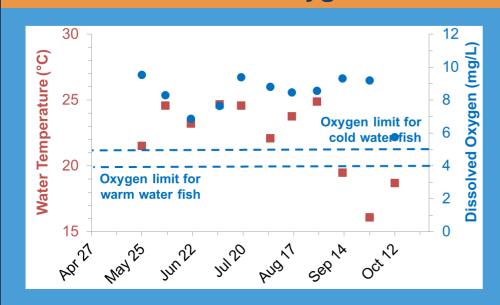
# **Surface Temperature & Bottom Water Dissolved Oxygen**

Oxygen levels have remained above the Provincial Water Quality Objectives for cold and warm water fish, even during periods of high temperatures.

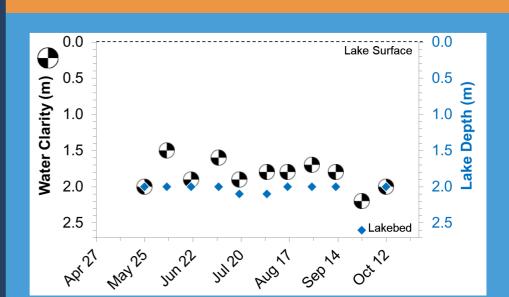
### **Water Clarity & Lake Depth**

Water clarity is considered good if the lakebed is visible. This was only the case on May 25th & Oct 12<sup>th</sup>. Algae and sediment contribute to low clarity.

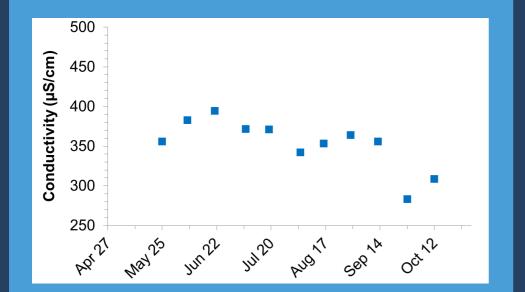
#### **Surface Water Conductivity**

Conductivity indicates the amount of dissolved material in the water. Values dropped recently with increased rainfall, which has a dilution effect.

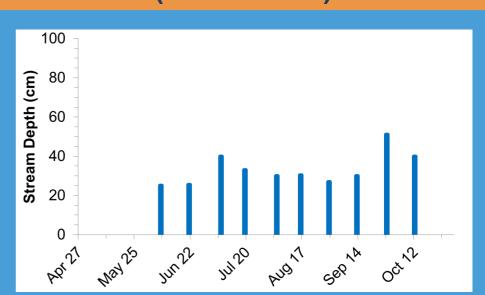
## **Wye River Stream Depth** (Baseline Rd.)

Wye River levels are closely linked to recent rainfall & the number logs in at the Orr Lake dam. High levels on Sept 28 occurred after heavy rains.
