# LITTLE LAKE (Midland) CONDITIONS UPDATE

Sample Date: May 8, 2023

# LITTLE LAKE (Midland)

## SEASONAL WATER QUALITY TRENDS

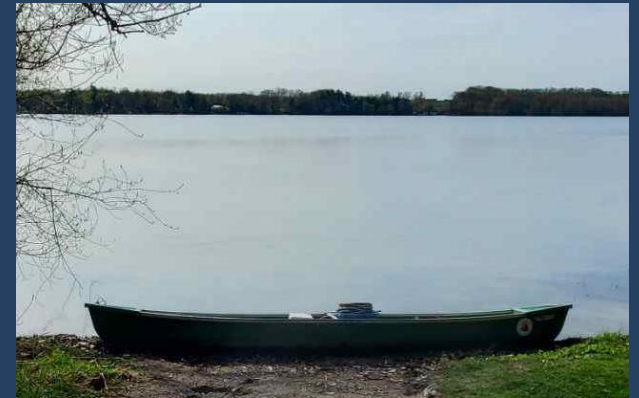
Water clarity is excellent when lakebed is visible. Clarity on May 8<sup>th</sup> was excellent.

View from Little Lake boat launch

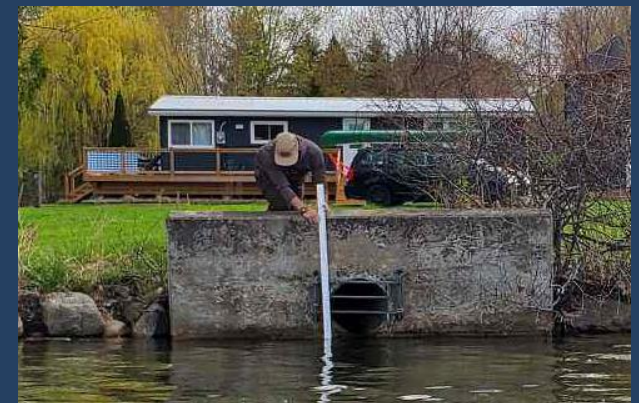
Readings taken at the McMurty Dr. outflow structure indicate that levels are slightly higher than this time last year.

Little Lake outflow on McMurty Dr.

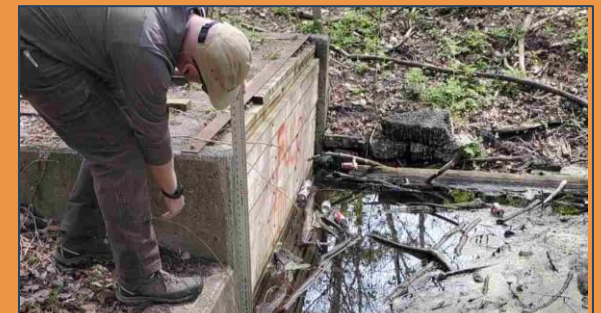
Staff measuring outlet water levels

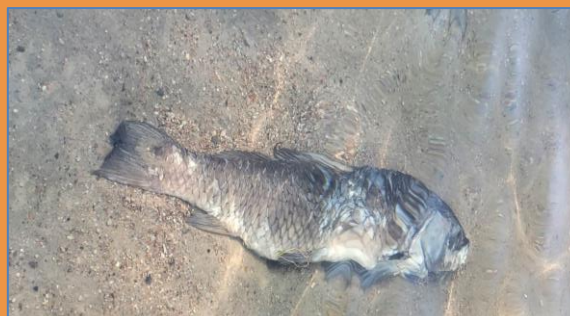
- Water clear
- Foam along beach
- Lake bottom is visible through plant growth
- Dead carp on beach, fishy smell

Dead carp on beach

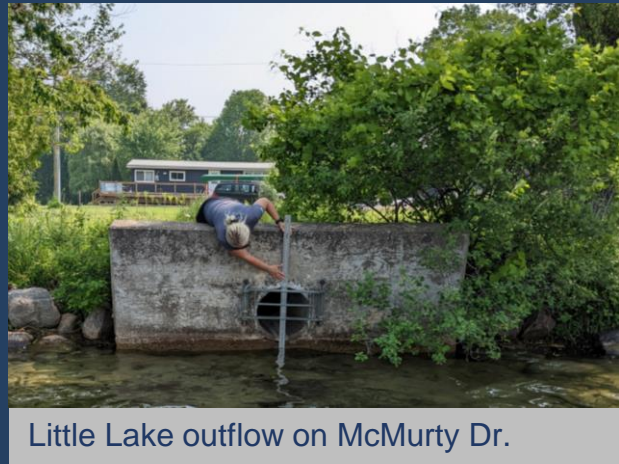
Readings taken at the McMurty Dr. outflow structure indicate that levels have decreased since the last update on May 23<sup>rd</sup>.

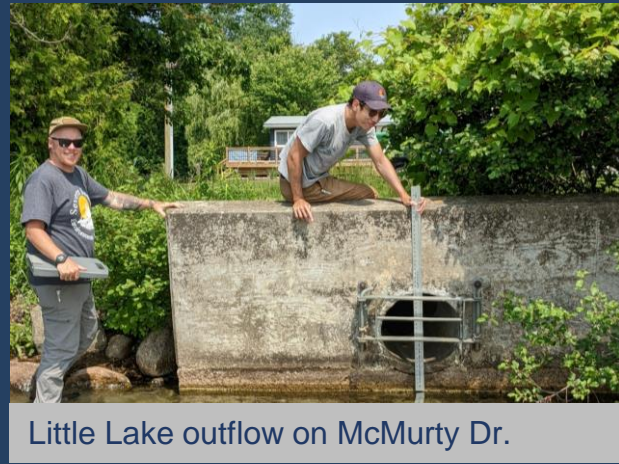
Little Lake outflow on McMurty Dr.

Readings taken at the McMurty Dr. outflow structure indicate that levels have decreased since the last update on Jun 6<sup>th</sup>.

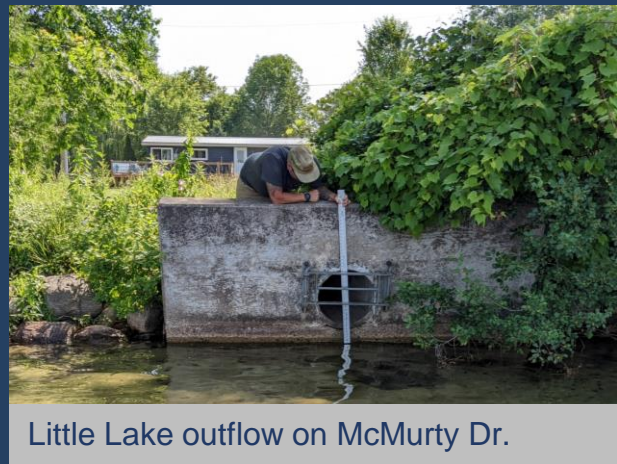
Little Lake outflow on McMurty Dr.

Readings taken at the McMurty Dr. outflow structure indicate that levels have been stable since the last update on Jun 19<sup>th</sup>.

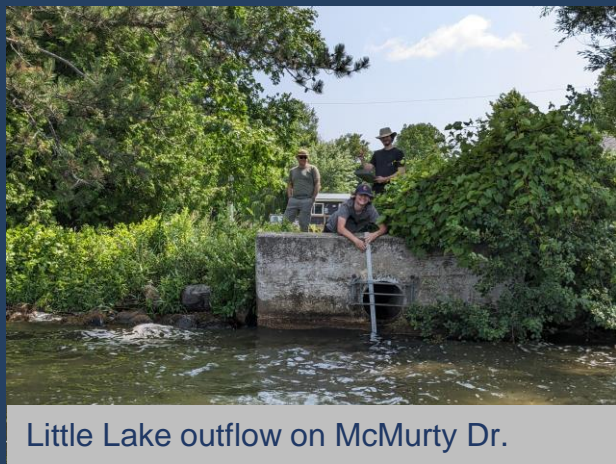
Little Lake outflow on McMurty Dr.

Readings taken at the McMurty Dr. outflow structure indicate that levels have increased since the last update on July 5<sup>th</sup> in response to recent rainfall.

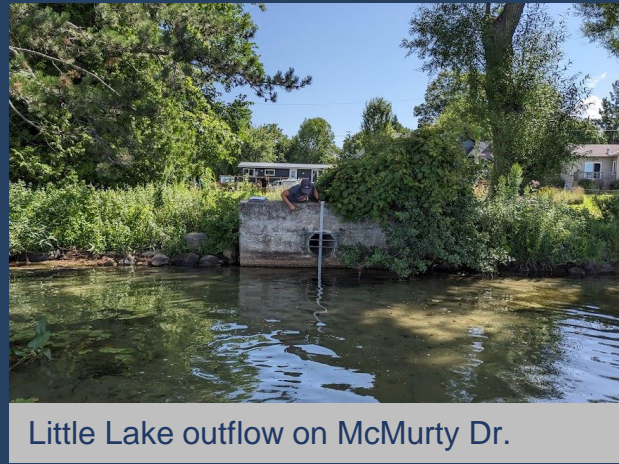
Little Lake outflow on McMurty Dr.

Readings taken at the McMurty Dr. outflow structure indicate that levels have increased slightly since the last update on July 17th.

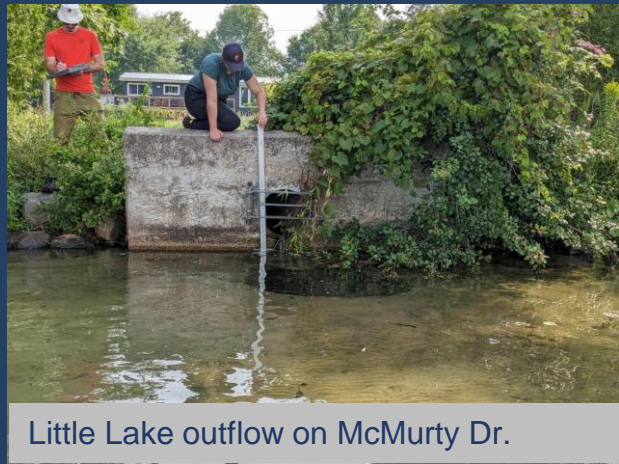
Little Lake outflow on McMurty Dr.

Readings taken at the McMurty Dr. outflow structure indicate that levels have decreased by 5 cm since the last update on Jul 31<sup>st</sup>.

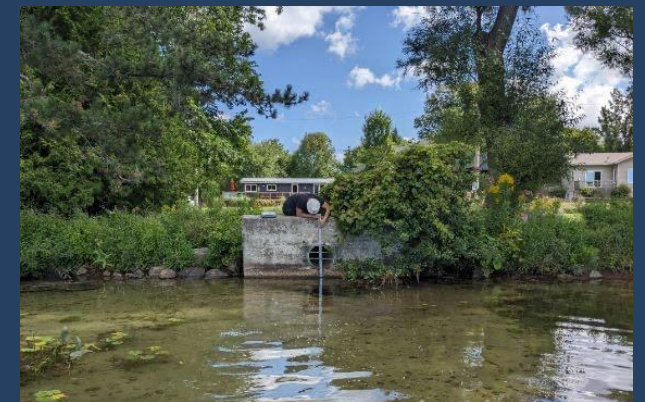
Little Lake outflow on McMurty Dr.

Readings taken at the McMurty Dr. outflow structure indicate that levels have decreased since the last update on August 15.

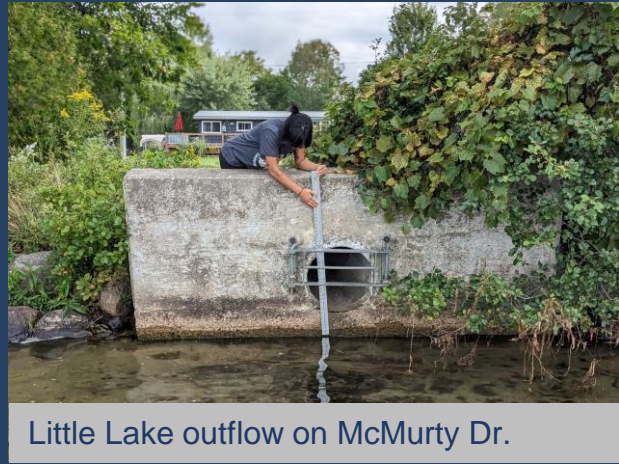
Readings taken at the McMurty Dr. outflow structure indicate that levels have dropped since the last update on Aug 28.

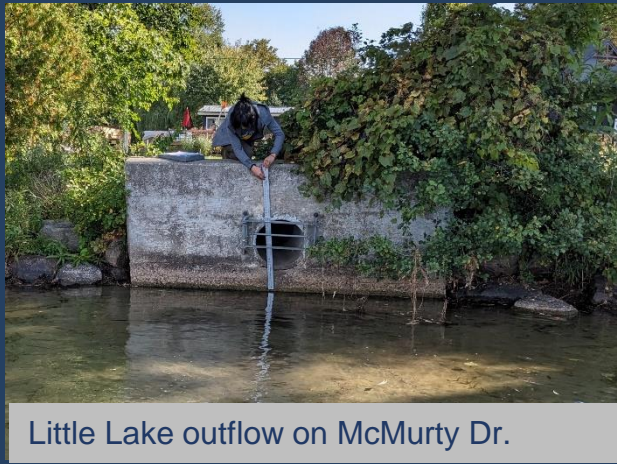
Readings taken at the McMurty Dr. outflow structure indicate that levels have decreased since the last update on Sept 11<sup>th</sup>.

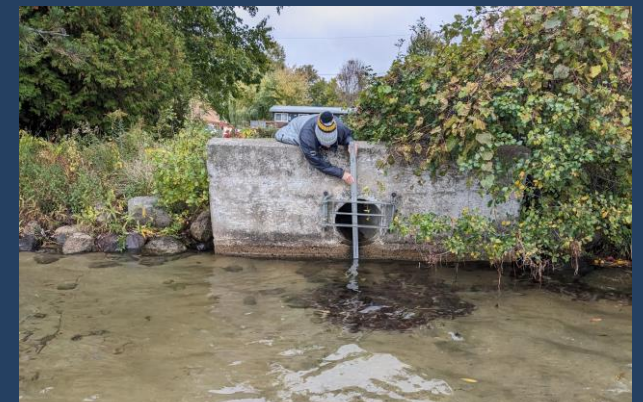
Readings taken at the McMurty Dr. outflow structure indicate that levels have increased since the last update on Sept 25th.

Little Lake outflow on McMurty Dr.

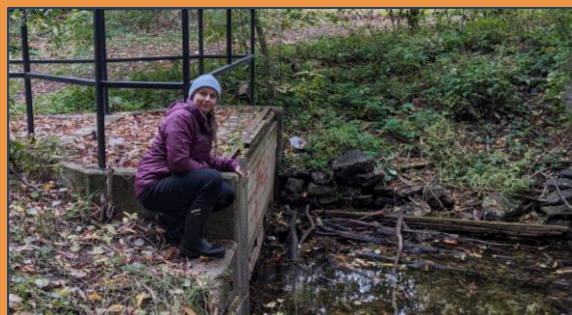
Little Lake outlet structure
